## INSTRUCTION TO SERVICE

**ITS: 5825**

| <b>SUBJECT:</b> | Replace brake pedal mounting plate and BVA valve |

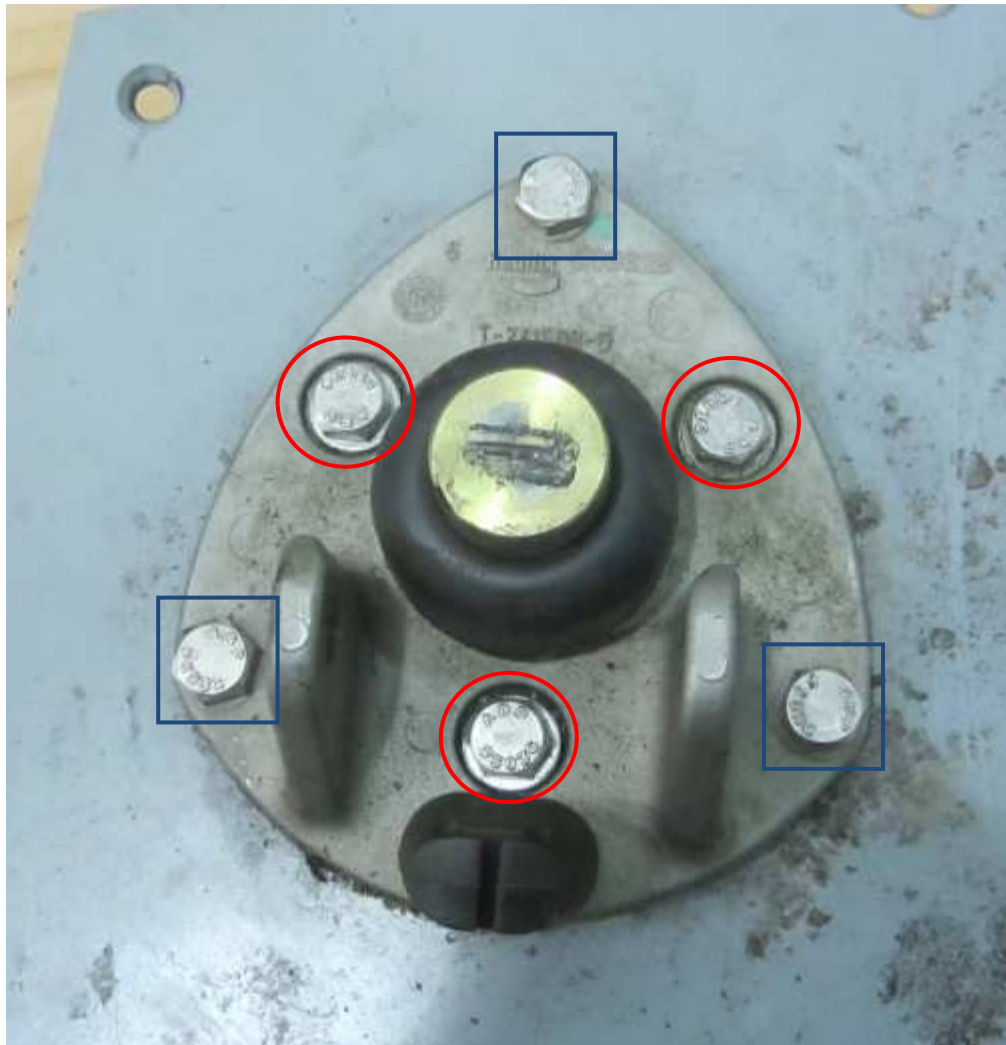
**Figure 6: Pedal Mount**

16. Remove the pedal plunger and rubber boots, set aside for reuse.
17. Remove 3 inner bolts shown by three circles in Figure 6 and disconnect the valve assembly. Set aside the hardware for reuse.
18. Remove 3 outer bolts shown by three squares in Figure 6 and disconnect the pedal mount from the pedal plate. Discard lock nuts and retain all remaining hardware for reuse.
19. Discard the brake pedal mounting plate (stainless steel plate).

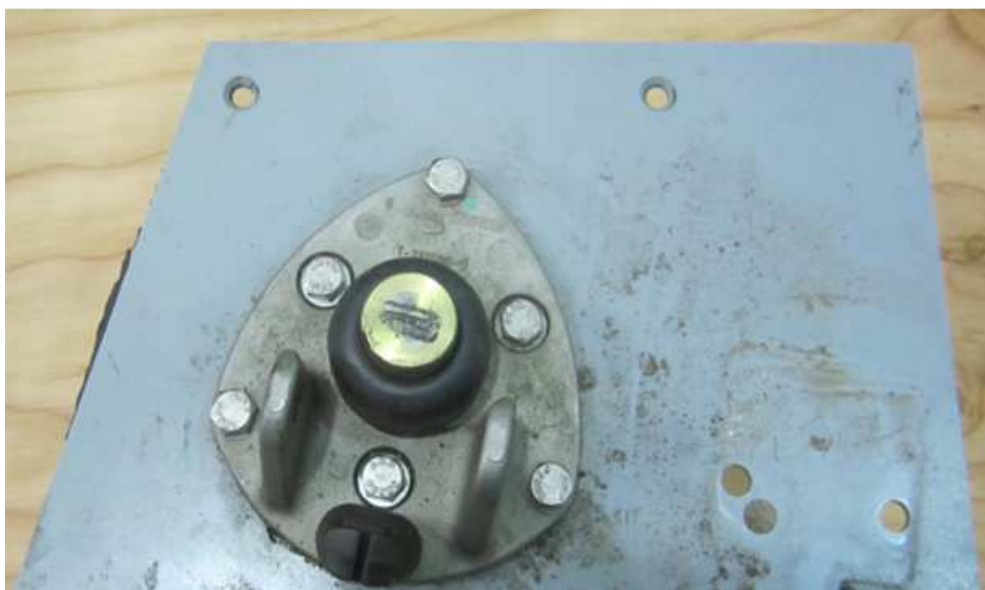
**Figure 11: Pedal Mount**

27. Locate the pedal mount on top of the hole in the brake pedal mounting plate, see Figure 11.
28. Secure the pedal mount to the brake plate using the hardware previously removed in Step 18 and 3 new lock nuts (PN: 40N05000), see Figure 12. Tighten the bolts.
- ☞ **NOTE:** Place a washer between the new plate and the locknuts, see Figure 13. No washer between the bolt head and the pedal mount, see Figures 12 and 13.
29. Align the BVA valve and the 45 degree elbow with the open slot in new plate as shown in Figure 14.
30. Attach the pedal mount to the BVA valve using the hardware previously removed in Step 17 (3 bolts, 6 washers), see Figure 11. Tighten the bolts.
- ☞ **NOTE:** Place two washers between the bolt head and the pedal mount, see Figure 15.
- ☞ **NOTE:** Apply loctite – 243 (PN: 081034) Medium to the mounting bolts.

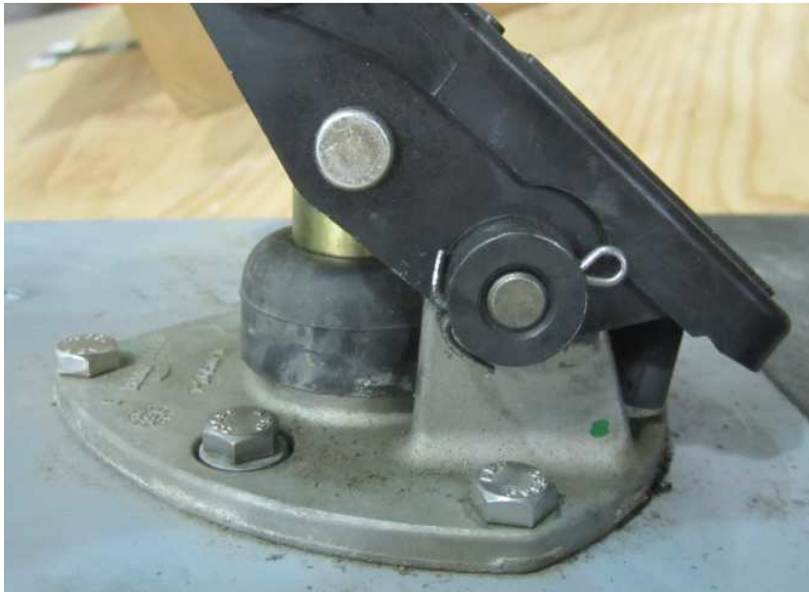
**Figure 17: Install Cotter Pin**

31. Clean and inspect the treadle roller, the roller pin, the hinge pin, the pedal mount, the plunger and the rubber boot in accordance with in accordance with the New Flyer Service Manual, Preventive Maintenance, Section Brake Treadle Assembly & Brake Valve, see Appendix A.
32. Apply a thin layer of Barium based grease per BW-204-M (PN: 117267) to pedal plunger and the bore in pedal mount, see Figure 16.
33. Put the plunger in the bore and install the rubber boot, ensure the rubber boot is seated properly.
34. Re-install the hinge pin and the brake pedal. Install a new cotter pin (PN: 6325654). Bend the cotter pin ends, see Figure 17.
