SAFETY ADVISORY # 14-216

Hideout 308BHDS GFCI

Models include: 2014 Hideout 308BHDS Travel Trailers
 2015 Hideout 308BHDS Travel Trailers

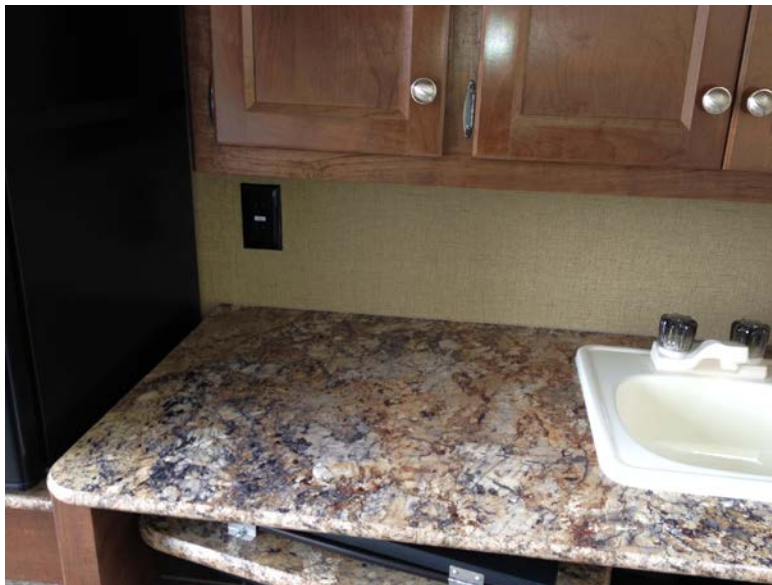
Step 1 Locate the GFCI receptacle in the exterior kitchen next to the sink and verify 120V power to it. Test for proper protection; trip the GFCI in the front bathroom and verify power to the 120V receptacle in the outside kitchen is shut off. If power remains on, the exterior kitchen receptacle must be replaced by a GFCI protected type.

Keystone RV Company is conducting a voluntary RECALL notification campaign in accordance with the National Traffic and Motor Vehicle Safety Act. It has been decided the 120V receptacle in the exterior kitchen may not be on GFCI protected circuit. If this condition exists it will lead to an increased risk of electrical shock if an electrical fault exists with an appliance plugged into the receptacle. Verify the outside kitchen receptacle is on a GFCI circuit and if not, replace the receptacle with a GFCI type.
