ITB14-050a

VOLUNTARY SAFETY RECALL CAMPAIGN 2014 Q50 HYBRID AND Q70 HYBRID; TRANSMISSION CASE INSPECTION

CAMPAIGN ID #: R1411

APPLIED VEHICLES: 2014 Q50 Hybrid 2WD (V37)
2014 Q50 Hybrid AWD (V37)
2014 Q70 Hybrid (Y51)

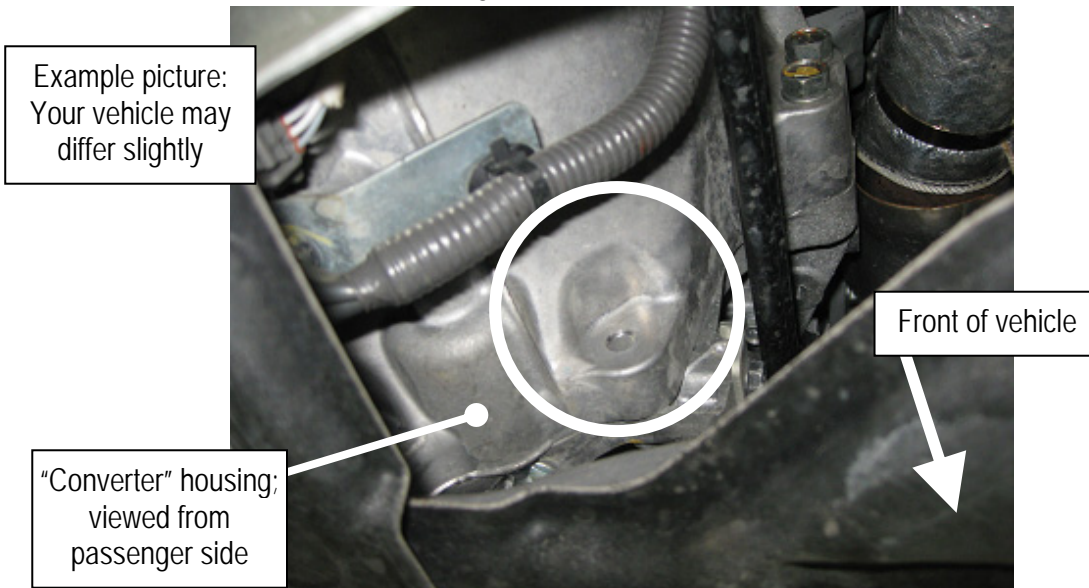
1. Raise the vehicle on a shop hoist.
2. Locate, and then clean the area circled in Figure 1 with C-NF Cleaner from the detection kit.

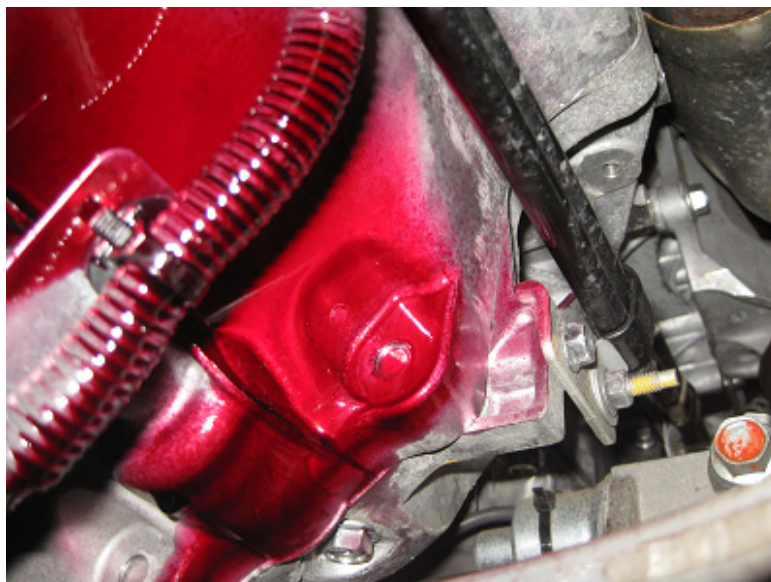
Figure 2

3. After C-NF Cleaner dries, spray PHF Penetrant (from the detection kit), and then leave the area momentarily. See Figure 2.
 - Leave the area for at least one (1) minute.

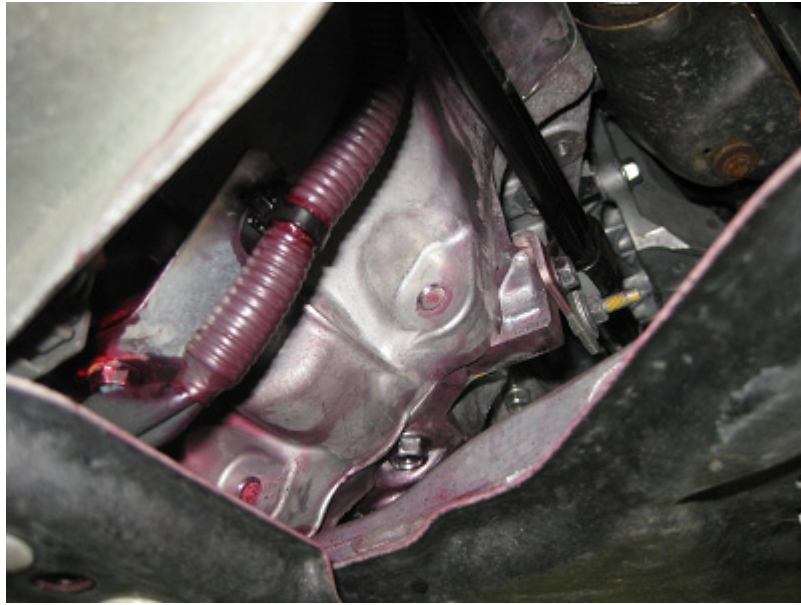
4. Wipe off the penetrant as shown in Figure 3 with a clean cloth pre-moistened with C-NF Cleaner.

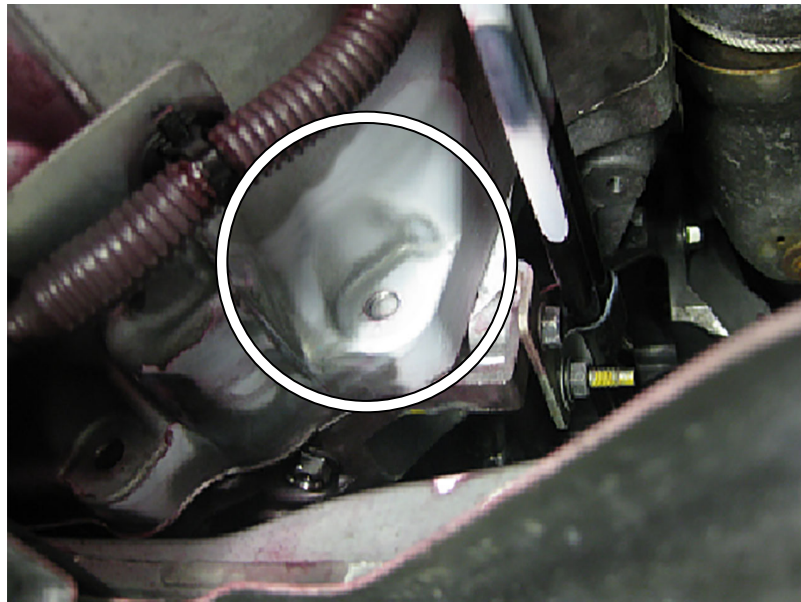
Figure 4

5. Apply D-NF Developer (from the detection kit) where shown in Figure 4.

6. After the application of D-NF Developer has dried, check for a crack.
 - a. If NO crack is found, clean off D-NF Developer with C-NF Cleaner.
 - Inspection is complete. No further work is needed.
 - b. If a crack is found, **DO NOT** release the vehicle. Hold the vehicle until further instructions.
