**April 24, 2015**

00407-01886 Version 4

## **Safety Recall: Front Passenger's Airbag Inflator May Produce Excessive Pressure After Long-Term Exposure To High Absolute Humidity**

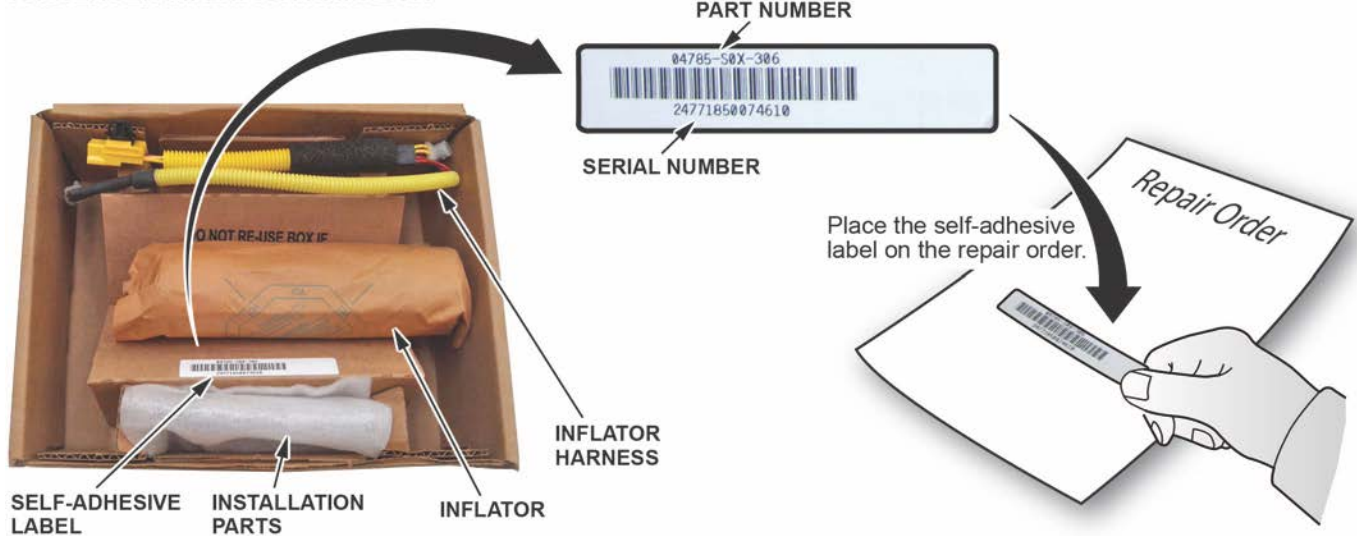
### PASSENGER INFLATOR PARTS BOX

- The replacement part number is printed on the top part of the label and the serial number is printed on the bottom. **Make sure you attach the label to the R.O. and give it to the warranty clerk.**
- There may also be a colored sticker located in the kit, ignore it because it is not used.
- Not all inflator kits have a label included. In those cases, write the serial number and part number from the side of the inflator box on the R.O. The part number always starts with 047.

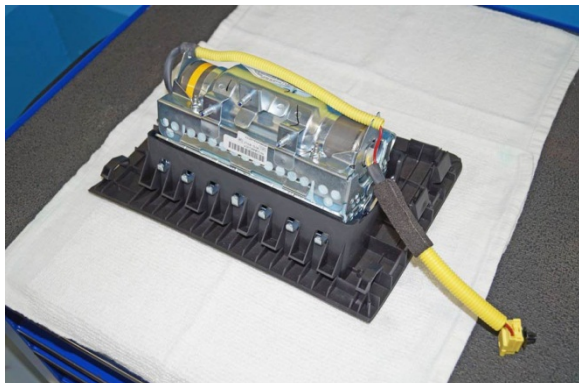
2. Remove the front passenger's airbag.
3. Place the airbag, face-down, on a clean shop towel.

- The orientation of the airbag is critical because if the inflator is installed incorrectly, the harness will be too short when you reinstall the airbag.
- The brackets between the various models are similar but may differ from the example shown.

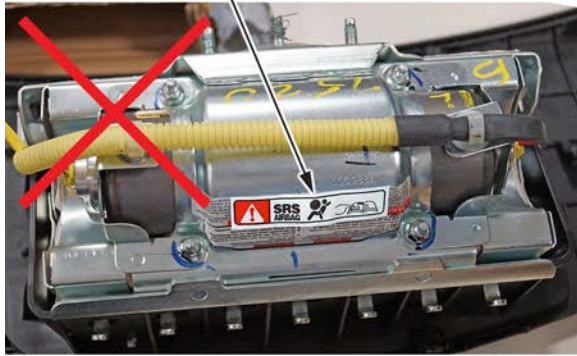
NON-STANDARD SAFETY LABEL

- If there is nothing unusual about the airbag or the inflator, go to step 5.
- If there are any unusual markings, like an incorrect label or a model year written in marker, the airbag and inflator may not be the correct airbag and/or inflator for the vehicle or it may be a counterfeit part. For more information about counterfeit airbags, you can refer to [safercar.gov](http://safercar.gov), enter keywords **MANAGING COUNTERFEIT**, and select **Recommended Dealer Guidance for Managing Counterfeit Air Bags** from the list. **If you suspect that the airbag or inflator is counterfeit, do not continue this procedure.** Contact your DPSM for assistance.

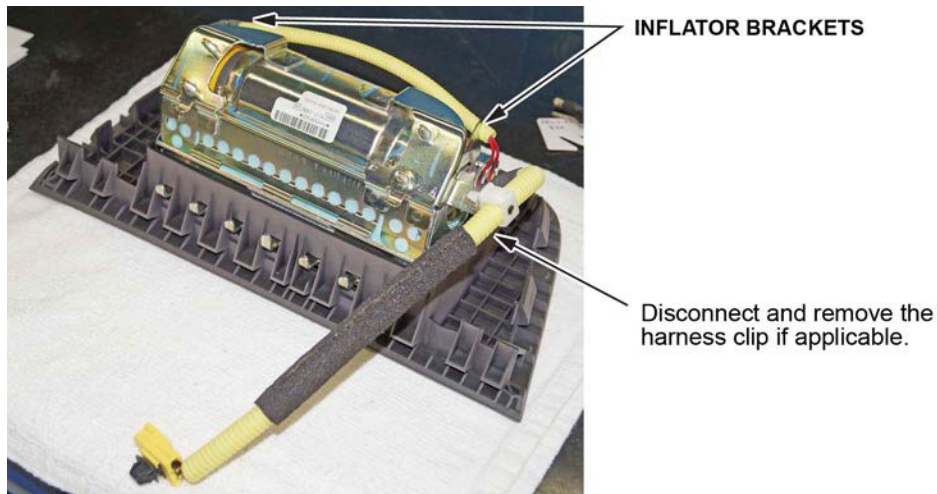
5. Remove the harness from both ends of the inflator bracket.

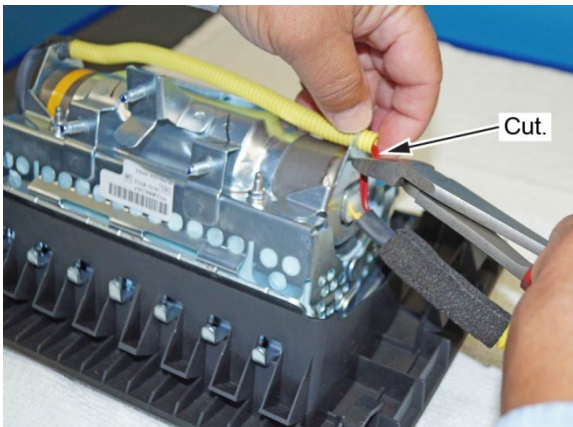
6. Short the red wires.

**NOTE: You must cut and short the wires** as indicated to prevent accidental deployment.

- Cut the red wires as shown.

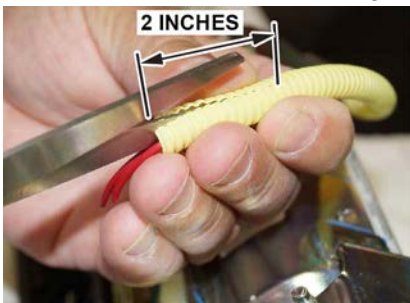
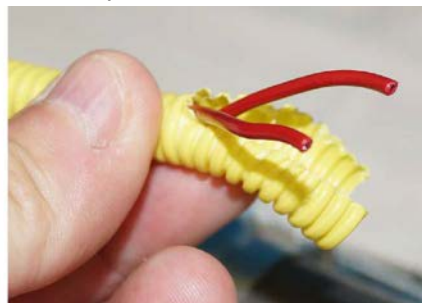
- Cut about 2 inches of the corrugated tube, then pull out the two red wires.

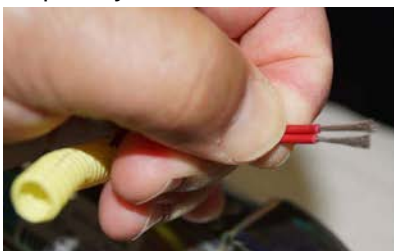
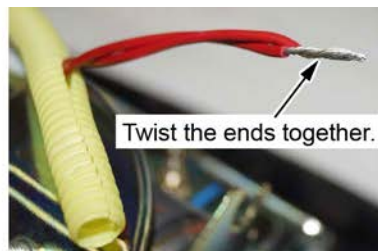
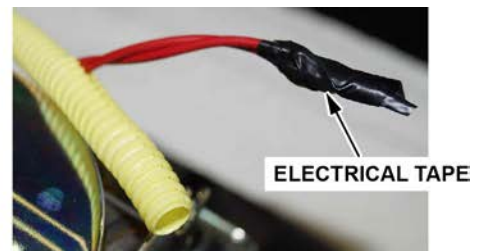
- Strip away about 1 inch of the wire insulation, then twist the wires together.

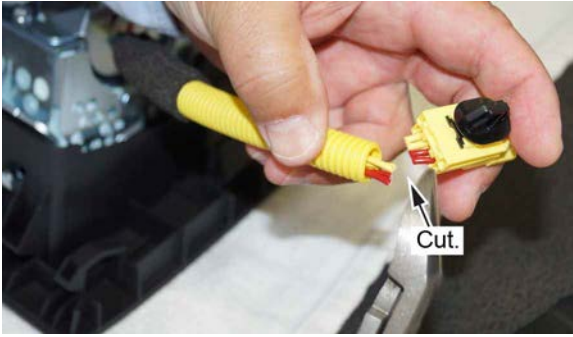
7. Cut off the connector and short the yellow wires.

You must cut and short the wires as indicated to prevent accidental deployment.

- Cut all four wires to remove the connector.

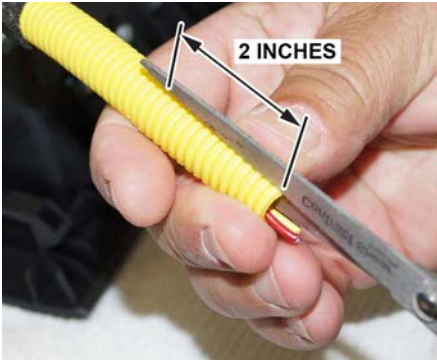
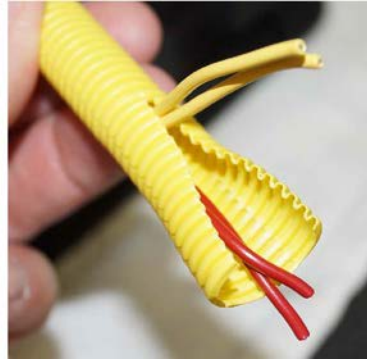
- Cut about 2 inches of the corrugated tube, then pull out the yellow wires.

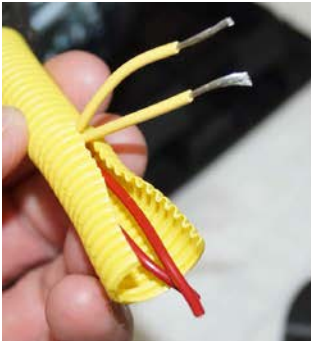
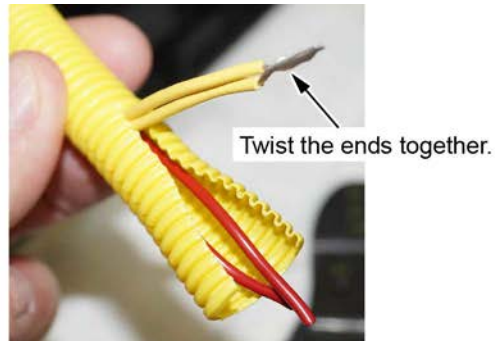
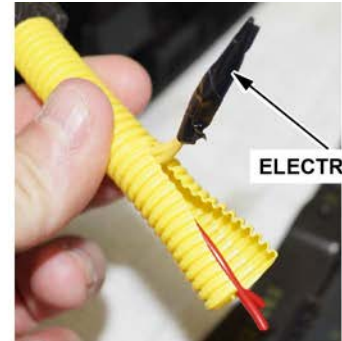
- Strip away about an inch of the wire insulation, then twist the wire ends together.

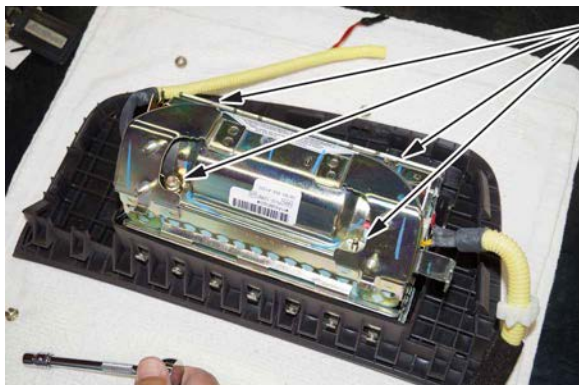
INFLATOR NUTS

8. Remove the four inflator nuts.

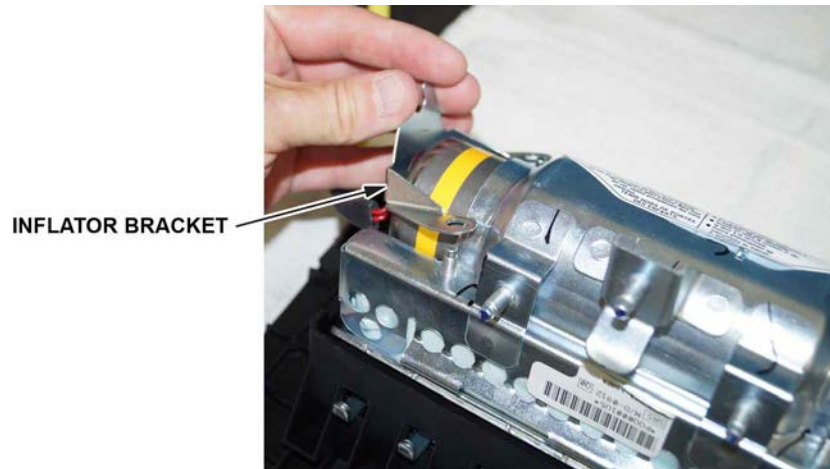
9. Remove the inflator bracket.

NOTE: You can only remove one of the brackets, as the other is welded to the airbag housing.

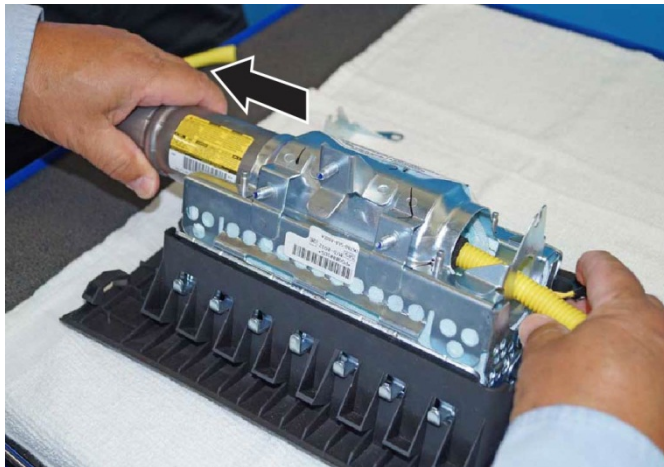
10. Remove the inflator by pushing it out.

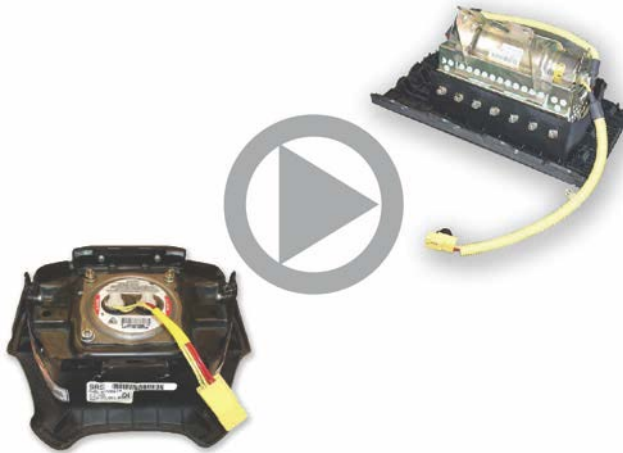
Click on the image below for a short video about the different variations of the driver's and front passenger's replacement inflators involved with the recalls related to inflators. While both the driver's and front passengers inflators are shown in the video, this is informational only. Replace inflators only as directed by the iN VIN status inquiry.

11. Install the new inflator.

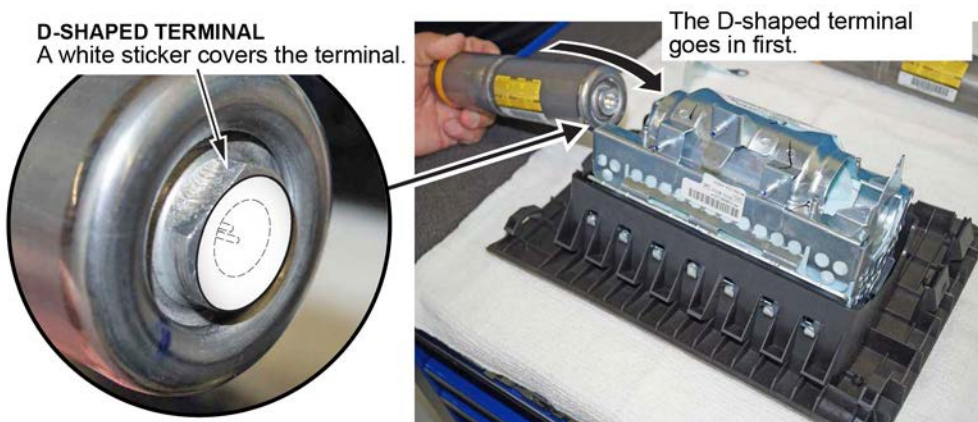
- One connector looks like a "D" whereas the other connector is a circle. Make sure you insert the "D" shaped terminal into the airbag first.

NOTE: There is a yellow band marking on the circle side.

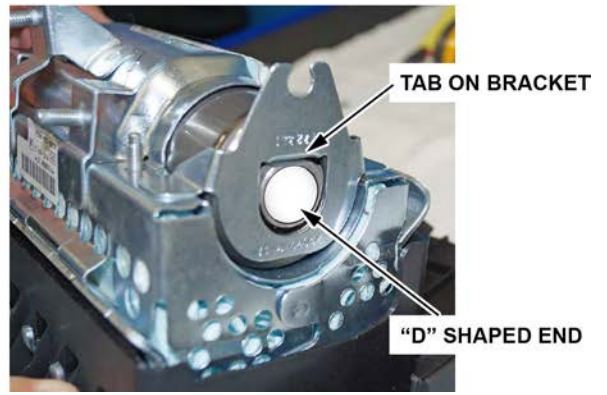
No gap.

- Slide the inflator in until the “D” aligns with the tab on the inflator bracket. There should be no space or gap between the inflator and bracket.

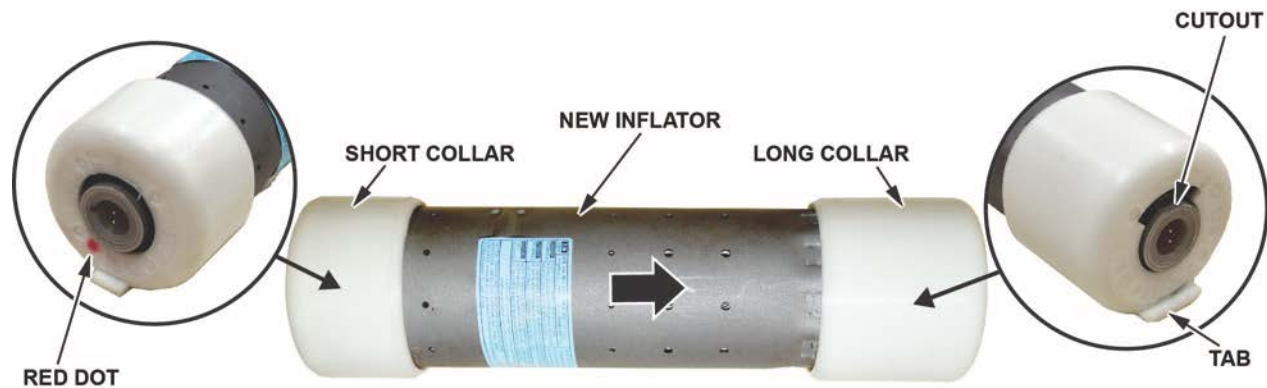
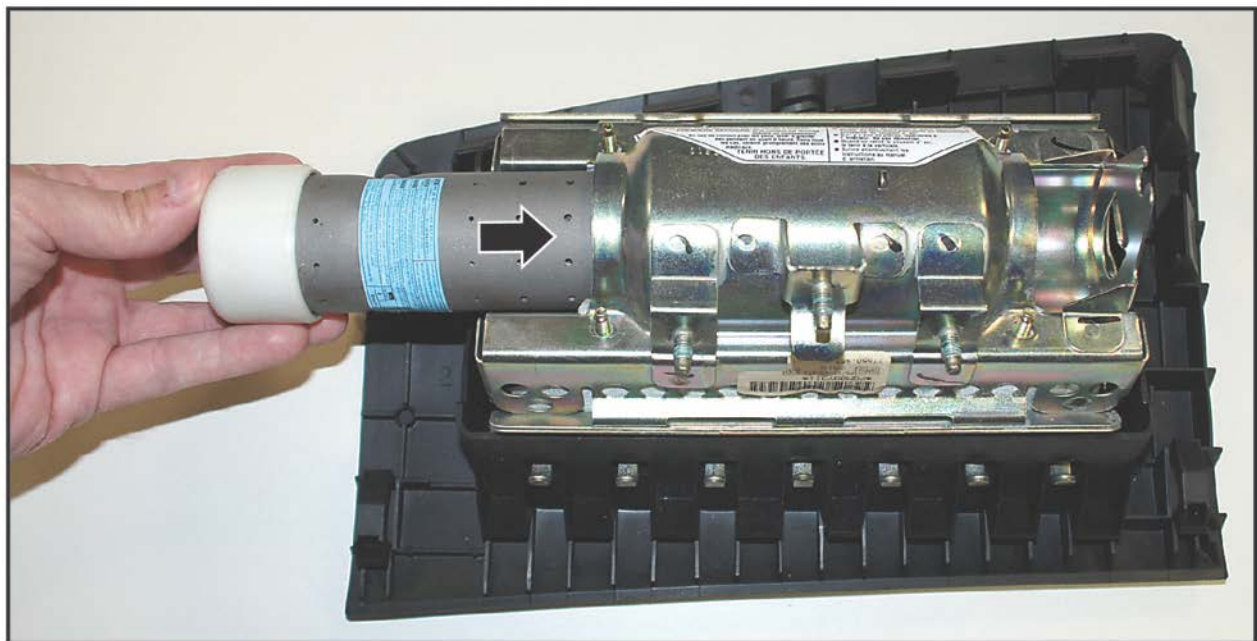
- One side of the inflator has a longer collar, a longer tab, a plastic cutout, and a small flat spot on the connector. The other side of the inflator has a shorter collar, a shorter tab, and a red dot. Make sure you insert the end with the longer collar into the airbag first.

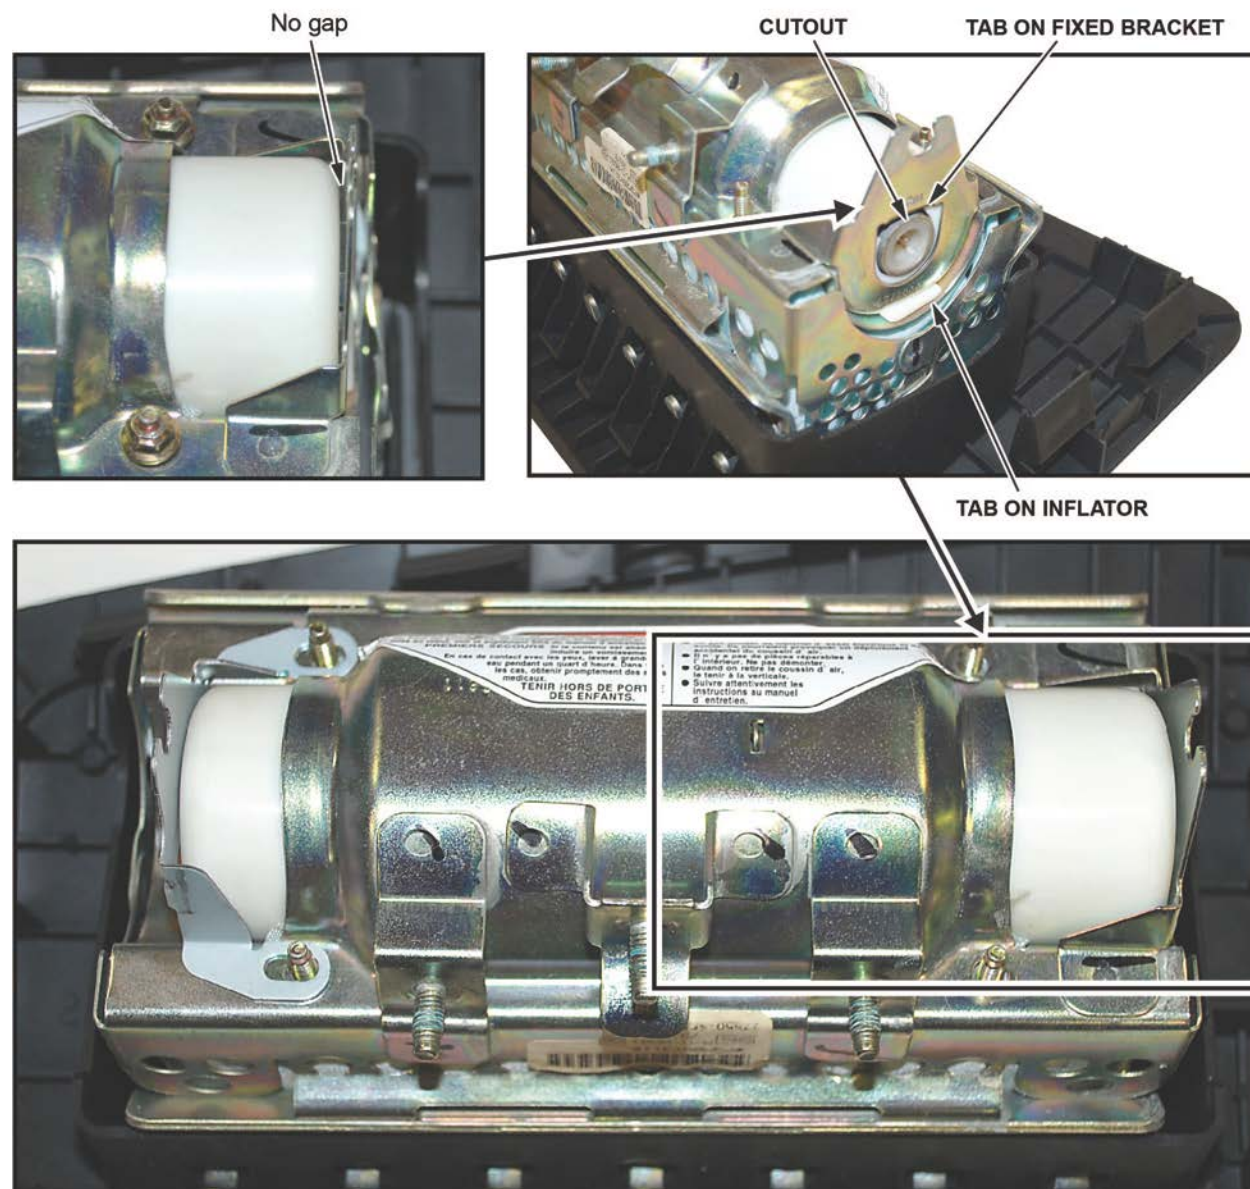
#### FIXED BRACKET END

- Slide the inflator in until the plastic cutout and the small flat spot align with the tab on the bracket. There should be no space or gap between the inflator and bracket.

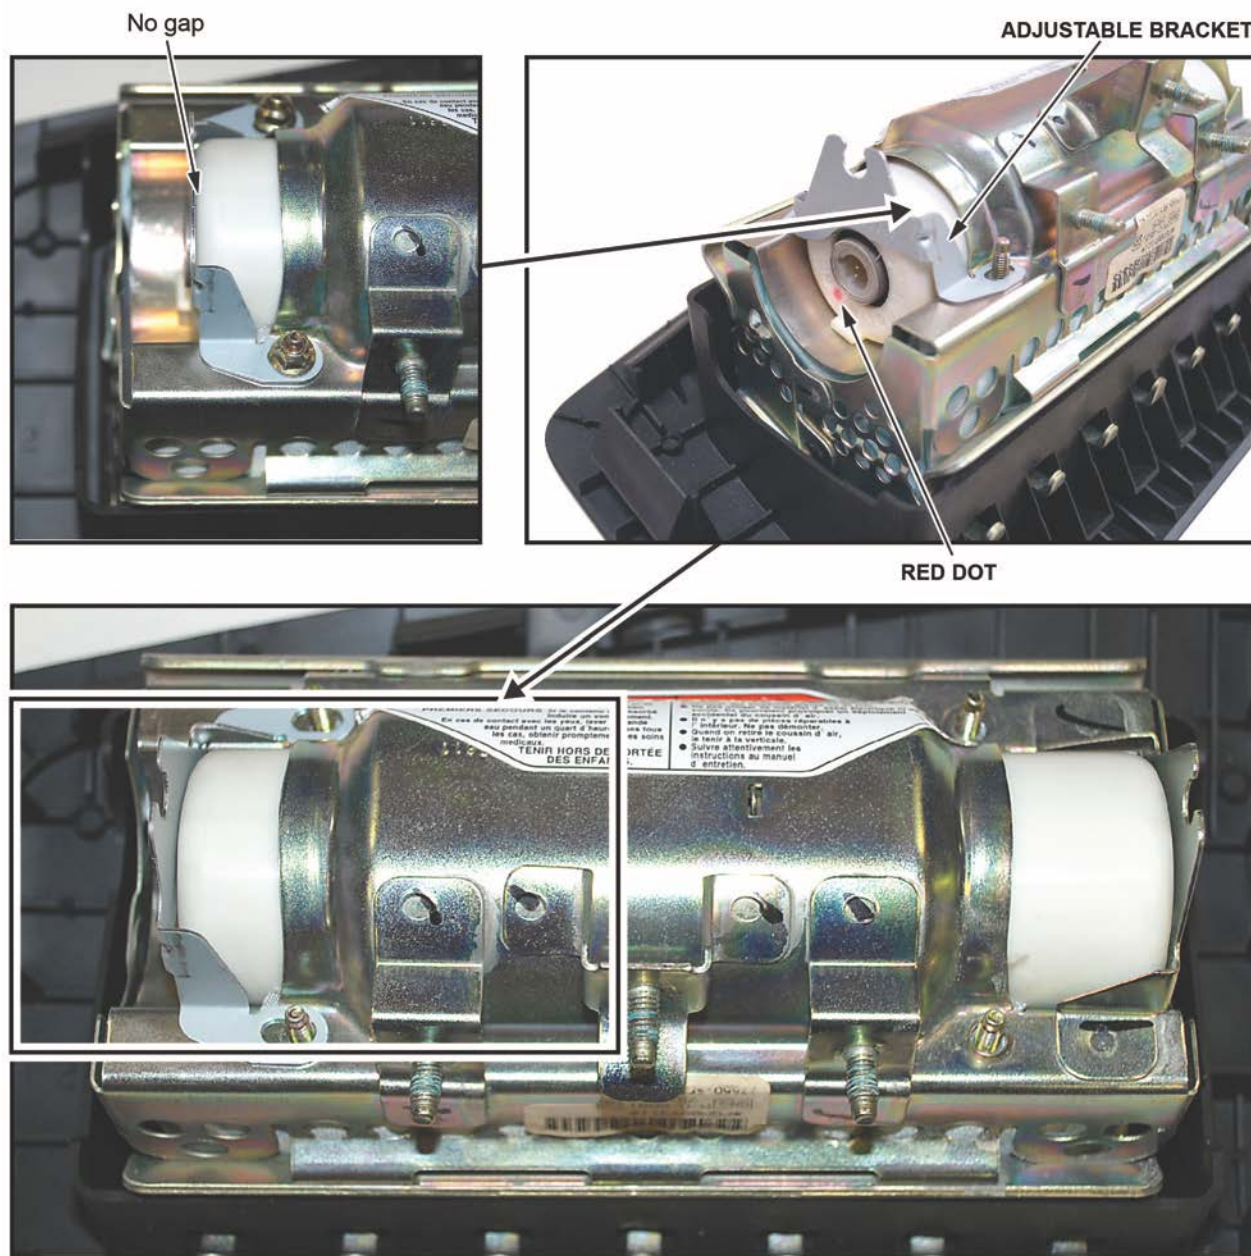
#### ADJUSTABLE BRACKET END

- Install the bracket included in the kit onto the airbag module. There should be a red dot visible on the end of the plastic connector. There should be no space or gap between the inflator and bracket.

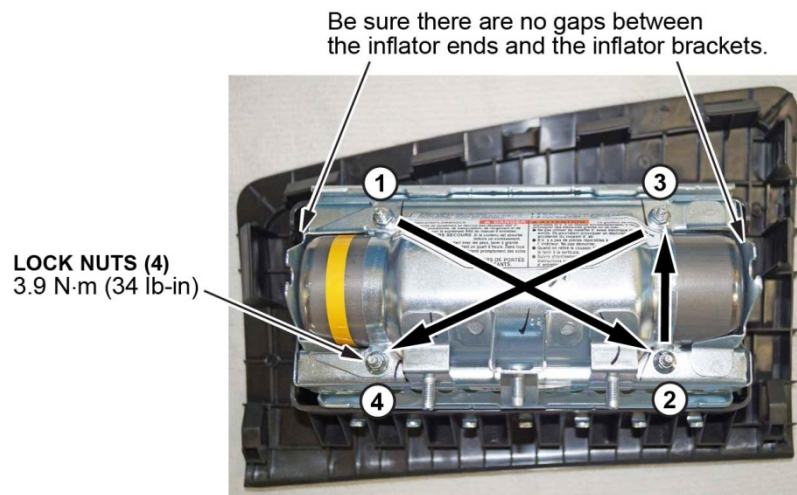
12. Install the new 5 mm locknuts and torque them in sequence to **3.9 N•m (34 lb-in)**.

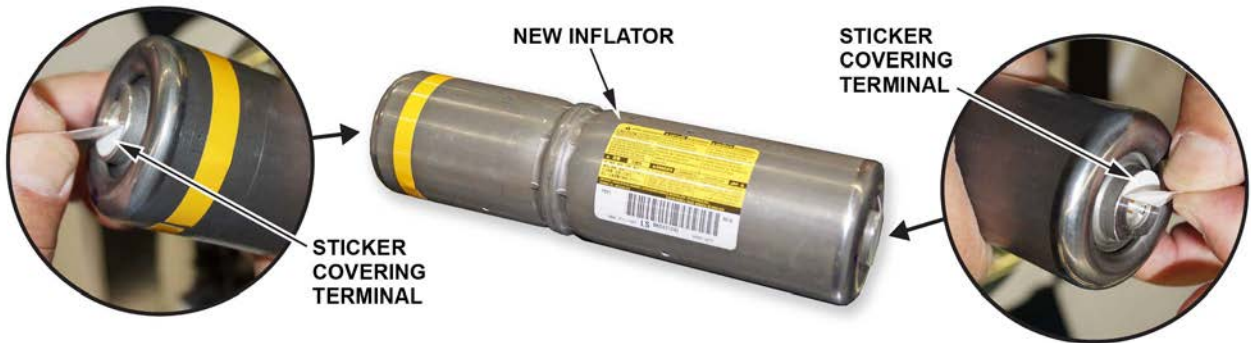
13. Remove the stickers covering the terminals on both sides of the new inflator.

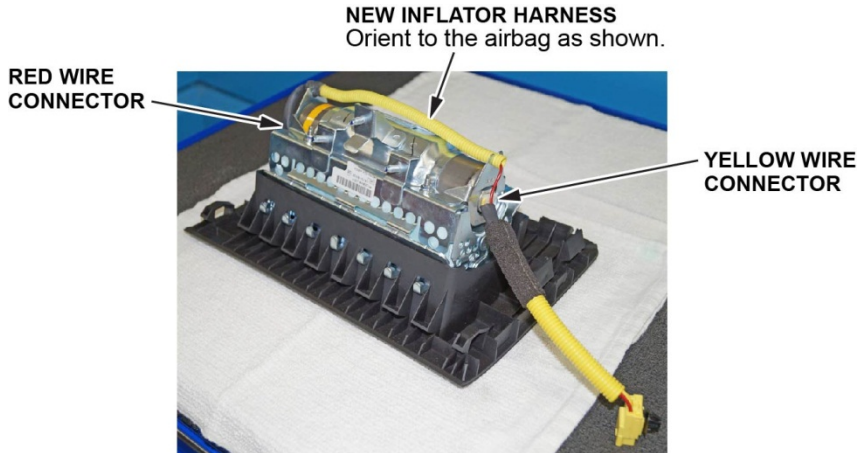
- Make sure the airbag and harness are aligned as shown.

- **Make sure you have the orientation correct as shown below.** If you connect the harness incorrectly, the harness cannot be removed, and you will not be able to reinstall the airbag because the harness will be too short.
- On the replacement inflators with plastic collars, connect the red wire connector to the connector with the red dot.
- On the replacement inflators without plastic collars, connect the red wire connector to the connector nearest the yellow band.

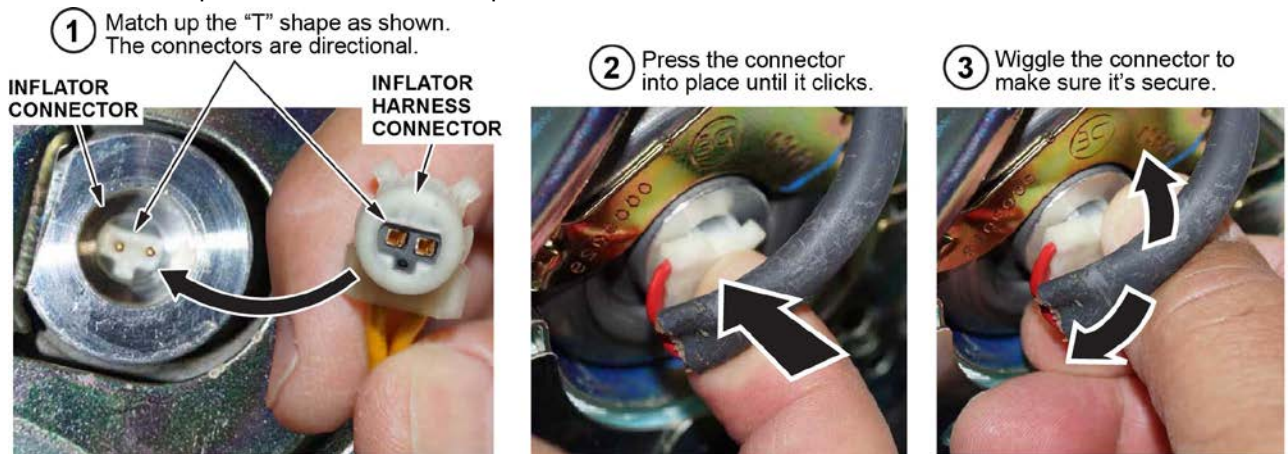
- Connect the two connectors. Align the "T" shape in the inflator harness connector with the T-shaped inflator connector, then press the connector into place.

- After you hear each connector click, wiggle it to make sure it is secure.

NOTE: If the connector is not properly aligned, it will come out.

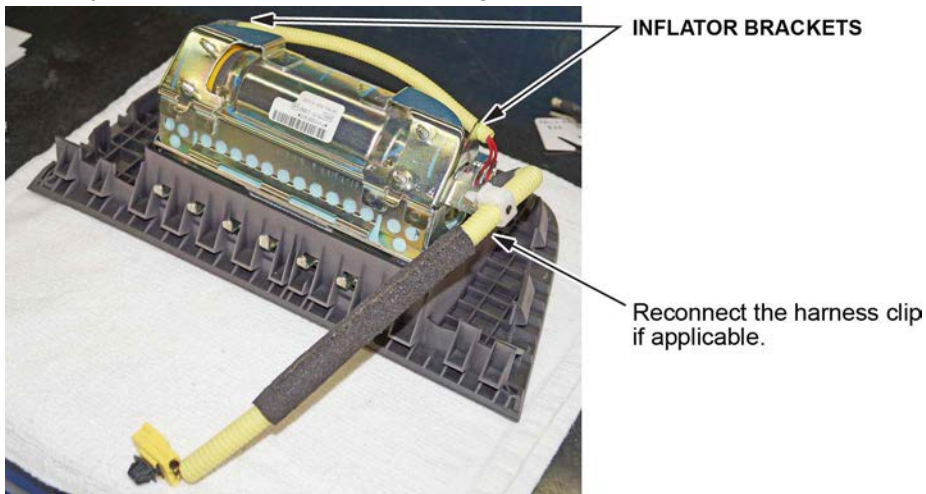
15. Connect the harness to the inflator brackets.

- Insert the side without the shrink-wrap tubing first. Insert the harness at the third “valley” in the corrugated tube.
- Insert the side of the harness with the shrink-wrap tubing into the inflator bracket. Make sure the harness is securely inserted and that it does not sag.
