April 28, 2016

00406-01910 Version 6

## Safety Recall: Front Passenger's Airbag Inflator May Produce Excessive Pressure After Long-Term Exposure To High Absolute Humidity

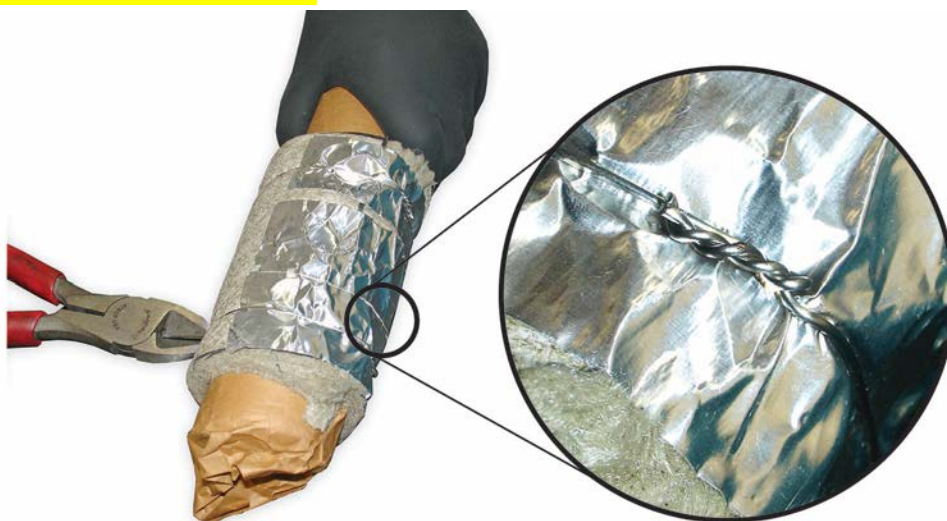
- Wear disposable gloves and protective glasses. The insulation is not toxic or dangerous, but some people may be sensitive to the insulation.
- Dispose of the insulation and wrapping paper to avoid getting the insulation dust/fibers on you or the airbag assembly.
- Do not reuse the insulation or wrapping paper. You do not need to wrap the inflator being removed from the vehicle when it is returned.
- Cut the wires off from the opposite side from where they are tied (twisted) together.

NOTE: Do not cut the insulation.

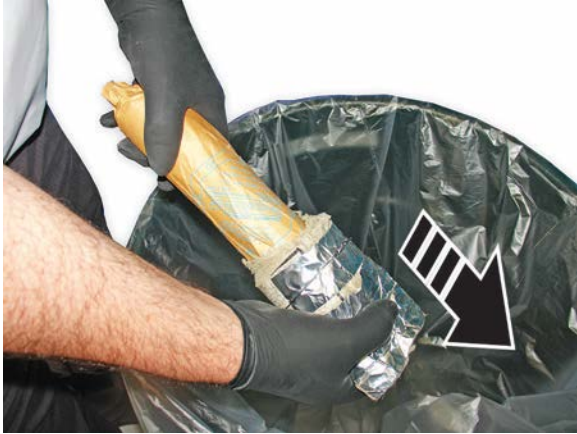
- Hold the paper wrapping the inflator with one hand and slide the insulation off into the trash.

NOTE: The insulation is securely wrapped around the inflator. You may have to use some force to slide the insulation off. Do not cut the insulation and be careful that you do not move the white or orange plastic ends.

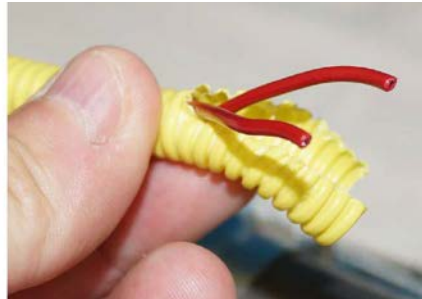
- Cut about 2 inches of the corrugated tube, then pull out the two red wires.

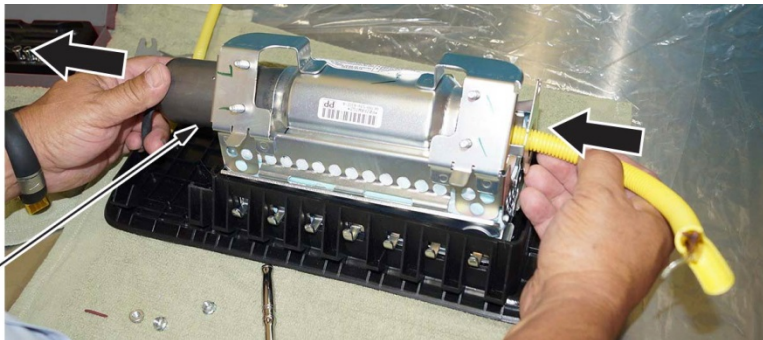
13. Remove the inflator by pushing it out.

INFLATOR  
Do not reuse.

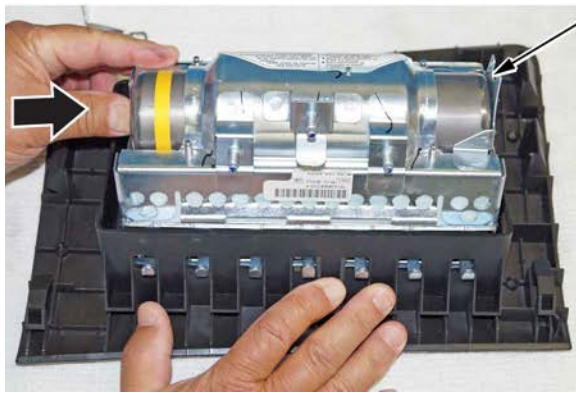
No gap.

- Slide the inflator in until the “D” aligns with the tab on the inflator bracket. There should be no space or gap between the inflator and bracket.

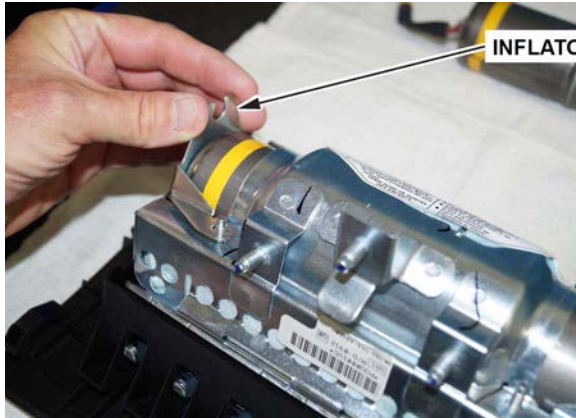
- Reinstall the inflator bracket. There should be no space or gap between the bracket and inflator.

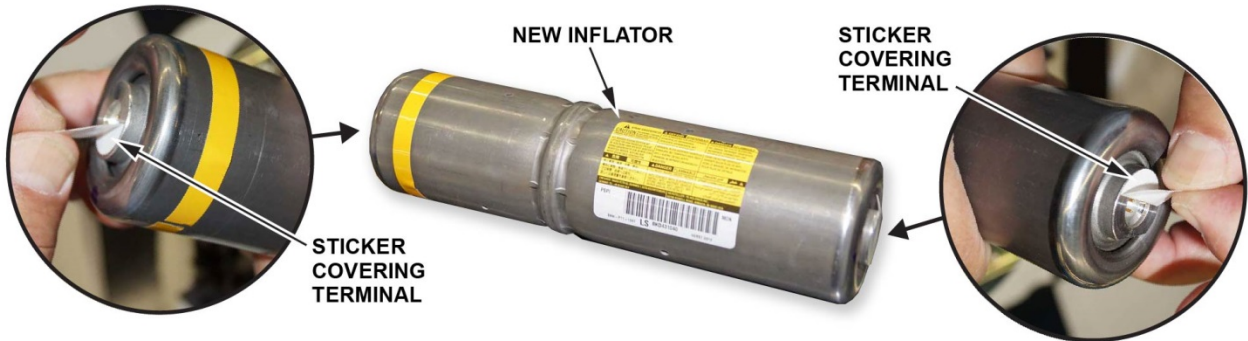
16. Remove the stickers covering the terminals on both sides of the new inflator.
