April 17, 2015

00407-01827 Version 3

Safety Recall: Front Passenger's Airbag Inflator May Produce Excessive Pressure After Long-Term Exposure To High Absolute Humidity

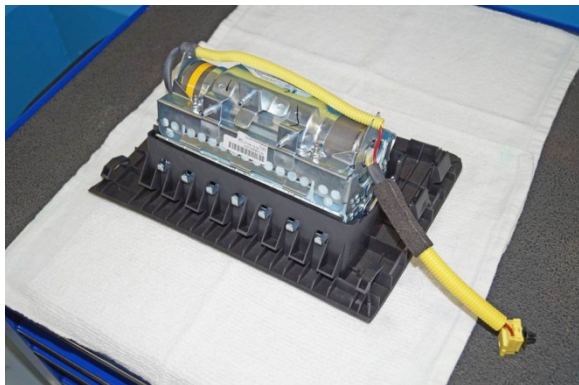
2. Remove the front passenger's airbag.
3. Place the airbag, face-down, on a clean shop towel.

- The orientation of the airbag is critical because if the inflator is installed incorrectly, the harness will be too short when you reinstall the airbag.
- The brackets between the various models are similar but may differ from the example shown.

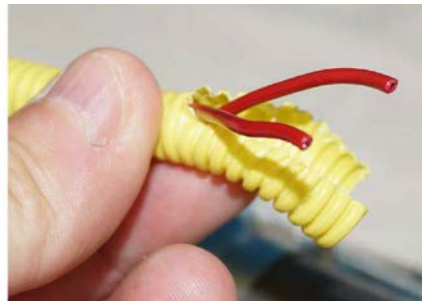
- Cut about 2 inches of the corrugated tube, then pull out the two red wires.

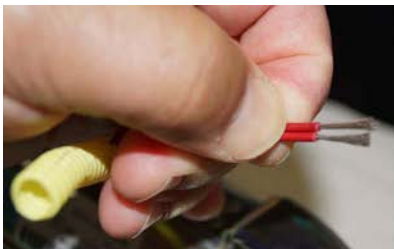
- Strip away about 1 inch of the wire insulation, then twist the wires together.

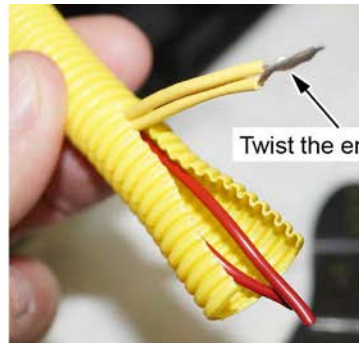
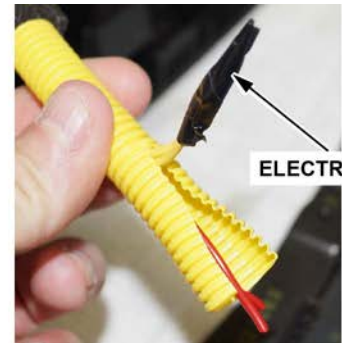
- Strip away about an inch of the wire insulation, then twist the wire ends together.

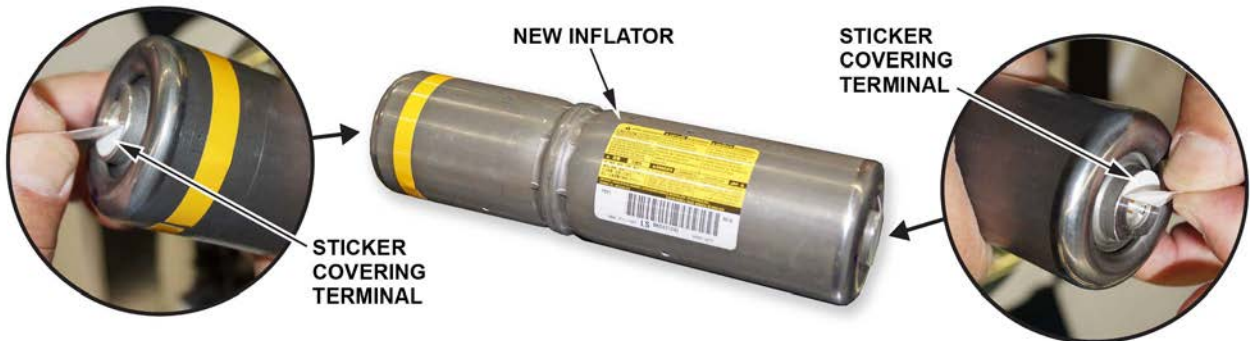
13. Remove the stickers covering the terminals on both sides of the new inflator.
