ATB 00407 (1412)

Safety Recall: Front Passenger's Airbag Inflator May Produce Excessive Pressure After Long-Term Exposure To High Absolute Humidity

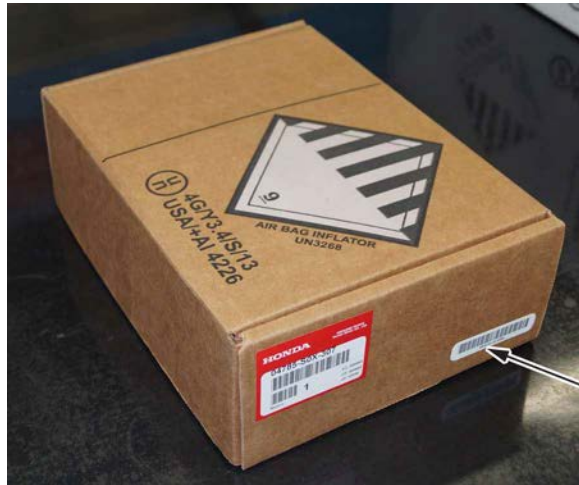
SERIAL NUMBER

- If the VIN status inquiry indicates that the vehicle is subject to any open safety recalls, including the driver's airbag inflator, make sure to also complete those recall repairs before returning the vehicle to the customer. If you are unable to complete any open recall, advise the customer of the recall status and when the recall could be completed.
 - Be careful not to damage any parts when replacing the inflator, and **follow the procedure exactly**.
 - If, before removing the airbag, you suspect that it may be the incorrect airbag for the vehicle or a counterfeit, **do not remove the airbag**. Contact your DPSM for assistance.
1. Write down the serial number located on the right side of the new inflator box. For the warranty claim to be paid, your warranty clerk must enter this serial number in the Diagnostic Trouble Codes field on the warranty claim.

19. Give the warranty clerk the inflator serial number that you wrote down in step 1. For the warranty claim to be paid, your warranty clerk must enter the serial number in the Diagnostic Trouble Codes field on the warranty claim.

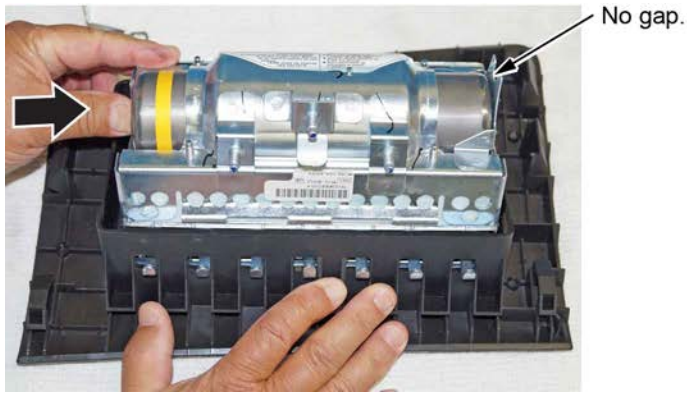
- Slide the inflator in until the “D” aligns with the tab on the inflator bracket. There should be no space or gap between the inflator and bracket.

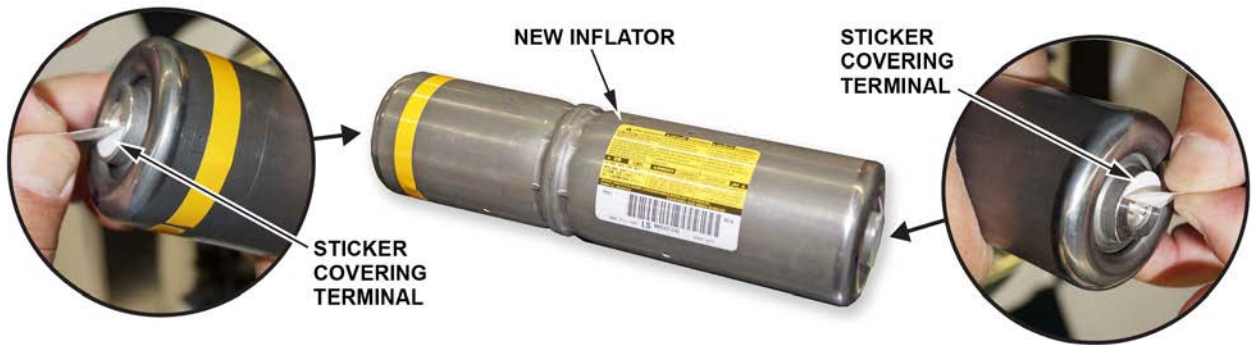
12. Remove the stickers covering the terminals on both sides of the new inflator.
