<p> <input checked="" type="checkbox"/> Safety Recall <input type="checkbox"/> Field Campaign <input type="checkbox"/> Service Information <input type="checkbox"/> Product Improvement </p>	<p align="center"> <u>FIELD SERVICE BULLETIN</u> <u>All Models</u> <u>Passenger Seat Securement</u> </p>	<p> FSB_2014-107 Revision: 0 Issue Date: 11/26/14 Manual Section: N/A Author: JNaracon Approval: RP Form Rev. D 11/21/14 </p>
---	---	--

UNITS AFFECTED: All Models built between 09/02/14 and 10/08/14

DESCRIPTION: Spring Nuts used in seat securement did not pass durability testing.

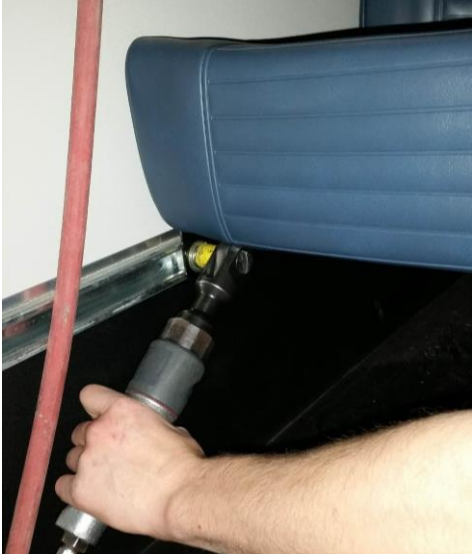
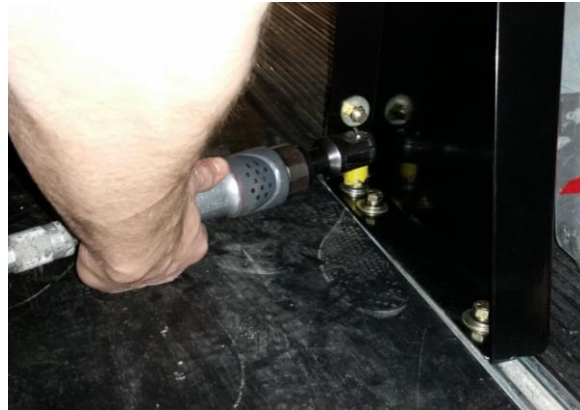
- 1.) Remove (6) bolts retaining seats (4) from floor, (2) from wall.

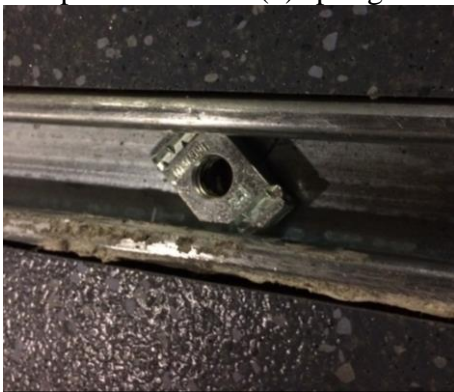
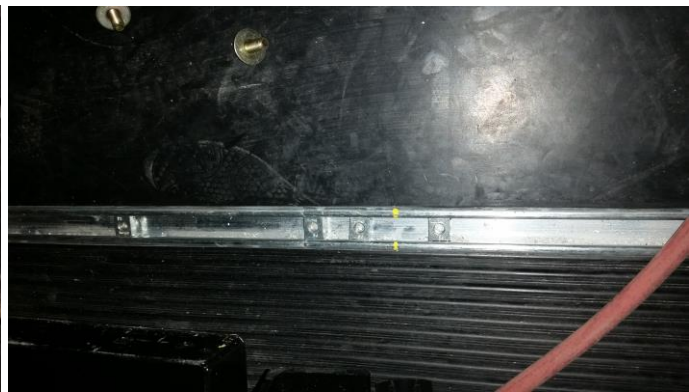
- 2.) Compress and twist (6) spring nuts out of seat track.

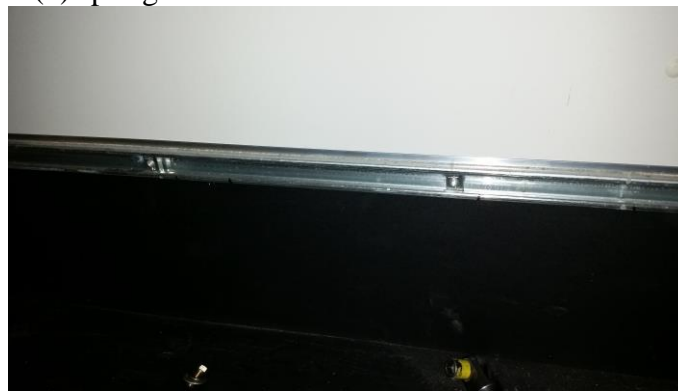
- 3.) Compress and twist (6) spring nuts to install into wall track.

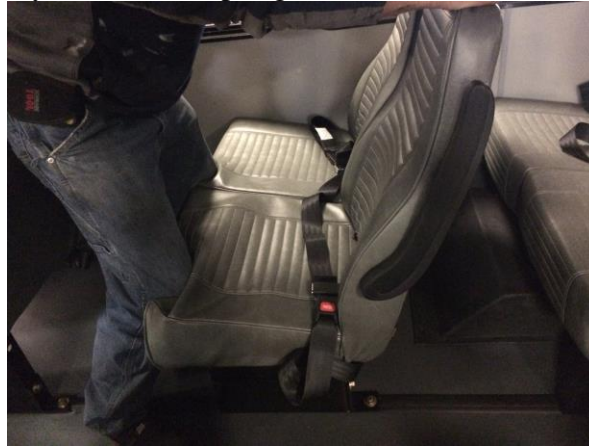
4.) Relocate seat assembly in line with spring nuts.

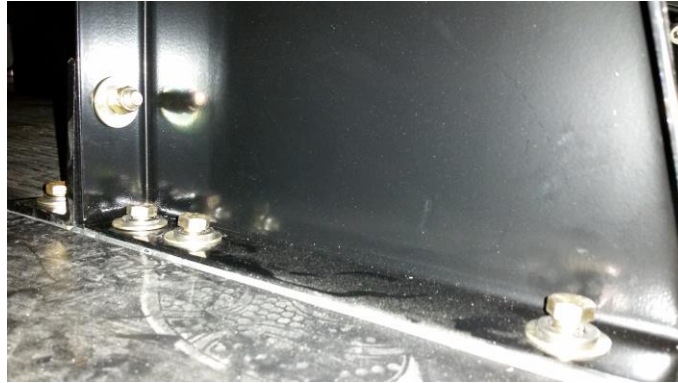
5.) Re-install bolts into spring nuts (leave loose enough to adjust location of seat).

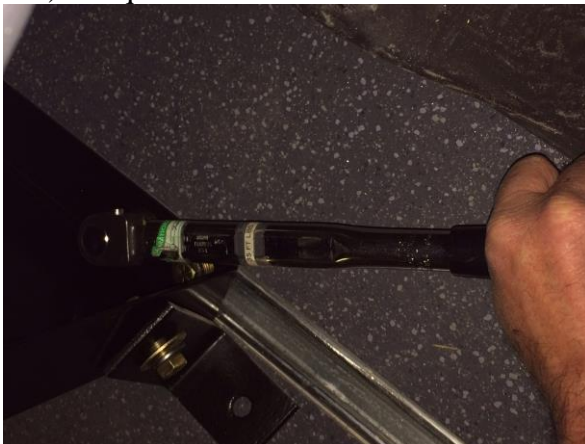
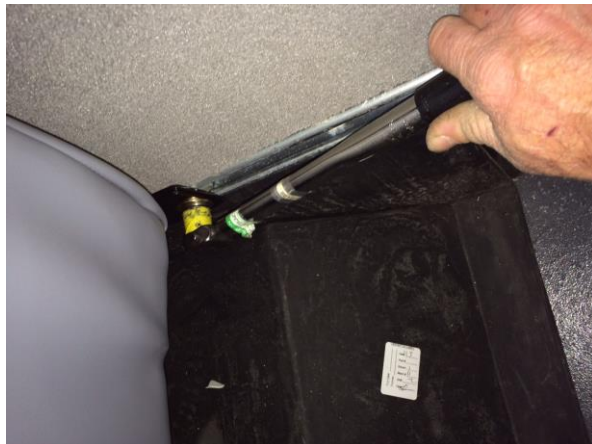
7.) Torque bolts to 35 ft-lbs.
