PRODUCT CAMPAIGN BULLETIN

APPLICABILITY: 2009-2013 Subaru Forester
 2008-2011 Subaru Impreza, WRX, and STI
 2012-2014 Subaru WRX and STI

NUMBER: WQQ-52R
DATE: January 2015
REVISED: 05/06/25
NHTSA ID: 14V-830

SUBJECT: Application of Anti-Corrosion Material to the Four-Way (2-2 way) Joint Connector of the Brake Line System

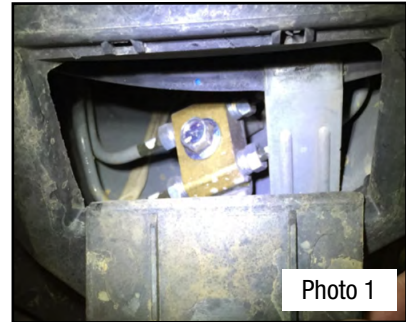
(1-2) Open inspection hole door on fuel tank cover (Photo 1). located on the right-hand side of the vehicle.

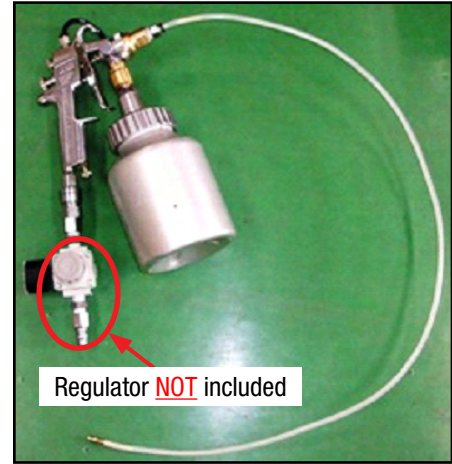
- (1-1) Assemble the spray gun and nozzle according to the spray gun assembly and adjusting instructions outlined above.
- (1-2) Set zero-point of discharge knob and air needle of spray gun.
- (1-3) Fill the tank with anti-rust wax.
- (1-4) Adjust wax amount and air volume by setting the discharge knob, air needle, and compressor air pressure of spray gun.
- (1-5) Test-spray wax to confirm gun operates as intended.

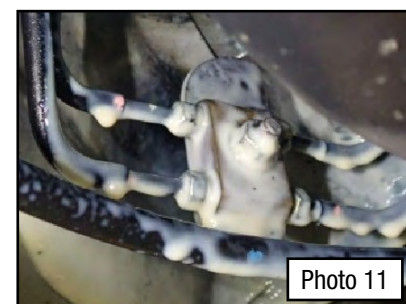
- Spray until the sprayed wax material drips. (Photo 11)
- To insure the proper amount of wax is applied, follow the steps listed above closely.
