**IMPORTANT SAFETY RECALL INTERIM
NOTICE 14518**

IC Bus has decided that a defect which relates to motor vehicle safety exists in certain AE, BE, CE, FE, and RE model commercial buses built 02 January 2006 thru 23 September 2014 with Ricon Public Use, "S" 2000 and 5500 Series lifts.

Subject: S-Series Platforms: 34in. x 54in., 32in. x 51in.
Applicable Products: S1205, S2005, S2010, S5005, S5010, S5505, S5010
Effectivity: 6/24/2014

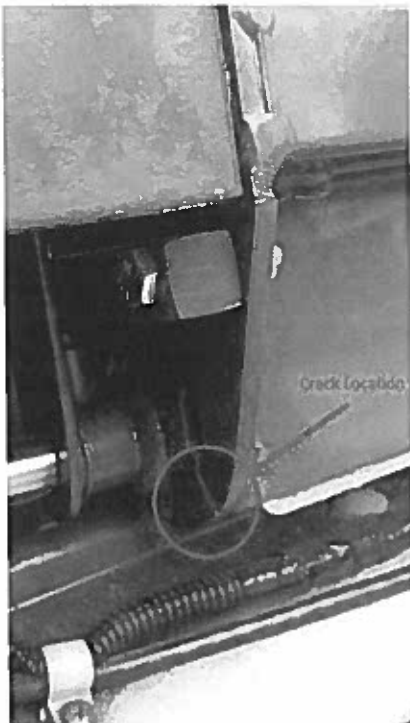
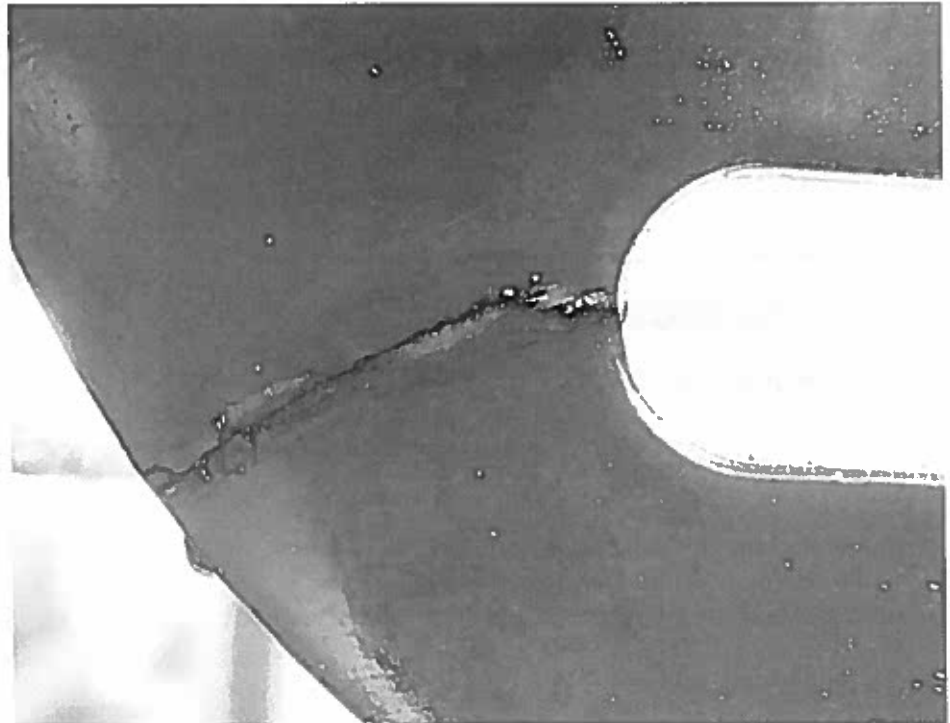
Under certain conditions the side plate of the larger platforms included on the subject S-Series model wheelchair lifts can exhibit cracking while in the stowed position which, if left unchecked can propagate to the point where separation of the rear portion of the side plate occurs rendering the lift inoperable and possibly unsafe to use.

During the interim period to mitigate the risk of injury to the operator, follow the Ricon instructions on the back of this letter to inspect the platform for cracking in either of the platform side plates. If cracks are found, discontinue use of the vehicle and contact
