2015 Rogue (T32) Rear Door Lock Assembly
Voluntary Recall Campaign

Reference: PC382
Date: July 17, 2015

Door Lock Assembly Inspection Procedure

2015 Sentra/Versa Note and Rogue

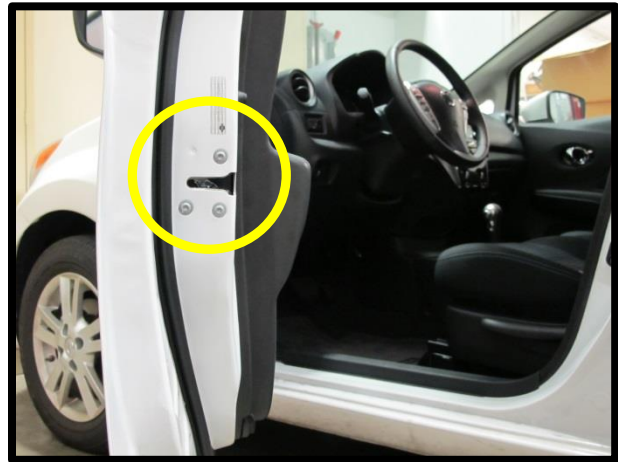
Figure 1

1. Locate door lock Julian Date on applicable vehicle door/s listed below.

- **Sentra/Versa Note:**
Left Front and Left Rear Doors
- **Rogue:**
Left Rear Door ONLY

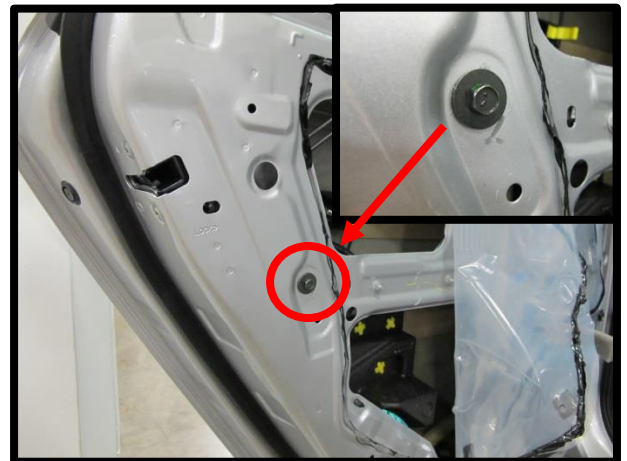
Figure 8

Sentra Left Rear Door ONLY. Refer to Figure 8.

- Remove the (1) 10 mm run channel retaining bolt.
- Push the bottom of rear window run back providing clearance to remove the door lock assembly.
- Do NOT attempt to remove the run channel as it is attached to the door at the top and could cause run channel damage.

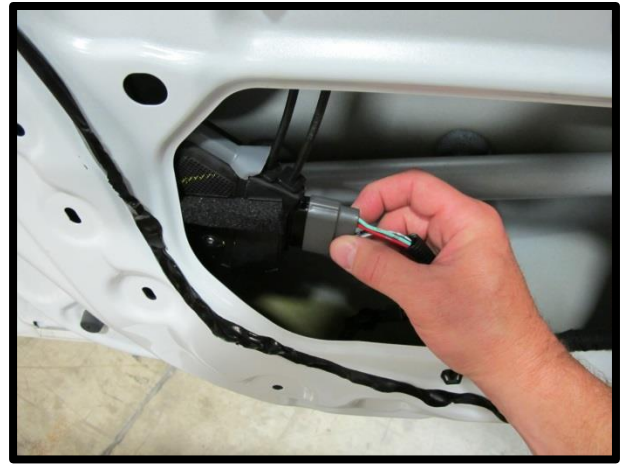
Figure 10

9. Vehicles Equipped With Power Door Locks:

Locks:
Disconnect the door lock harness connector.

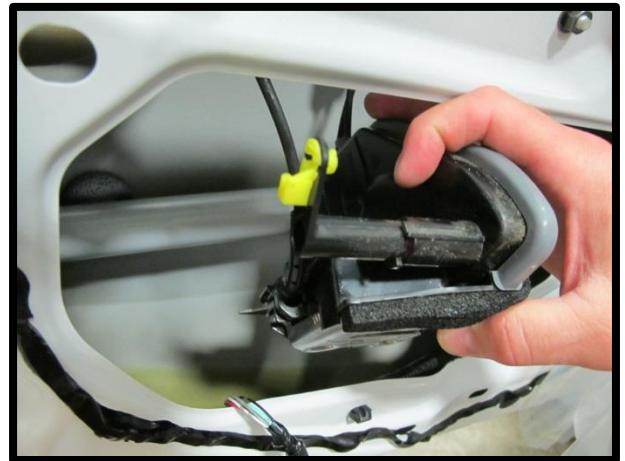
Figure 11

10. Pull the door lock assembly out of the door.

- Do not kink the door lock cables or disconnect them from the door handles.
