IMPORTANT SAFETY RECALL

Subject: Safety Recall 215-D Tire/Rim Inflation Label
NHTSA # 15V-132
EXPIRATION DATE: NONE

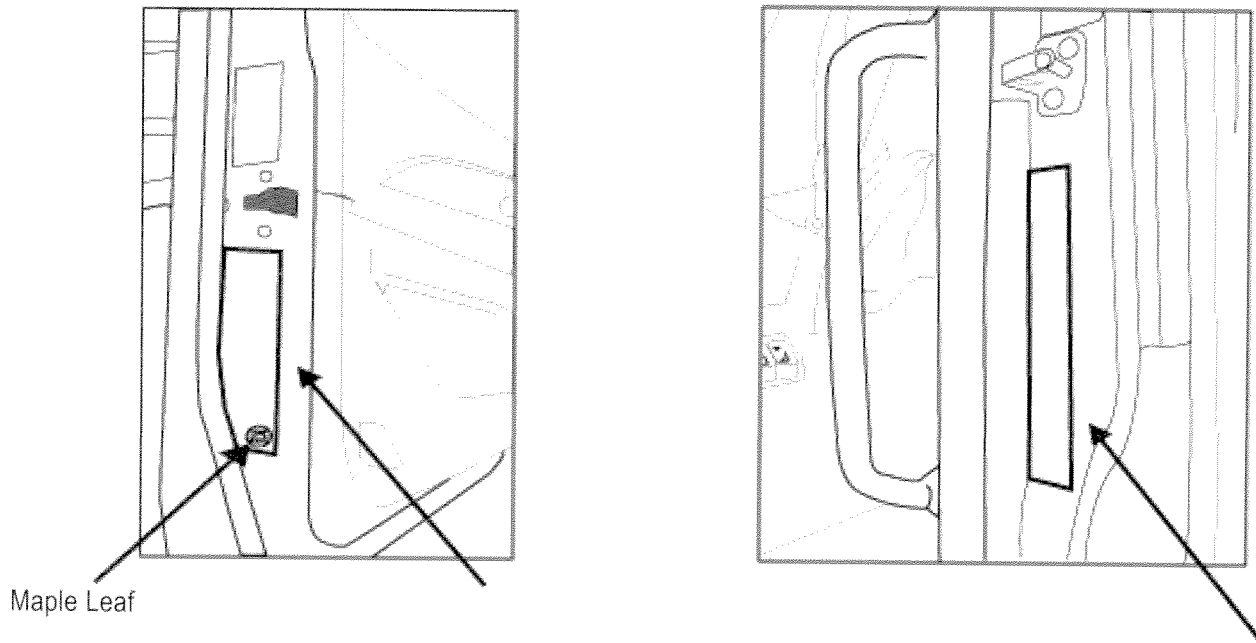
Default Tire and Rim Location

1. Verify VIN on label matches the VIN on your vehicle.
2. Locate and Replace Complete or Incomplete vehicle label located on the driver's side door or door jamb.
3. Place the new label on top of the existing label that it corresponds with.

TIRE AND RIM CERTIFICATION LABEL INSTRUCTIONS & LOCATION
