TECHNICAL INSTRUCTIONS
FOR
SAFETY RECALL ESG
(Supersedes the E0G campaign)
SRS ECU & SUB HARNESS (FILTER) INSTALLATION
2003 – 2004 MODEL YEAR AVALON
COLUMN MOUNTED SHIFT LEVER
(FRONT BENCH SEAT)

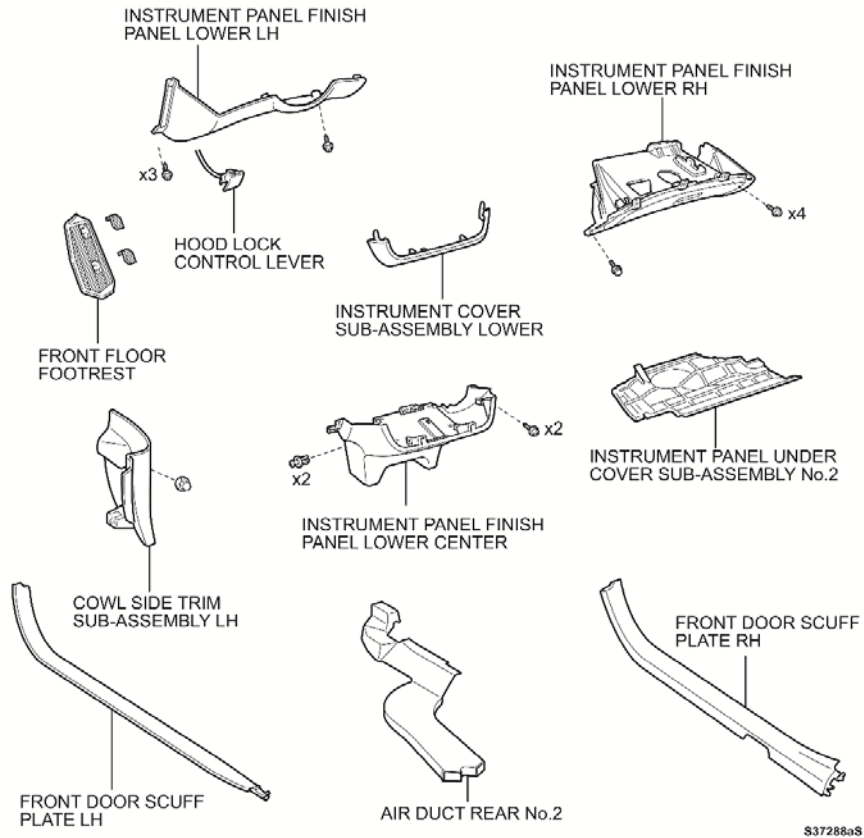
For installation of sub wire harness

Components to be installed:

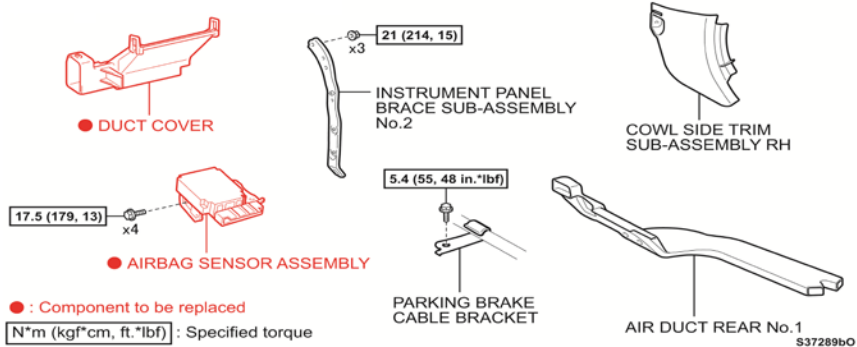
For replacement of airbag sensor assembly

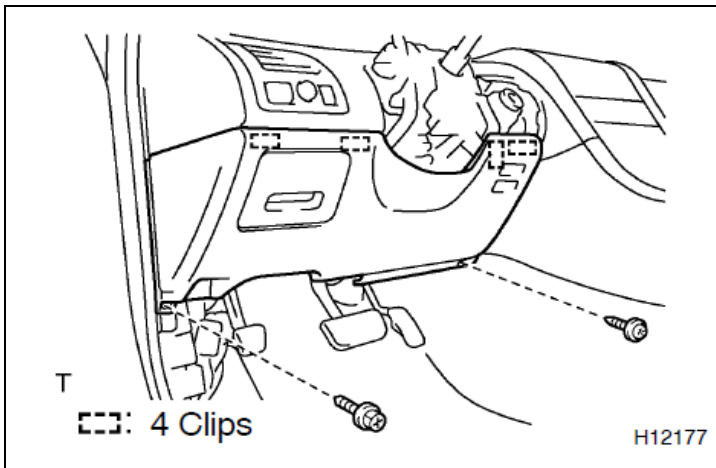
- a) Remove the left and right front door scuff plate.
- b) Remove the instrument panel under cover sub-assembly No.2.

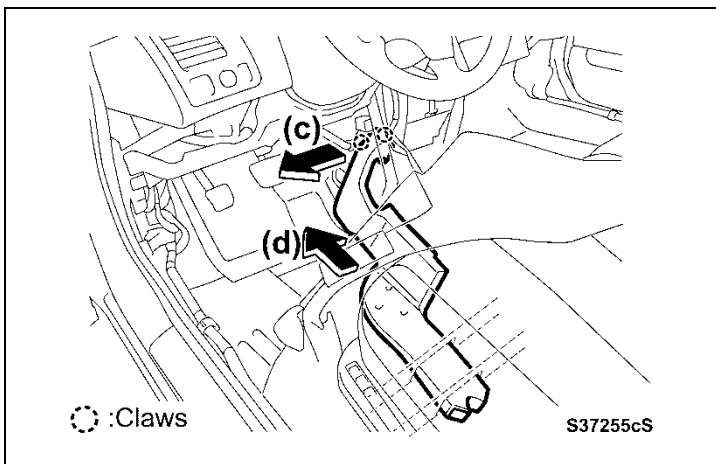
- a) Disengage the claw for the floor wire harness clamp.
- b) Unhook the carpet from the bracket.
- c) Fold the carpet back half way.

NOTE: Wear gloves to protect your hand from sharp edges.

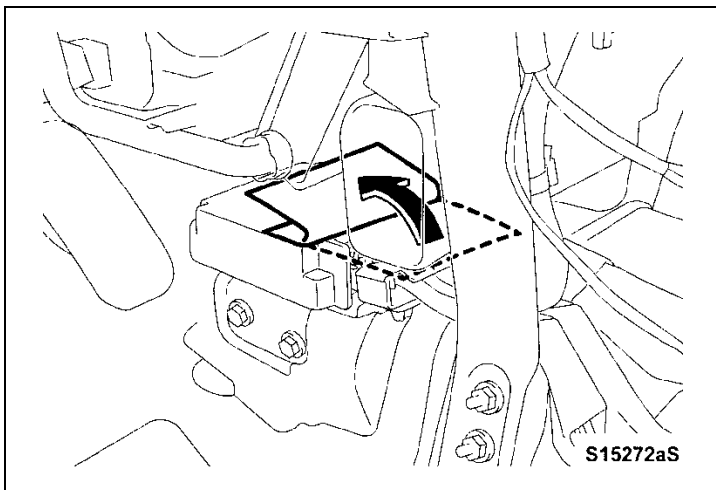
- d) Move the air duct to the left to disengage the 2 claws.
- e) Pull the air duct towards the front and remove it from the vehicle.

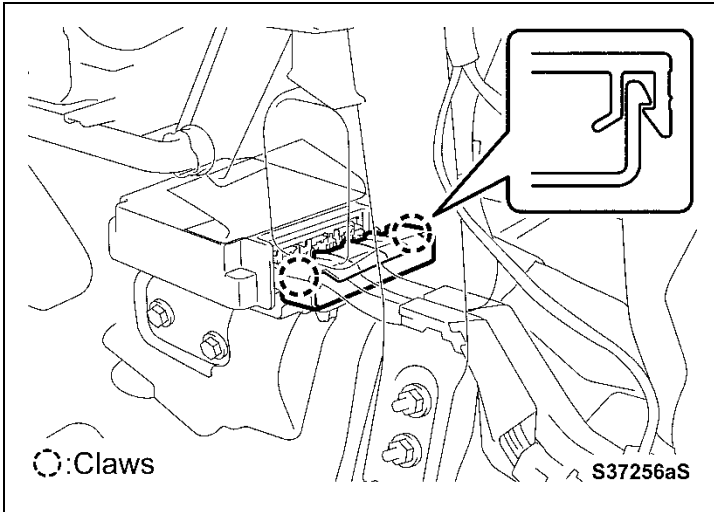
- a) Fold back the plastic sheet that covers the connectors.

DO NOT remove the plastic sheet from the airbag ECU

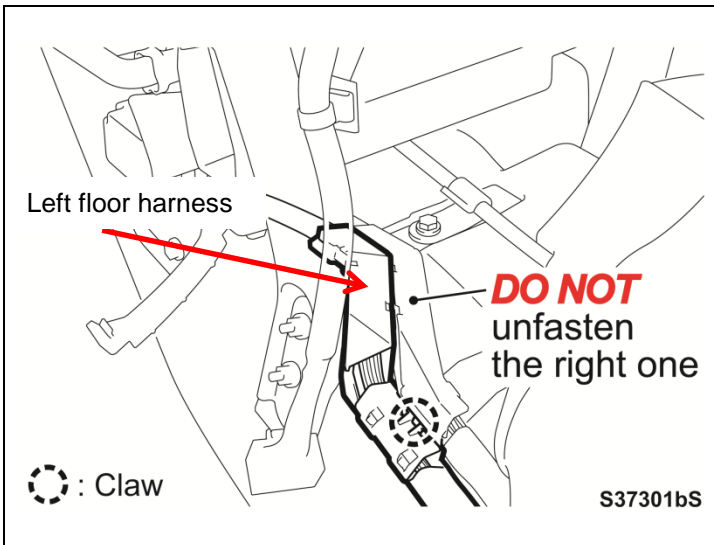
b) Disengage the 2 claws for the wire harness bracket.

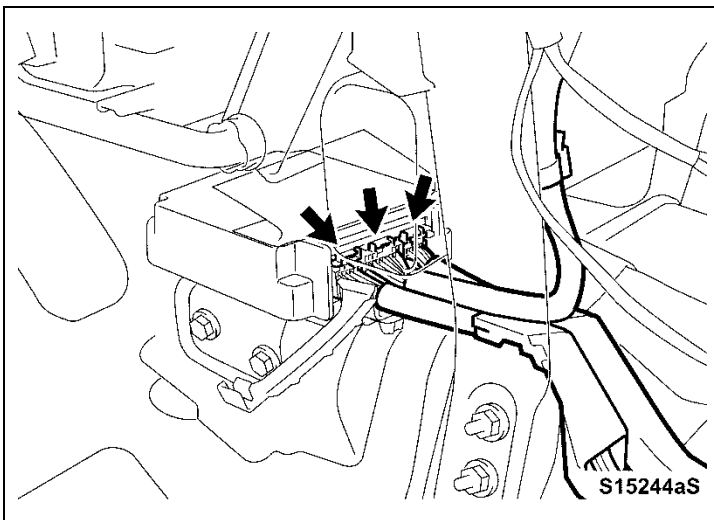
c) Disengage the claw for the left floor wire harness clamp protector.

NOTE: Do not unfasten the right side protector wire harness clamp.

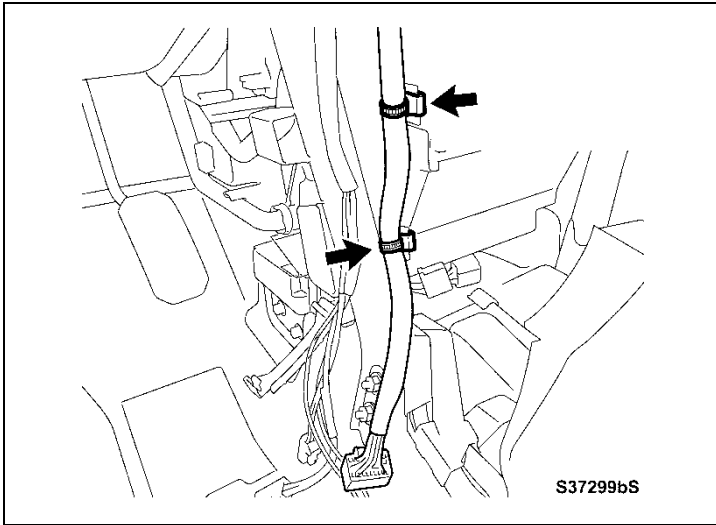
d) Disconnect the following from the airbag ECU:

- Left Floor Harness
- Dash Harness
- Right Floor Harness

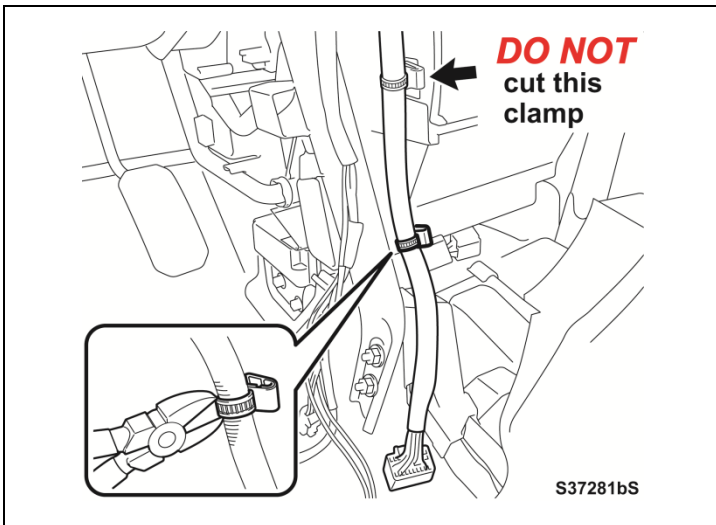
e) Disengage the 2 dash harness clamps as shown.

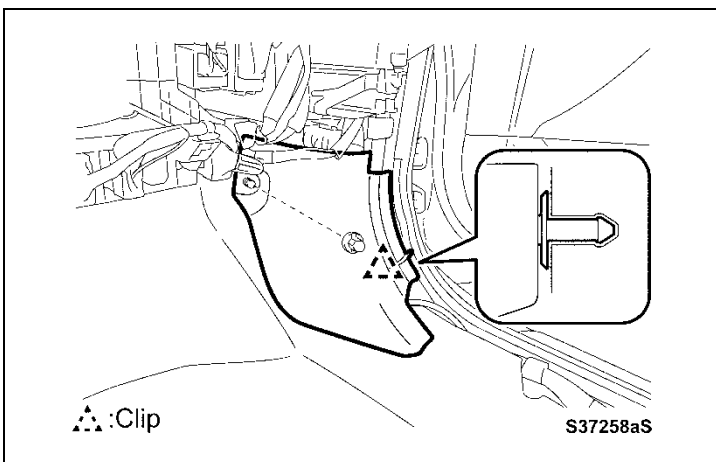
f) Cut and remove the clamp from the dash harness.

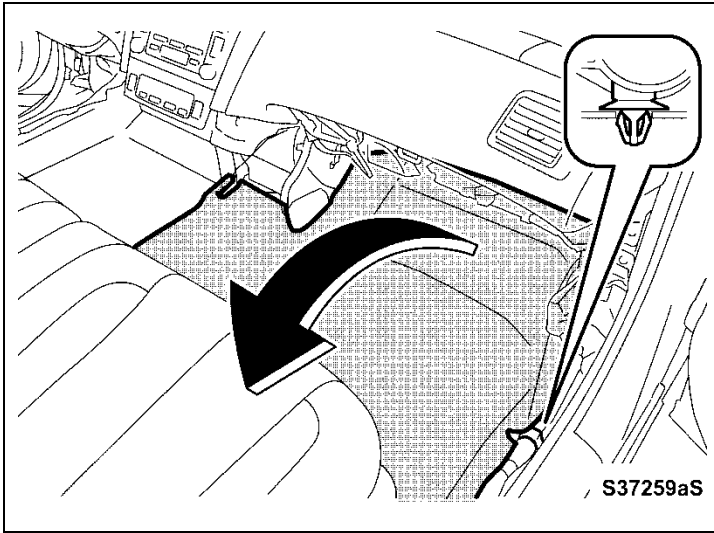
- a) Remove the right cowl side trim.
 - 1) Remove the nut.
 - 2) Remove disengage the clip.

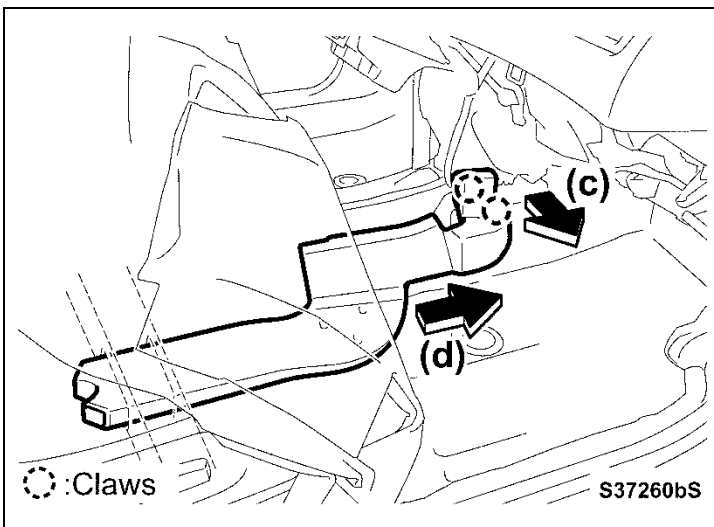
- b) Disengage the claw for the floor wire harness clamp.
- c) Fold the carpet back half way to access the airbag ECU.

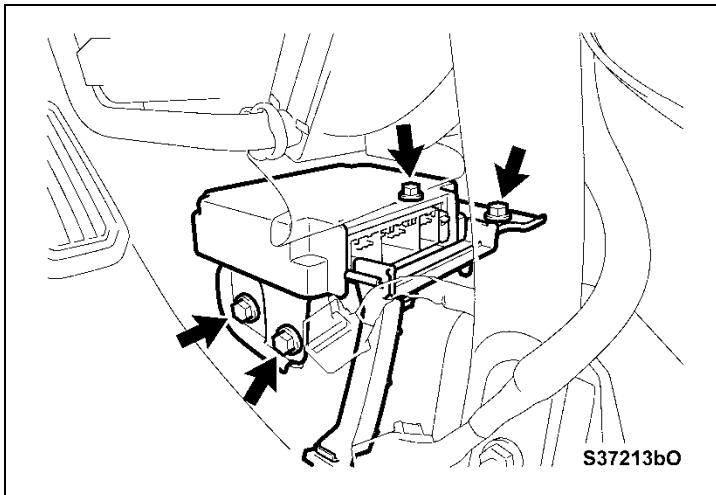
- m) Remove the wire harness bracket from the original ECU.
- n) Reinstall the wire harness bracket onto the new ECU.

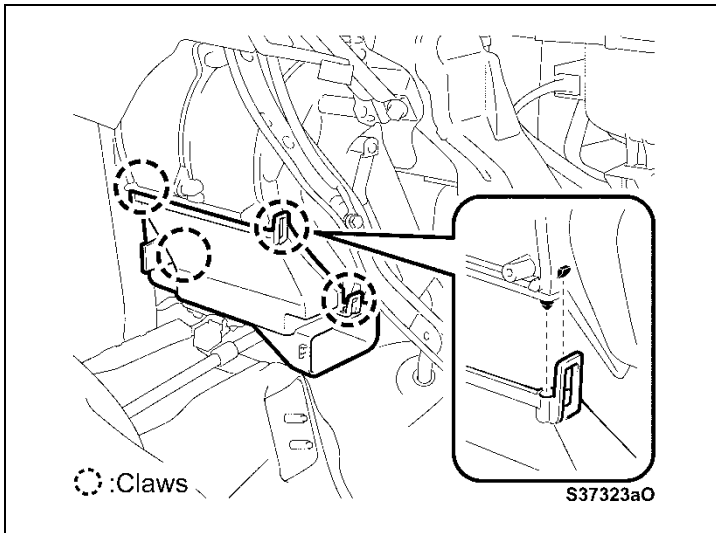
- q) Reinstall the parking brake cable bracket.
Torque: 5.4 N•m (55 kgf•cm, 48 in.•lb)

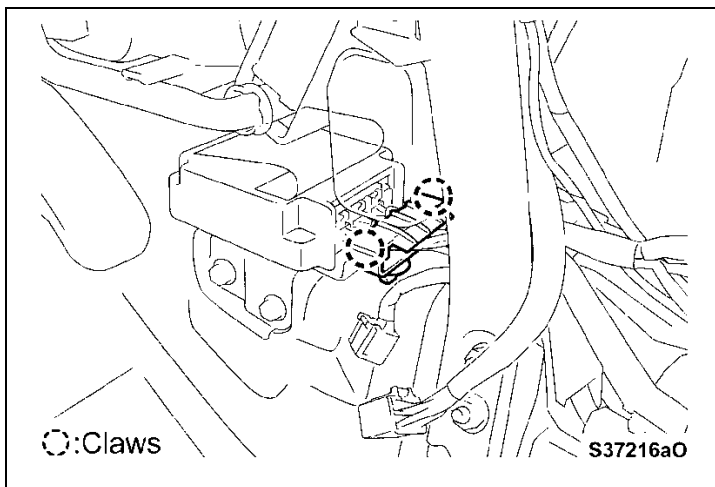
- a) Connect the 3 connectors of the sub wire harness to the airbag ECU.

NOTE: Ensure that the sub wire harnesses with the connectors near the blue tape are fully engaged into the ECU.

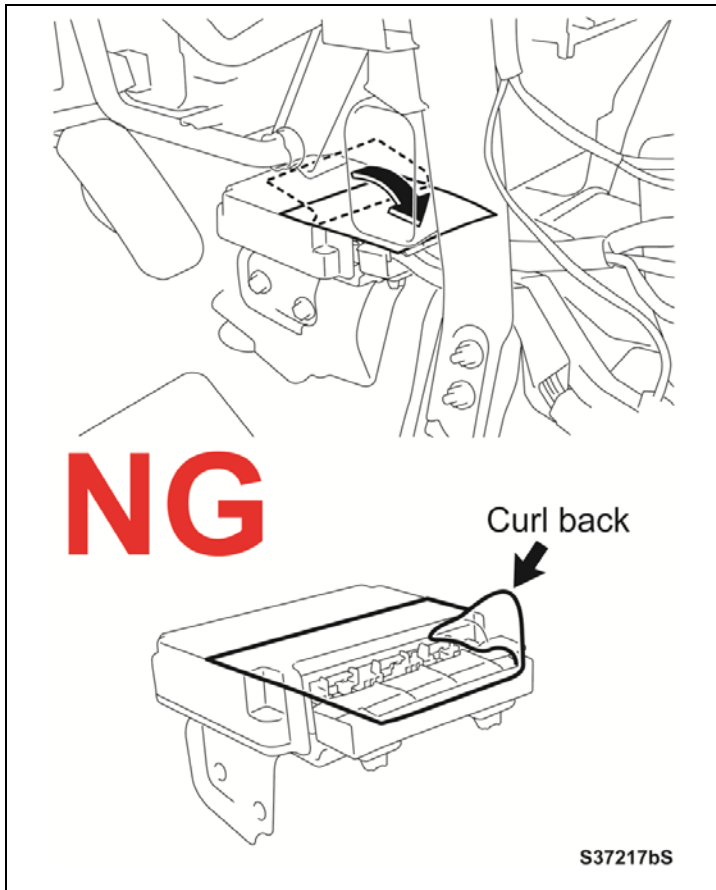
- b) Reengage the 2 claws for the wire harness bracket.

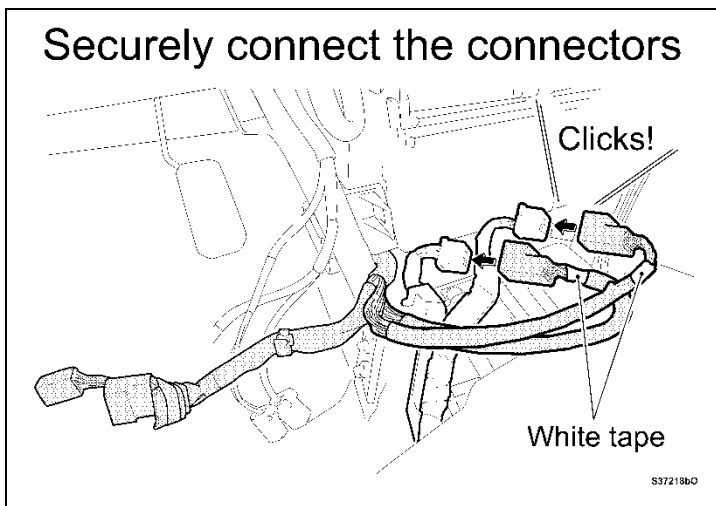
- c) Unfold the plastic sheet that is attached to the airbag ECU so that it covers the connectors.

NOTE: Ensure that the plastic sheet is positioned correctly and is not curled back on itself.
The plastic sheet protects the ECU and connectors in case of water condensation from the HVAC unit.

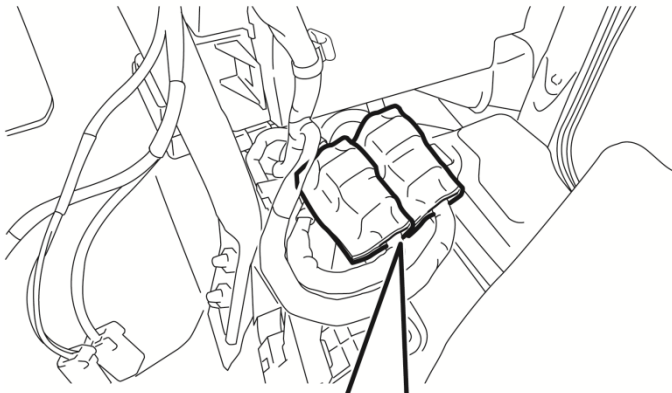
S37325aO

- d) Connect the 2 floor harnesses to the sub wire harness.

NOTE: Ensure that the 2 floor harness connectors are fully engaged into the sub wire harnesses.

Wrap the connector

Press

Water guard tape

- e) Using the small water guard tape, wrap each floor harness connector as shown.

NOTE: When wrapping the connectors ensure that the water guard tape is oriented correctly.

Ensure that the connector is completely sealed with the tape and there are no gaps to protect the connector, in case of water condensation from the HVAC unit.

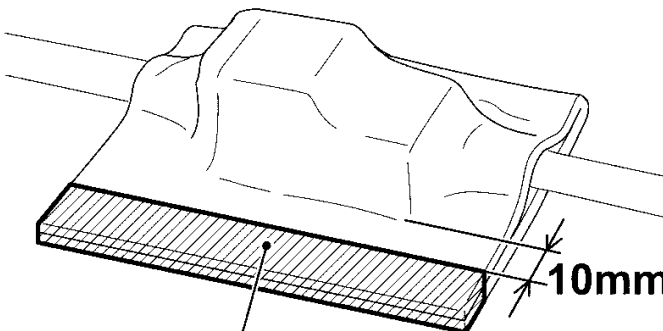
S37326aO

Cut off

- f) Cut off the highlighted portion of the water guard tape as shown. This will allow for both connectors to be stored under the HVAC unit.

NOTE: When cutting off the excess tape do not cut the wire harness.

Do not cut off more tape than is highlighted in the illustration.

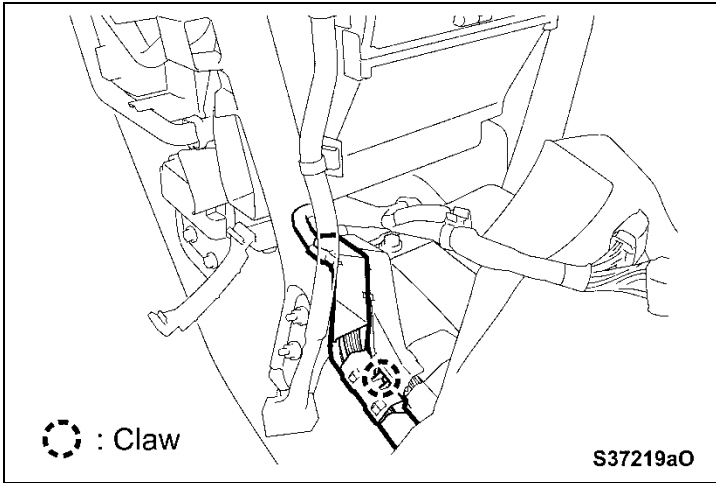
g) Engage the claw of the protector to fasten the wire harness.

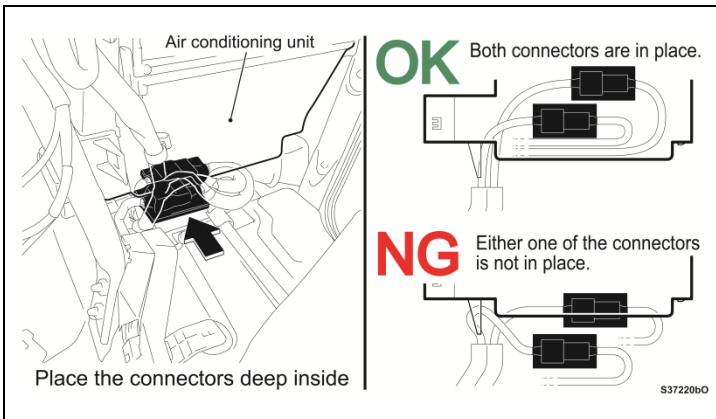
h) Place the 2 connectors under the HVAC unit as shown.

NOTE: Place the connectors as far back as possible this will allow enough clearance to reinstall the finish panel.

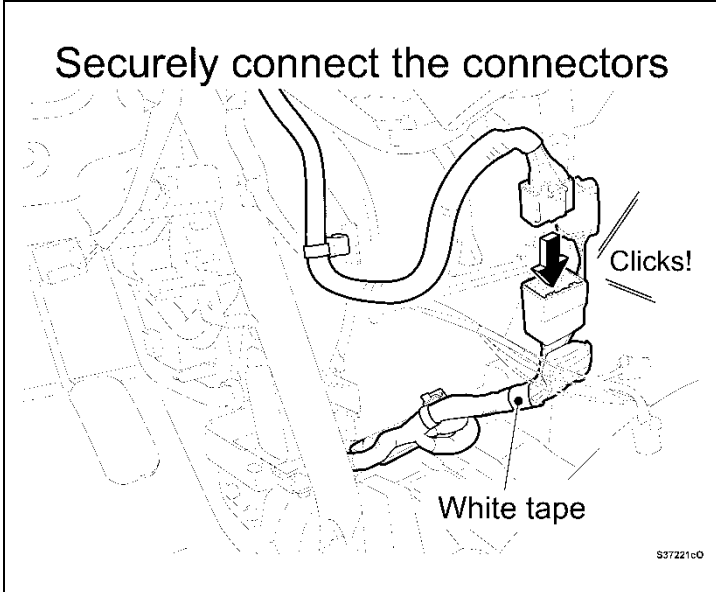
i) Connect the dash harness to the sub harness.

NOTE: Ensure that the dash harness connector is fully engaged into the sub wire harnesses connector with the white tape.

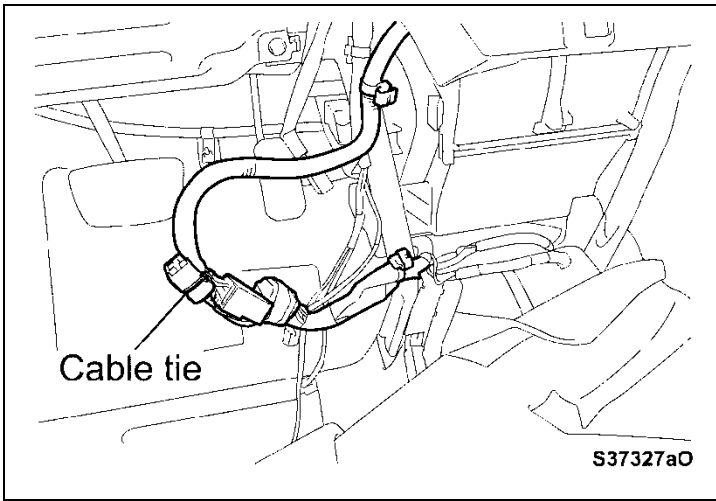
- j) Using a tie wrap. Wrap the diode pod to the dash harness.

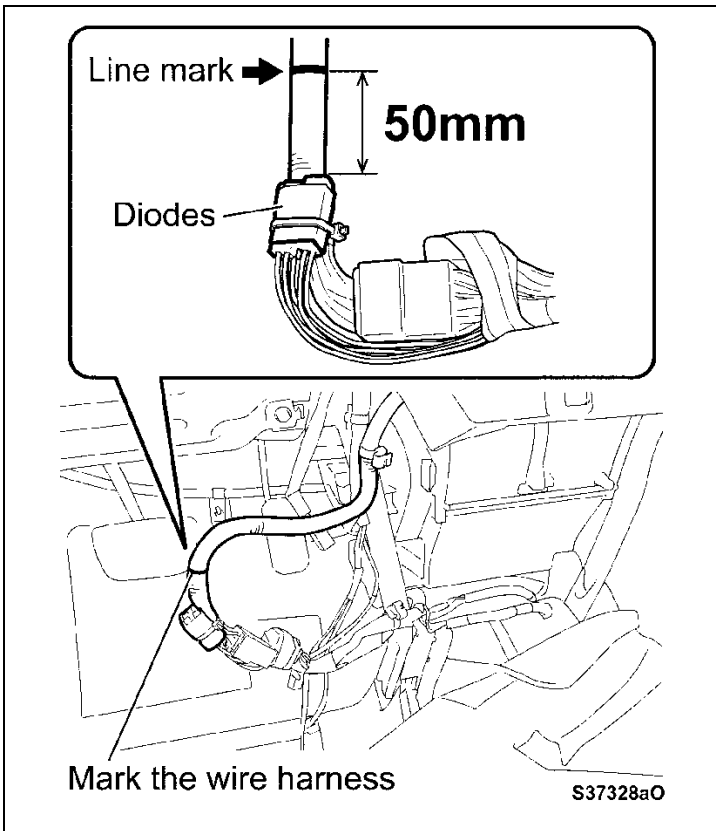
- k) Mark the dash harness as shown. Make a mark 50mm above the end of the diode pod.

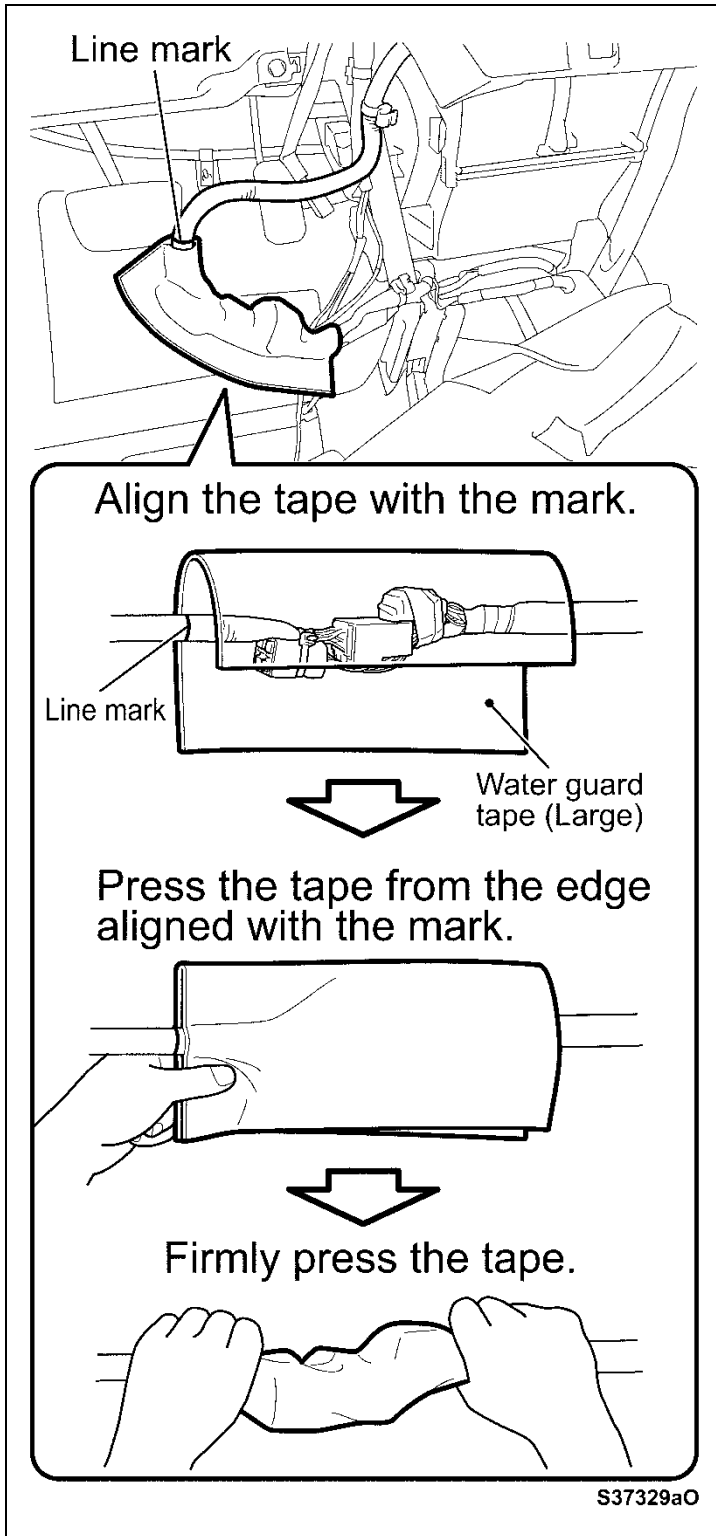
- 1) Protect the dash harness connection and diode pod with the large water guard sheet as shown.

NOTE: Ensure that the connector and diode pod are completely sealed with the tape and there are no gaps to protect the connector and diode pod, in case of water condensation from the HVAC unit.

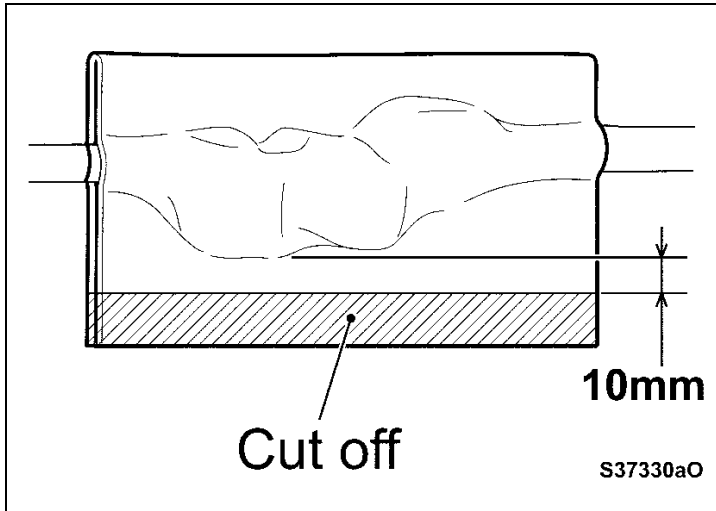
m) Cut off the highlighted portion of the water guard tape as shown. This will allow for connector storage.

NOTE: When cutting off the excess tape do not cut the wire harness.

Do not cut off more tape than is highlighted in the illustration.

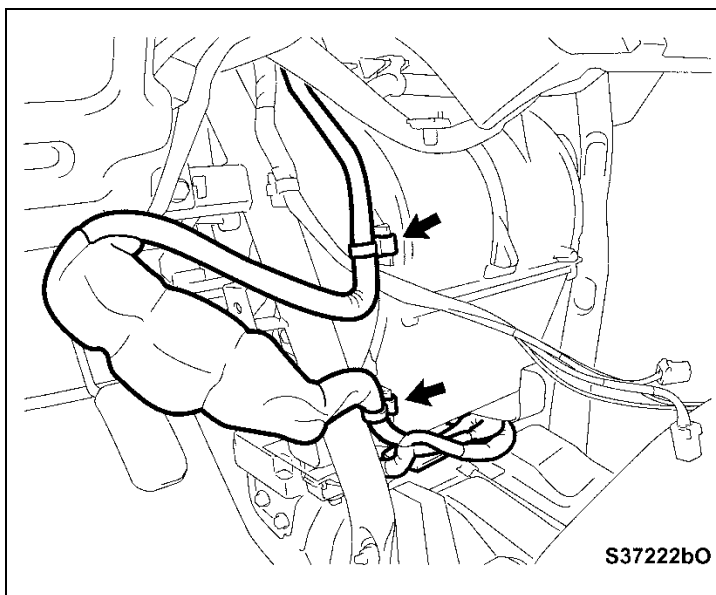
n) Install tie wraps onto the ribs of the HVAC unit as shown.

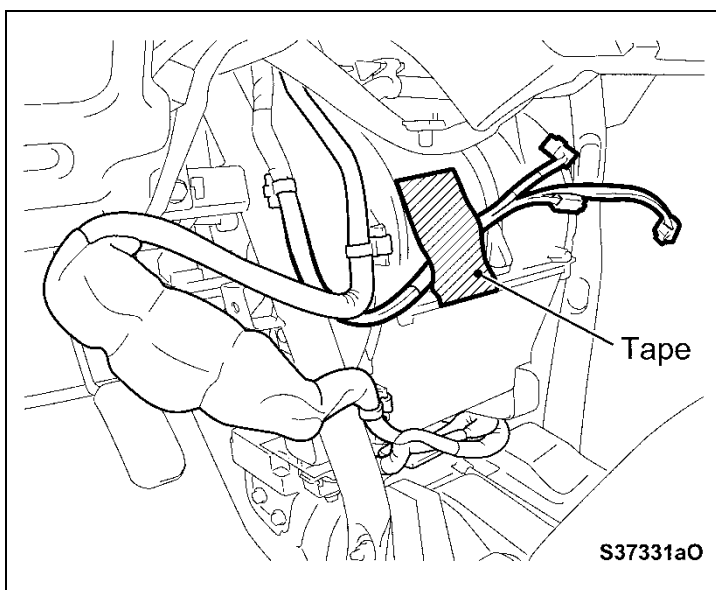
o) Temporarily attach the wire harness for the finish panel to the HVAC unit using tape.

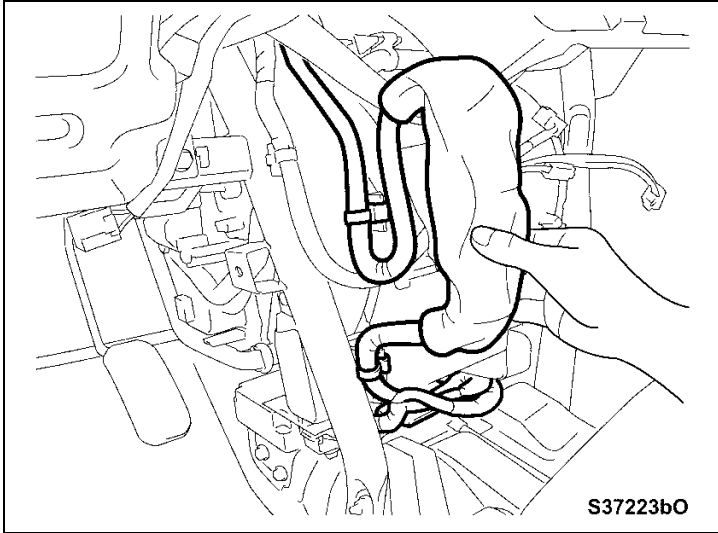
p) Route the dash and sub-harness as shown.

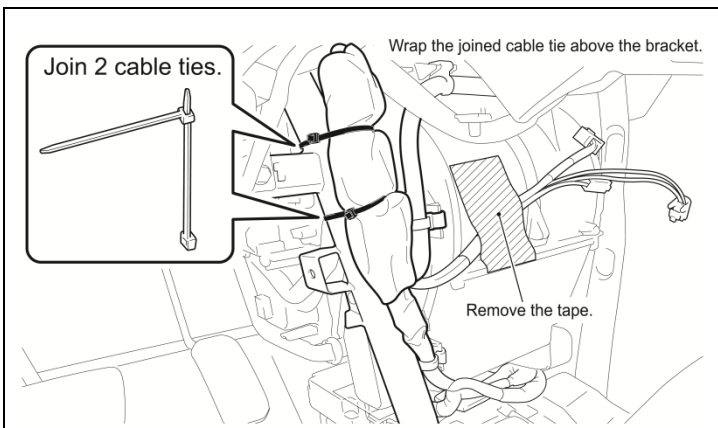
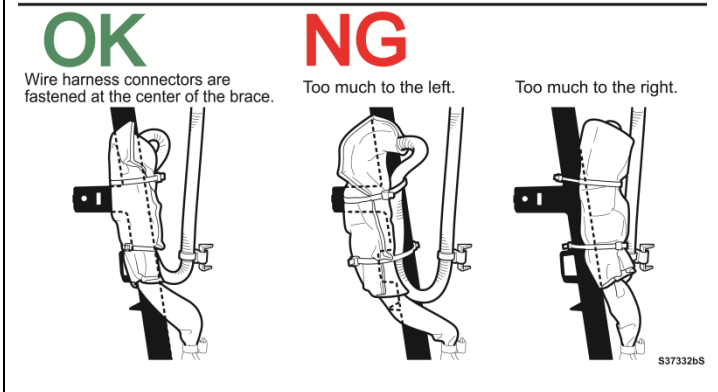
q) Using 4 tie wraps attach the dash/sub-harness to the dash brace as shown.

NOTE: To prevent the dash/sub-harness from moving place a tie wrap above the center bracket of the dash brace as shown.

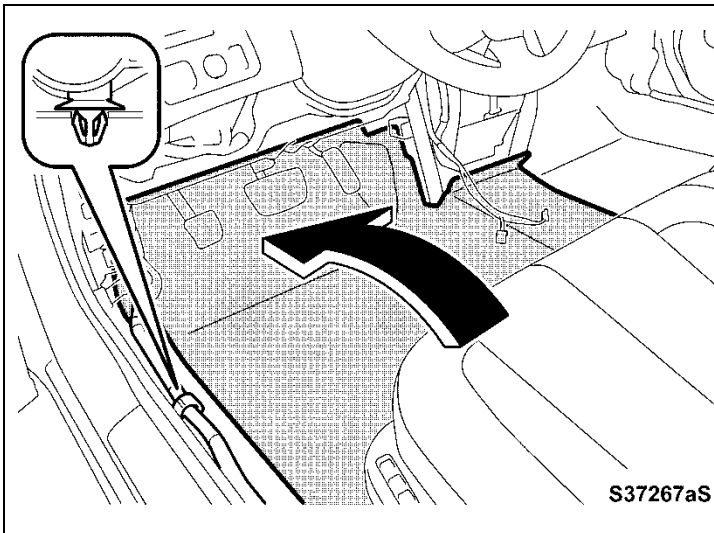
a) Reinstall the left rear air duct.

- 1) Insert the air duct into the opening under the left front seat.

NOTE: To prevent the duct from being caught on the carpet, pull the duct from the rear of the seat. Ensure that the duct does not catch the carpet.

- 2) Connect the air duct to the HVAC unit.

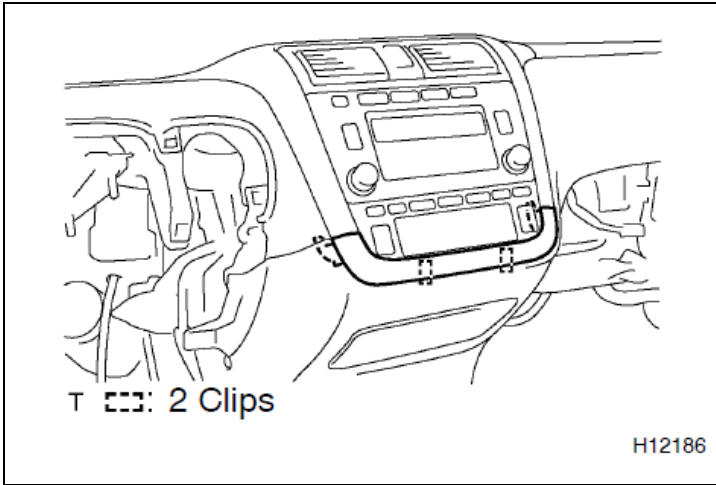
d) Reinstall the finish panel.

- 1) Reconnect the connector.
- 2) Reinstall finish panel.
- 3) Reinstall the following:
 - 4 screws
 - 2 clips
