Recall Bulletin

F/CMVSS NONCOMPLIANCE RECALL

SUBJECT: Goodyear P255/65R18 109S Fortera HL Tires

MODELS: 2015 Buick Enclave
2015 Chevrolet Traverse
2015 GMC Acadia
Equipped with 18" Goodyear Fortera HL Tires (RPO QLW)

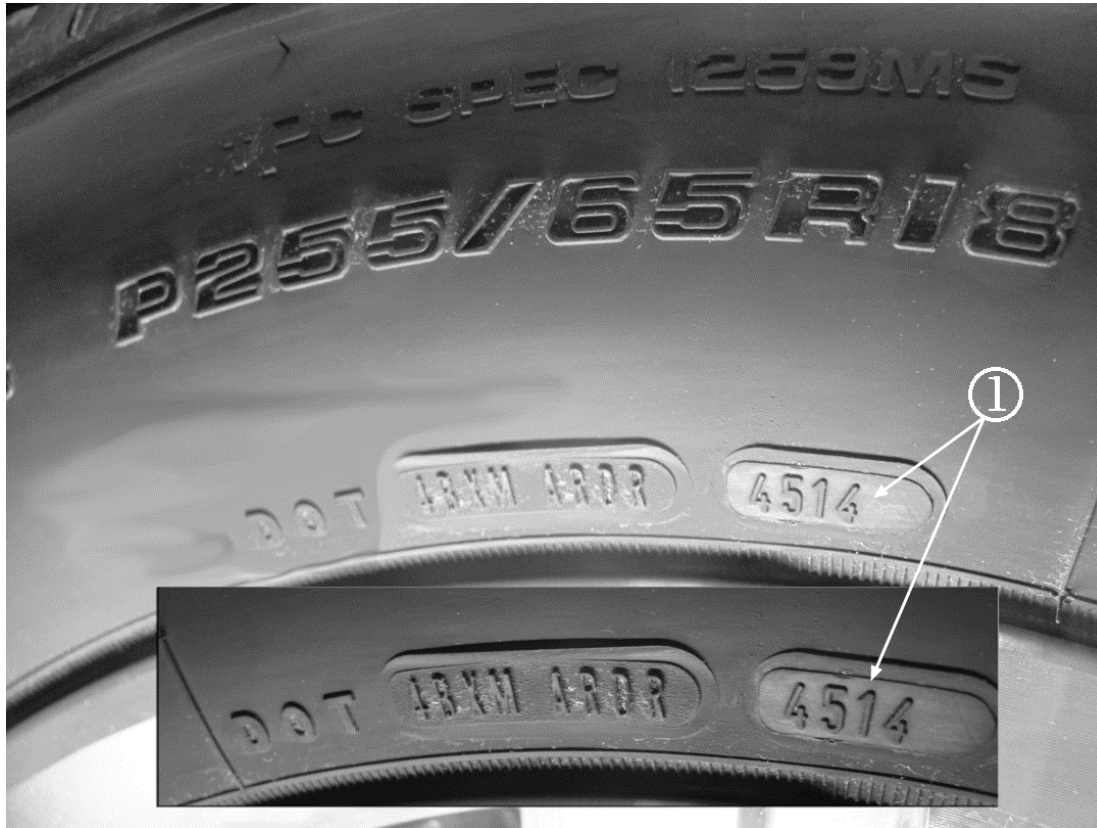
46064821

1. Inspect all vehicle tires for suspect DOT date codes. The date code is located on the sidewall of the tire. Refer to the photograph for the location of the DOT date code (1). All vehicles built with P255/65R18 Fortera HL tires with DOT date code 4814 (Nov, 2014) through and including 0115 (Jan 2015) REQUIRE REPLACEMENT.

Note: Each replaced Tire and Wheel Assembly MUST be checked for Radial Force Variation (RFV) before remounting on the vehicle. Tire and Wheel Assemblies must achieve an RFV of 24 lbs. (11 kg) or less. Assemblies with RFV above this specification MUST be Match Mounted (Vectoring) to achieve an RFV of 24 lbs. (11 kg) or less. Refer to the latest version of GM Service Bulletin #00-03-10-006K and Tire-to-Wheel Match-Mounting (Vectoring) in SI for complete information.

- If tire replacement is required, refer to *Tire and Wheel Removal and Installation* and *Tire Mounting and Dismounting* in SI.

Note: If the tire and wheel assembly cannot be made to return an RFV of 24 lbs. (11 kg) or less the tire must not be used. Contact your local tire distributor for exchange guidelines.

2. Ensure the recalled tires are damaged --- drilled or slashed --- so they can't be reused.
