Recall Bulletin

F/CMVSS NONCOMPLIANCE RECALL

SUBJECT: Rim Size Missing on Certification Label

MODELS: 2015 Buick Encore
2015 Chevrolet Trax

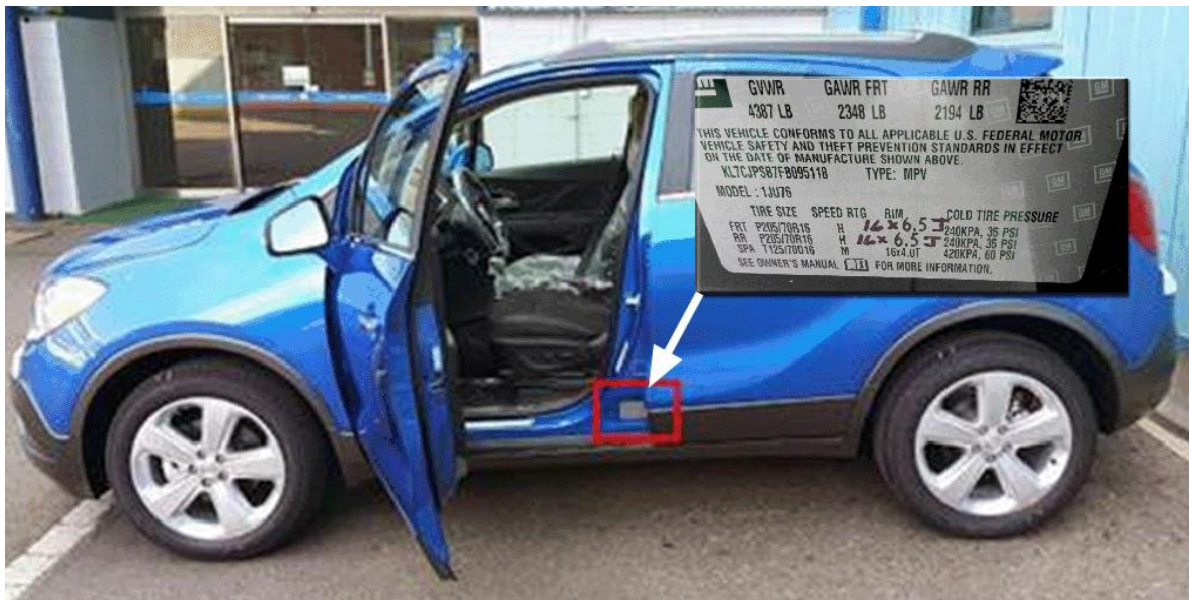
4122076

1. Locate Vehicle Certification Label on the lower section of the Driver Side B-Pillar.

2. Locate the blank RIM column on the label.
3. Clean the label (if required) and allow the surface to dry.
4. Using the chart below, locate the correct front (FRT) and rear (RR) wheel dimensions for the vehicle model you are working on.

5. Using a “Sharpie”® (or equivalent) Ultra Fine Point Black Permanent Marker write the vehicle RIM size as clearly and legibly as possible on the label as shown in the photograph.

Note: If the information written-in is not judged to be legible, the writing may be removed by briskly rubbing the label surface with Isopropyl Alcohol.

6. Allow time for the ink to dry before any contact with the label surface.
