### SAFETY RECALL DSF and E04

## FRONT PASSENGER AIRBAG INFLATOR MODULE

## CERTAIN 2003 – 2008 MODEL YEAR COROLLA

**Updated 04-18-18**

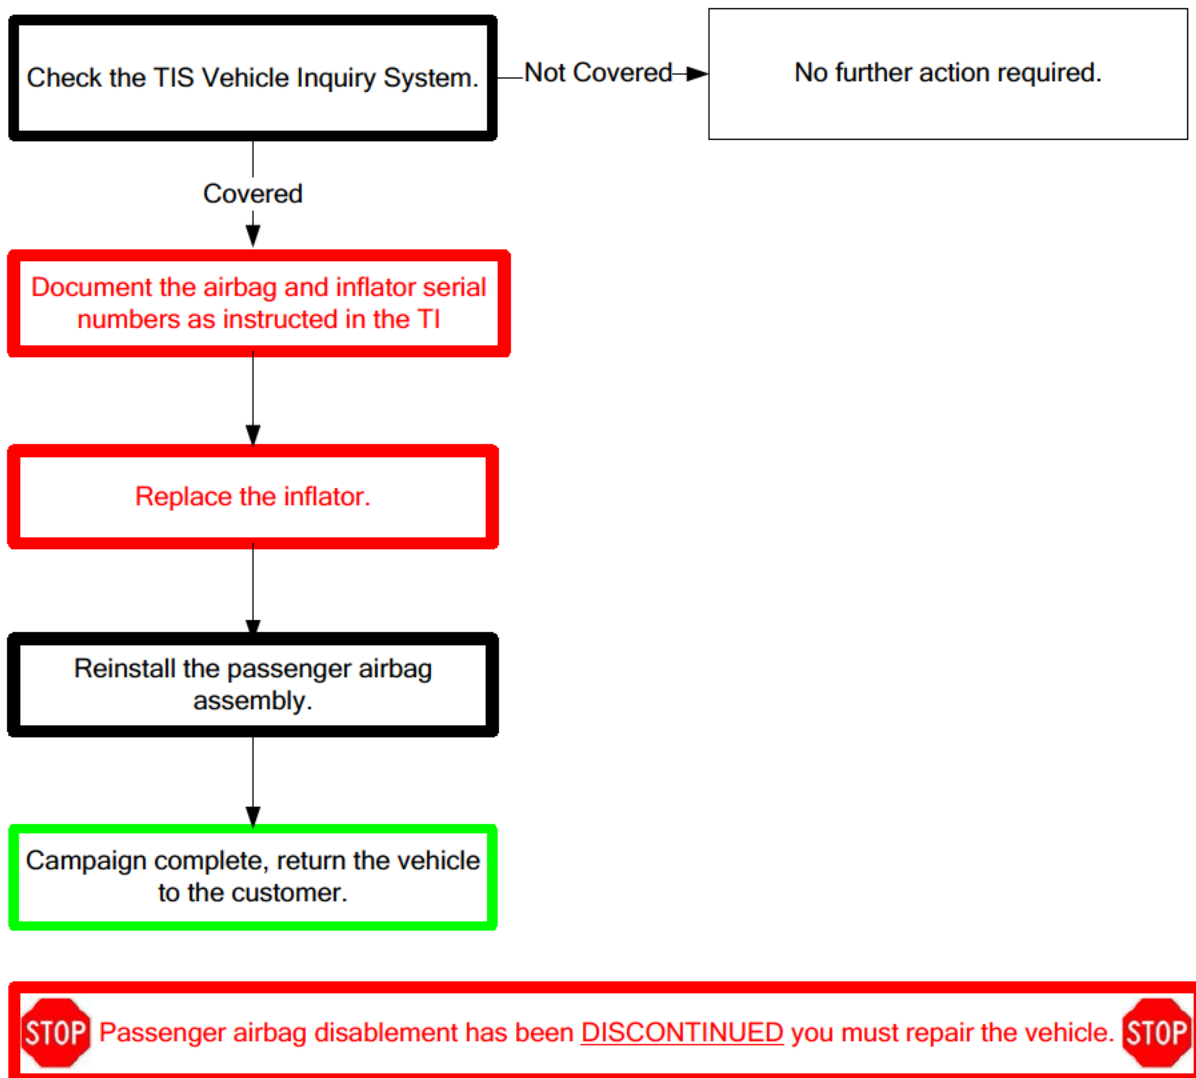
## I. OPERATION FLOW CHART

The flow chart is for reference only. **DO NOT** use it in place of the full technical instructions. Follow **ALL** steps as outlined in the full technical instructions to confirm the campaign is completed correctly.

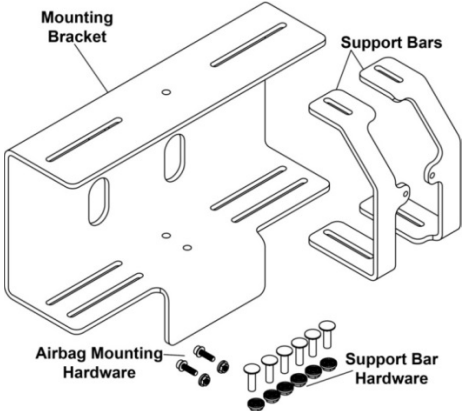
| Image | Name | Quantity |
|---|---|---|
| | Airbag Mounting Bracket & hardware | 1 |

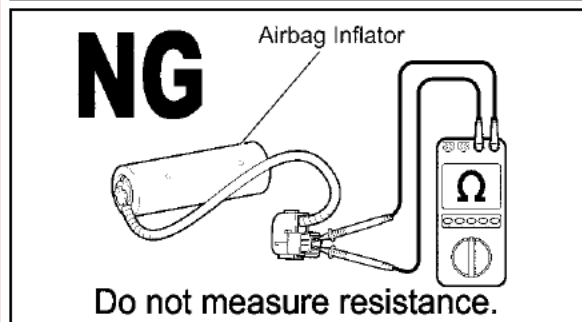
#### 2. DO NOT MEASURE RESISTANCE

- DO NOT** measure resistance of airbag components, this may cause accidental activation.

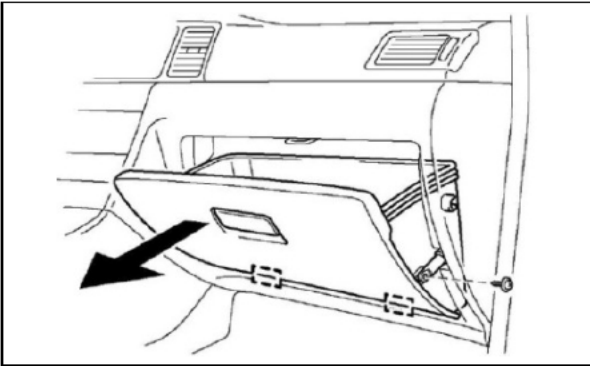
## 2. REMOVE THE GLOVE BOX

- a) Remove the screw and disconnect the stopper sub-assembly.
- b) Completely remove the glove box from the dashboard.

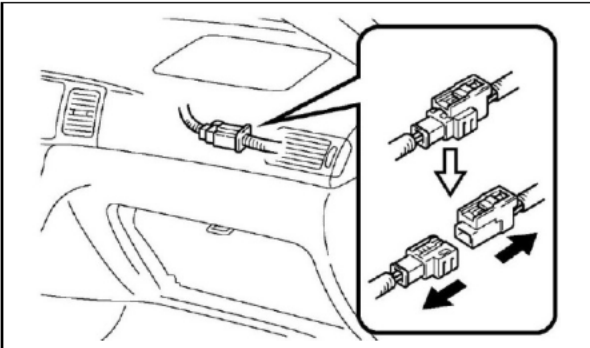
## 3. REMOVE THE AIRBAG ASSEMBLY

- a) Disconnect the negative battery cable.

- Wait at least 90 seconds after disconnecting the cable from the negative battery terminal to prevent airbag and seat belt pre-tensioner deployment.
- Follow all precautions as outlined on TIS before servicing the SRS system.

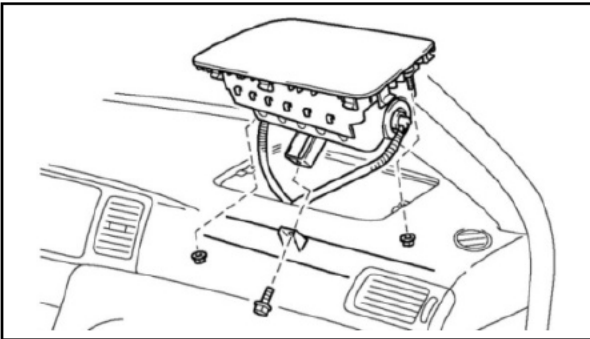
- c) Remove the bolt and 2 nuts and remove the airbag assembly.

**NOTE:** Use caution to avoid scratching or damaging the dashboard assembly, place protective tape on the dashboard if needed.

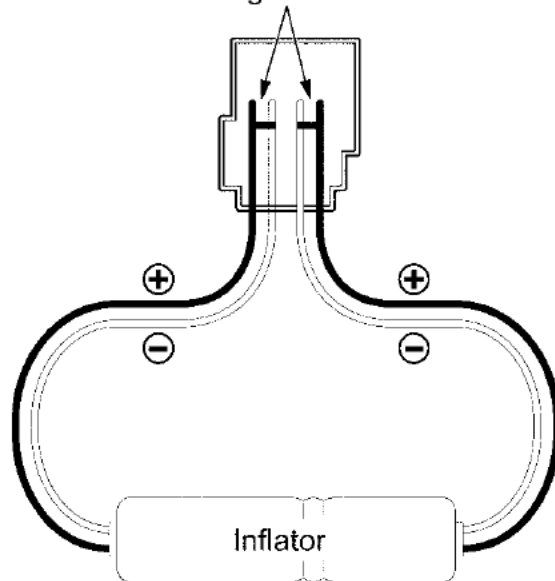
(1)

The connector of the inflator module contains a short circuiting mechanism to eliminate voltage variances when the connector(1) is disconnected. To allow for the replacement of the inflator module, a new short circuit(2) **MUST** be created before cutting the wires(3) and removing the inflator. The following steps **MUST** be followed exactly as described to ensure the work is completed correctly and safely.

Short circuiting on both sides.

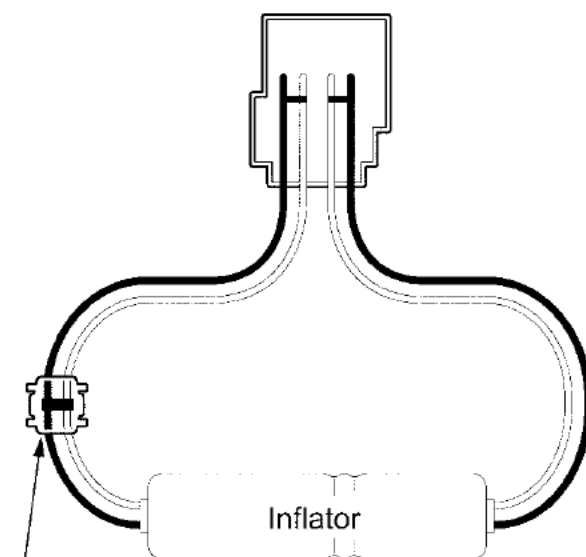
(2)

Create new short circuit using electro tap.

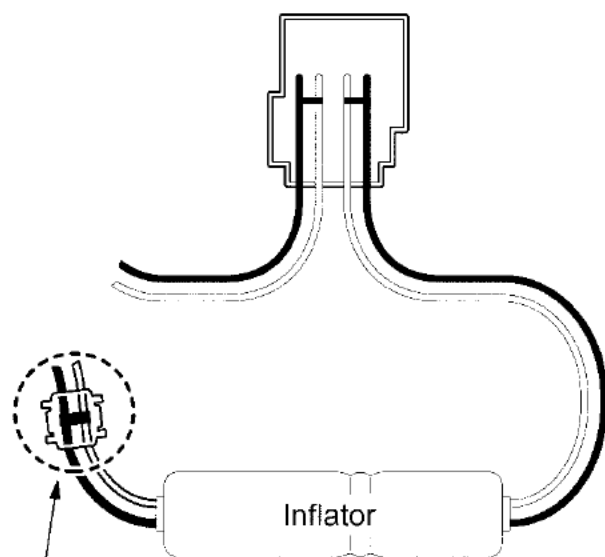
(3)

Short circuiting is maintained even after cutting harness.

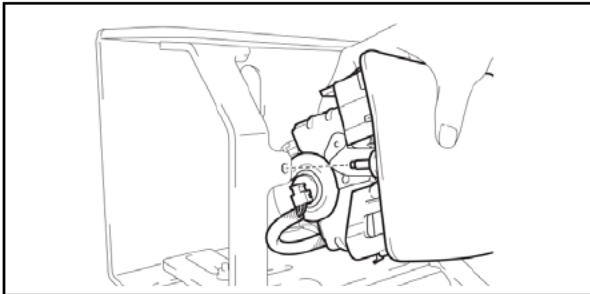
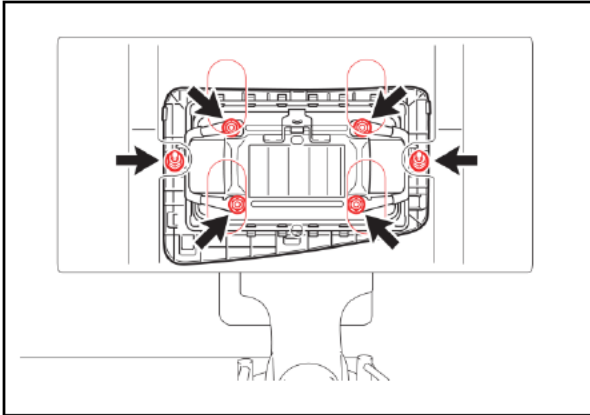
## 1. MOUNT THE AIRBAG IN THE MOUNTING BRACKET

- Position the two mounting studs on the airbag assembly into the holes on the bracket support bars.
- Install the airbag to the support bars with the nuts supplied in the bracket kit.
- Position the airbag so that all four stopper plate nuts can be removed through the access holes.
- Tighten the nuts holding the support bars to the mounting bracket.
- Confirm the following:
  - Mounting bracket is secure in the vise.
  - Airbag is secure in the support bars.
  - The center mounting bracket on the airbag assembly is facing upward.
  - Support bars are secure on the mounting bracket using 1 bolt/nut at the top of each support bar and 2 nuts/bolts at the bottom of each support bar.

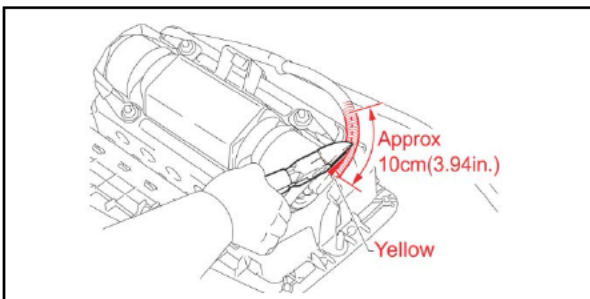
## 2. PREPARE TO INSTALL THE SHORT CIRCUIT

- Cut the yellow corrugated tube on the harness approximately 4 inches (10 cm) using nippers.

- DO NOT** damage the wires in the tube.
- DO NOT** use a knife or razor blade to cut the tube to avoid damaging the wires.
- This may be performed on either end of the inflator.

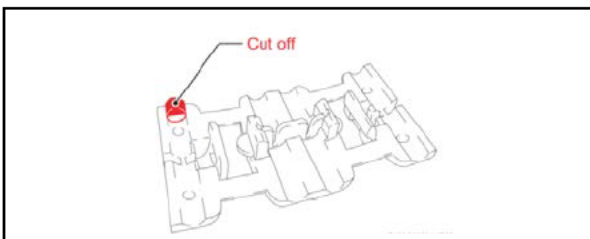
This tab **MUST** be removed to ensure a good short.

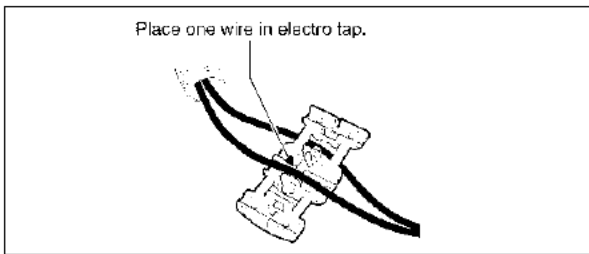
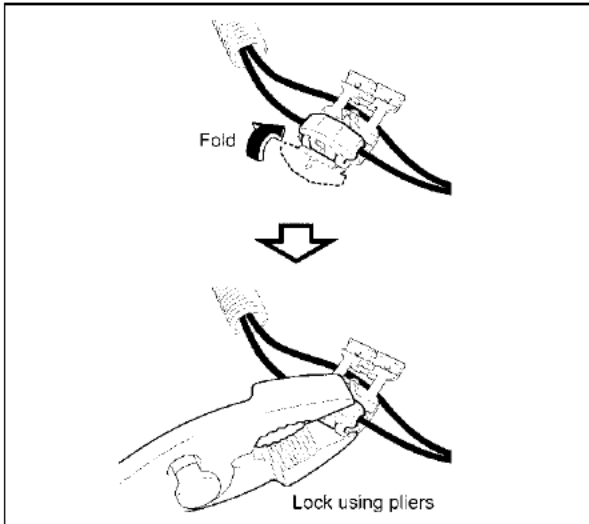
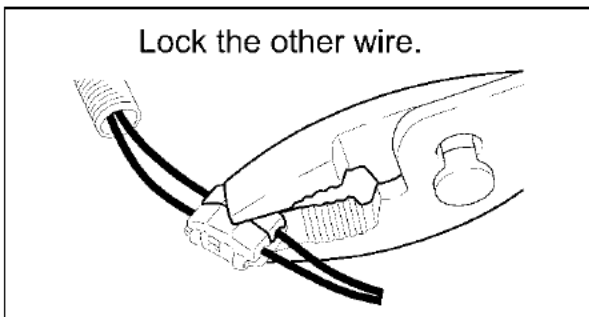
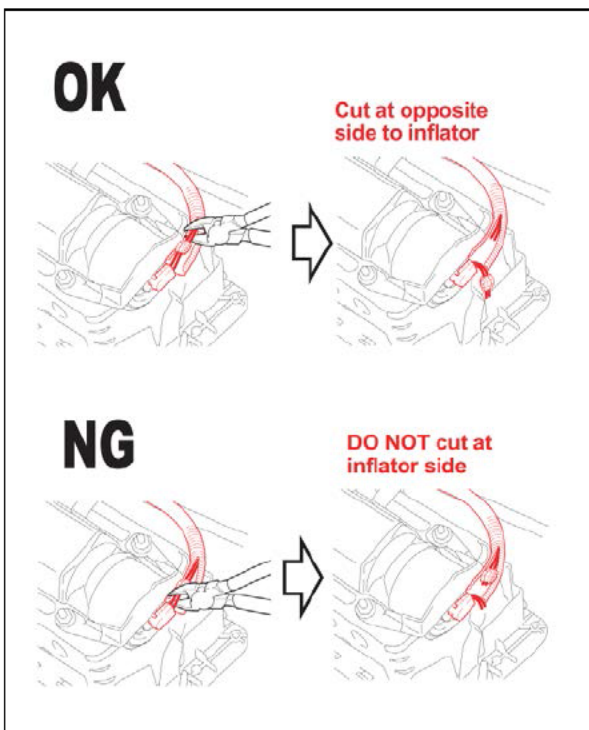
### 3. CREATE A NEW SHORT CIRCUIT IN THE INFLATOR HARNESS

a) Place one wire in the electro tap as shown in the illustration.

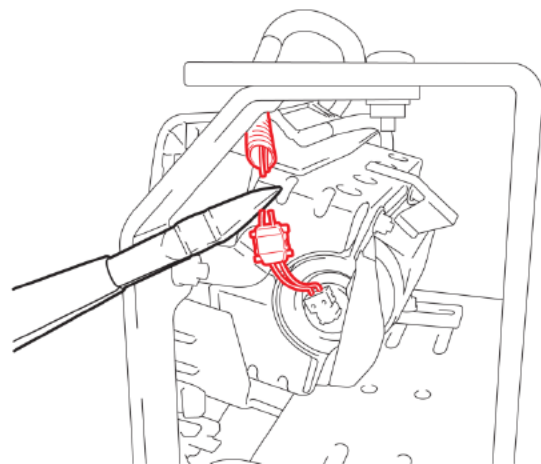
a) Cut the 2 wires at the side of the electro tap that is farthest away from the inflator.

Cut the wires opposite the inflator

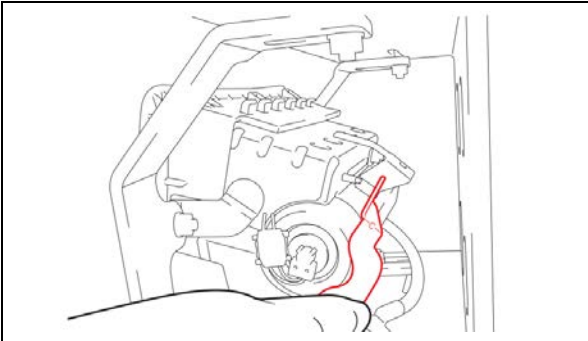
## 5. REMOVE THE SELF LOCKING NUTS

- a) Use the access holes in the bracket to remove the 4 nuts.

- **DO NOT** use power tools.
- The bracket support bars may need to be repositioned to remove the nuts through the access holes.

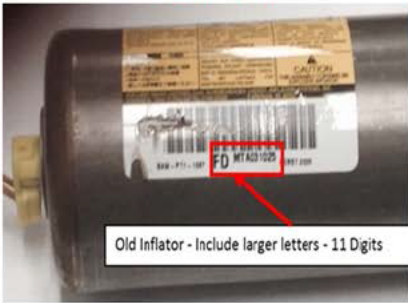
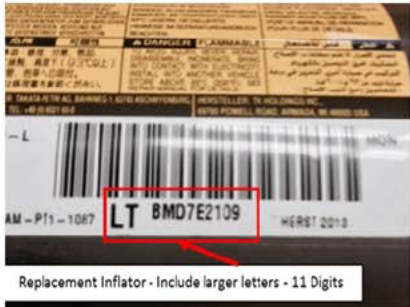
The Inflator serial code is an 11 digit code on the Inflator can. It can be found with a bar code on removing the Inflator can from the Airbag Assembly unit.

The first two characters of the **Replacement Inflator** Serial code will be either 'LT' or 'LR'.

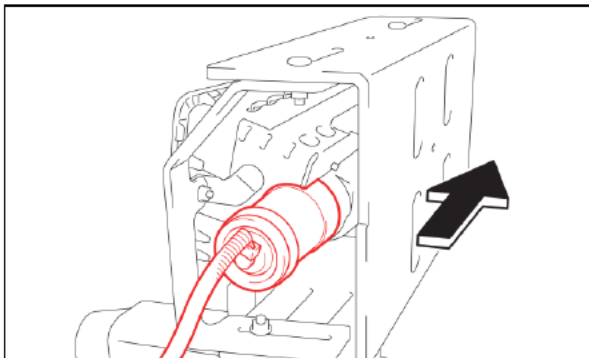
**8. INSTALL THE NEW INFLATOR**

- a) Carefully slide the new inflator into the airbag assembly.

- **DO NOT** connect the inflator harness at this time. It is **CRITICAL** to install the plates first to confirm the inflator is installed in the correct position before connecting the harness.

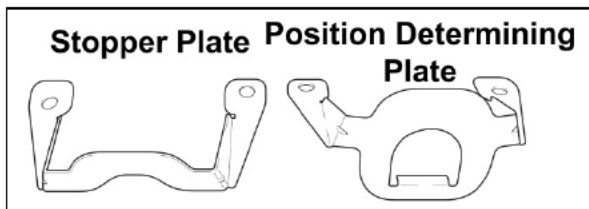
**9. CONFIRM THE NEW PLATES**

- a) Confirm the identification of the stopper plate and the position determining plate, **THEY ARE DIFFERENT.**

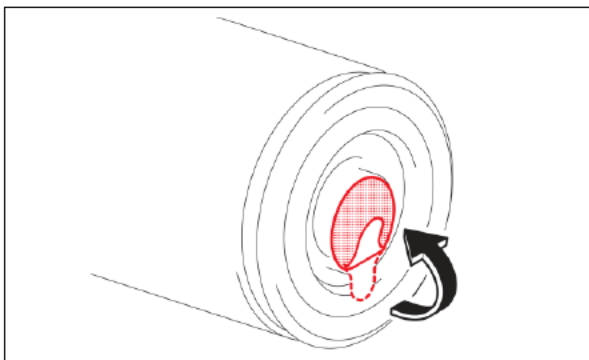
**10. FOLD THE CONNECTOR SEAL**

- a) Fold the seal in order to prevent it from being caught under the position determining plate in the next step.

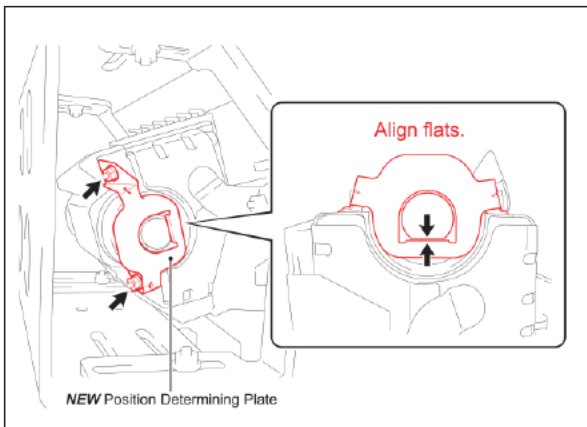
### 11. INSTALL THE NEW POSITION DETERMINING PLATE

- Place the **NEW** position determining plate on the airbag assembly on the side with the connector seal.
- Install **NEW** nuts by hand.

- Confirm the flats on the position determining plate and inflator are aligned.
- DO NOT** pinch the harness between the inflator and the plate.

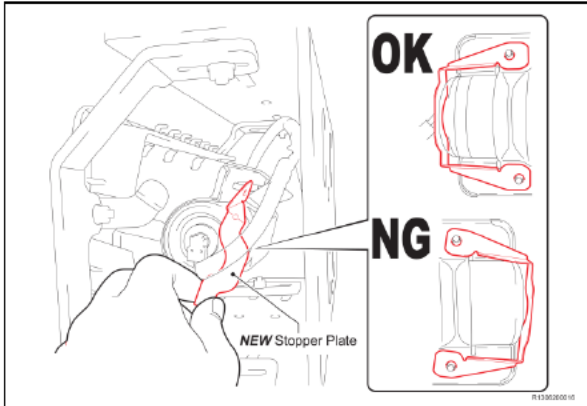
### 12. LOOSELY INSTALL A NEW STOPPER PLATE.

- Place the **NEW** stopper plate on the airbag assembly on the side where the harness is already connected.
- Confirm the end of the inflator sits flat against the stopper plate. If they do not align the inflator is installed backward.
- Install **NEW** stopper plate nuts by hand. They will be torqued on a later step.

- Confirm the stopper plate to inflator fitment is correct.
- DO NOT** pinch the harness between the inflator and the stopper plate.

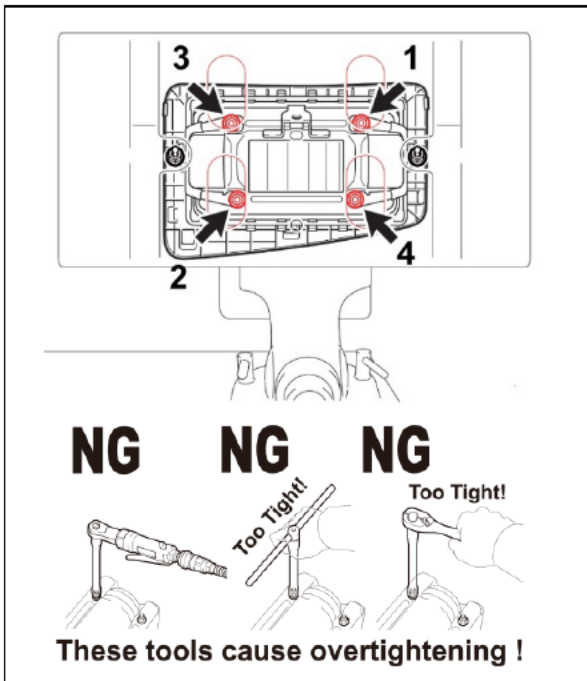
### 13. TORQUE THE PLATE NUTS

- Tighten the nuts evenly in two increments following the sequence shown in the illustration. Use a socket driver or torque wrench to tighten the nuts.

- There will be some resistance when tightening the nuts because they are self-locking, confirm the nuts are tightened correctly.
- DO NOT** use a power tool, T-handle, or ratchet when tightening the nuts to avoid over torquing.

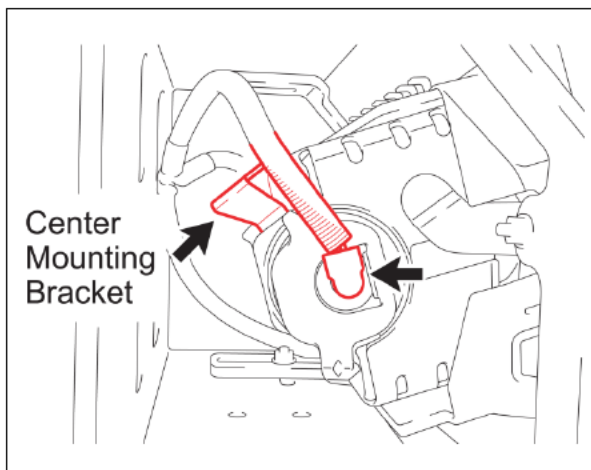
#### 14. CONNECT THE INFLATOR CONNECTOR

- Remove the connector seal from the inflator.
- Confirm the alignment of the harness connector as shown in the illustration, then connect the harness. The connector wires should lead toward the center mounting bracket on the airbag assembly.

- The connector should be connected **IMMEDIATELY** after removing the seal.
- The connector is one-way, once it is installed it **CANNOT** be removed.
- If the connector is installed in the incorrect orientation the terminals may be bent or the connector may not fully engage.

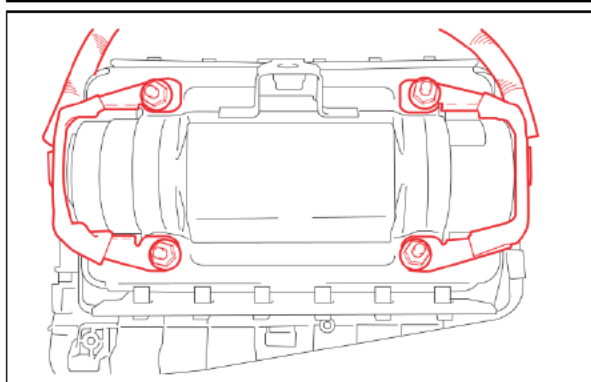
#### 17. INSPECT THE AIRBAG BEFORE INSTALLATION

- Confirm that the 4 **NEW** plate nuts are installed and tight.
- Confirm the **NEW** stopper and position determining plates are installed.
- Confirm the flats on the position determining plate and inflator are aligned.
- Confirm the orientation of the inflator wire harness.
