# IMPORTANT UPDATE

## TECHNICAL INSTRUCTIONS FOR SAFETY RECALL DSF FRONT PASSENGER AIRBAG INFLATOR MODULE CERTAIN 2003 – CERTAIN 2004 MODEL YEAR COROLLA CERTAIN 2003 – CERTAIN 2004 MODEL YEAR MATRIX

SSC D0F is no longer valid and has been replaced by SSC DSF

**Updated 5-12-15**

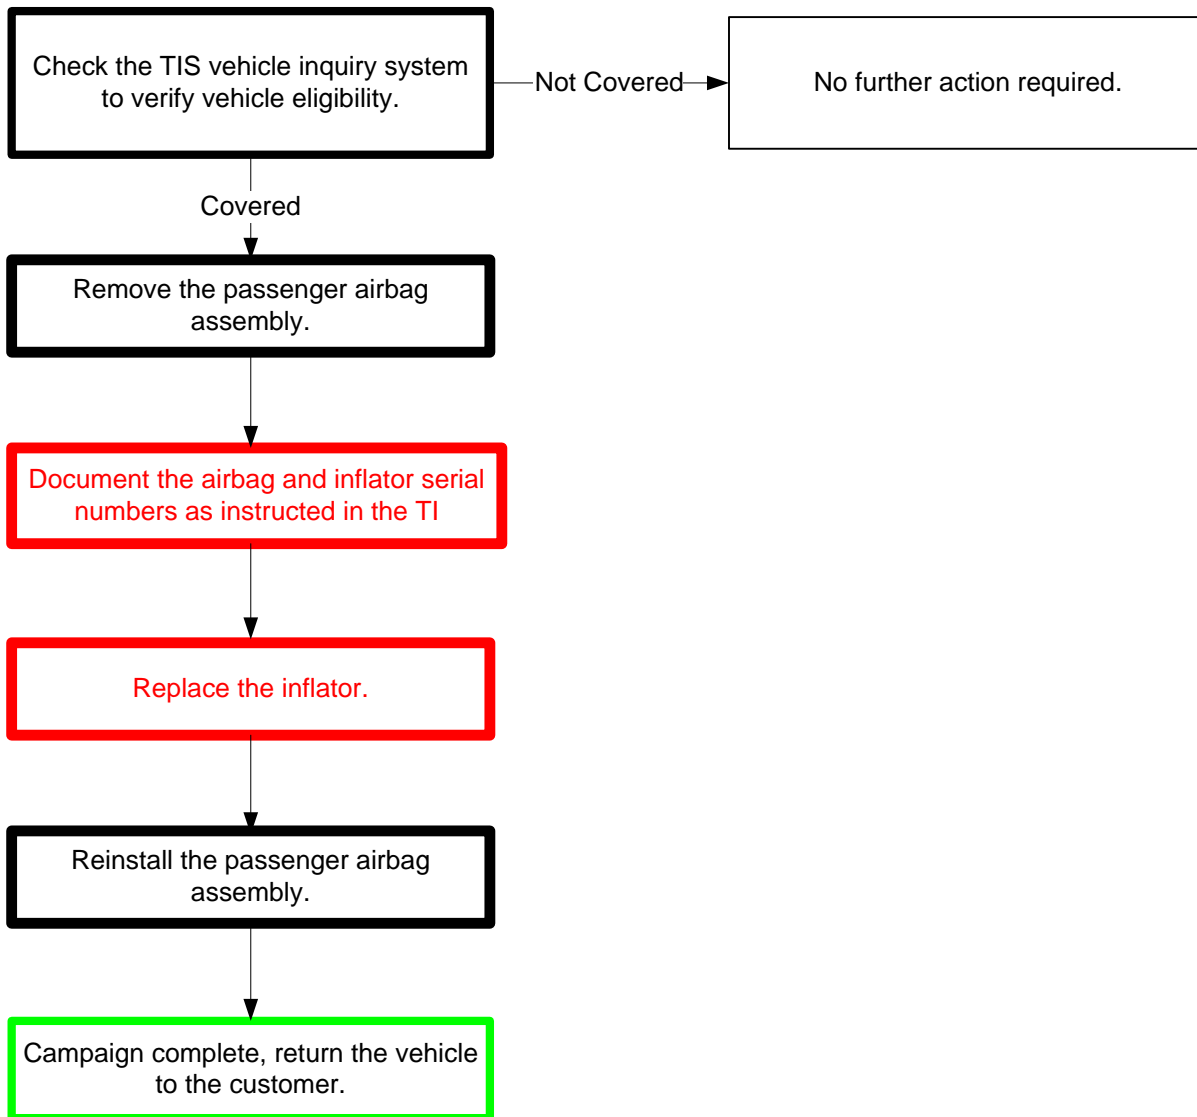
## I. OPERATION FLOW CHART

The flow chart is for reference only. **DO NOT** use it in place of the full technical instructions. Follow **ALL** steps as outlined in the full technical instructions to confirm the campaign is completed correctly.

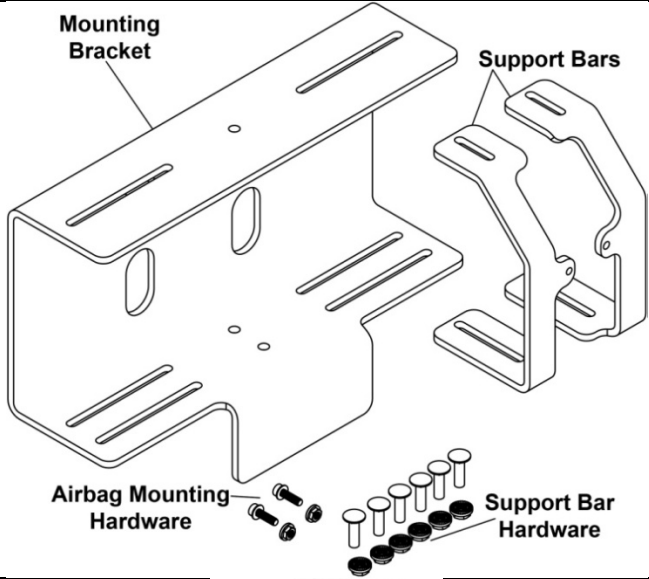
Airbag Mounting Bracket & hardware	1

Barcode Scanner	1

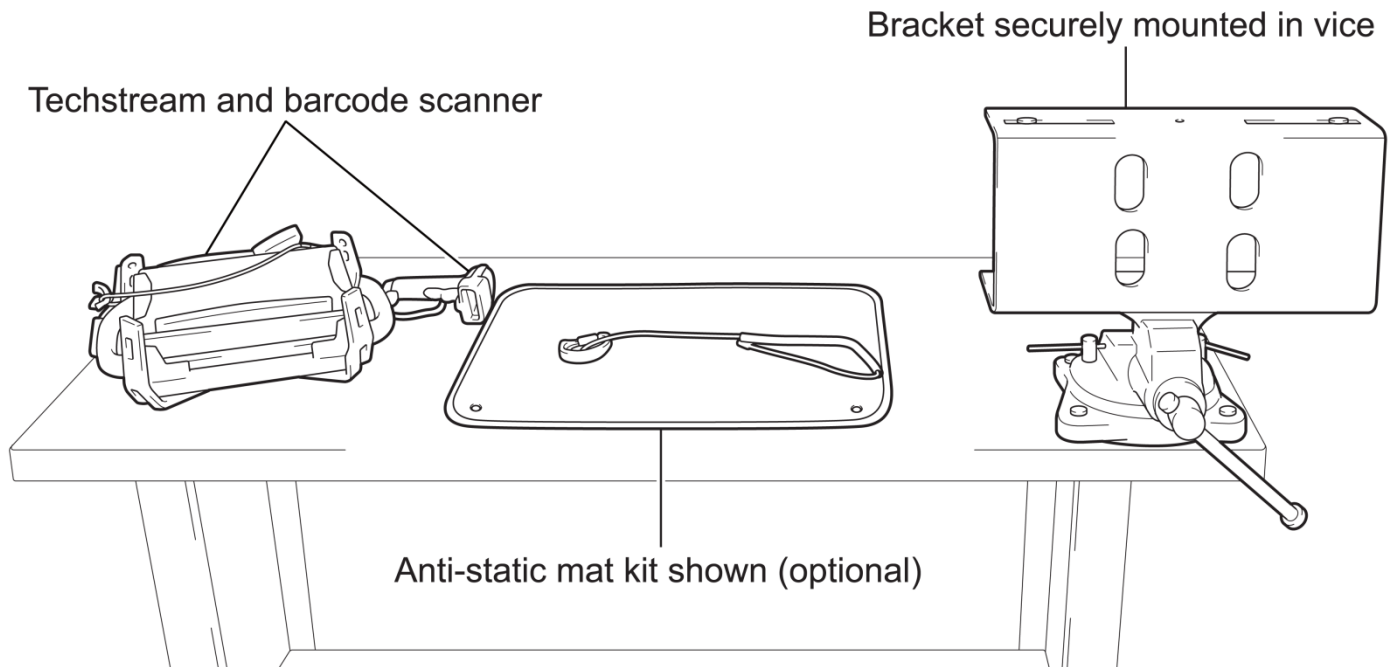
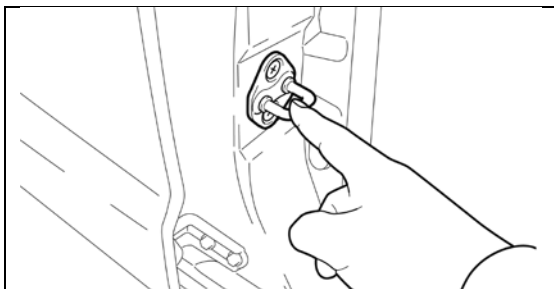
The bracket assembly that was provided at the launch of SSC D0F is a critical added-safety feature that **MUST** be used when replacing the inflator module. Confirm the bracket assembly is installed securely in the vise and confirm the work area being used is appropriate. The anti-static mat set that is an essential SST may be available at your dealership and is optional to use during inflator replacement. If the anti-static kit is not available, before starting work and periodically while working on the vehicle, touch a metallic part of the vehicle to discharge static electricity in the body.

Confirm there are no loose objects or people exposed to the back side of the bracket for safety in the unlikely event of airbag deployment due to improper work procedures (Remember that the inflator **IS NOT** being replaced due to an inadvertent deployment concern).

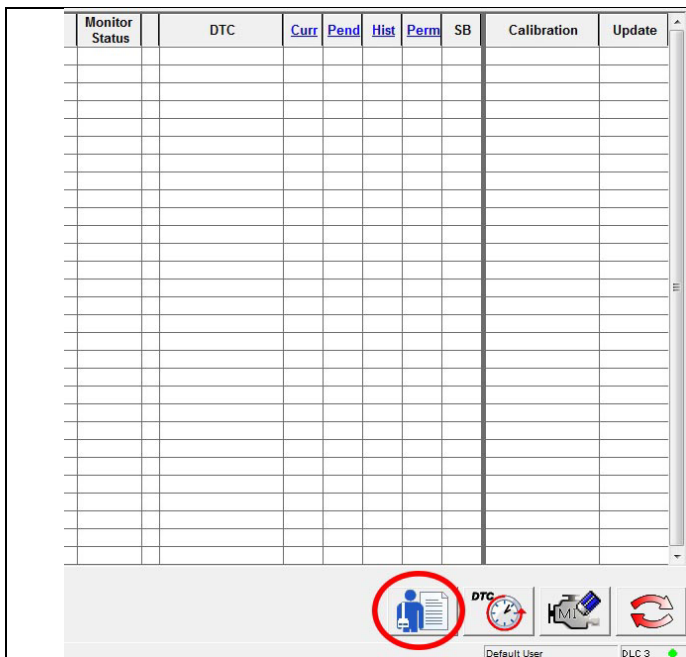
- After the health check has completed, run a diagnostic report by clicking on the link on the health check screen.

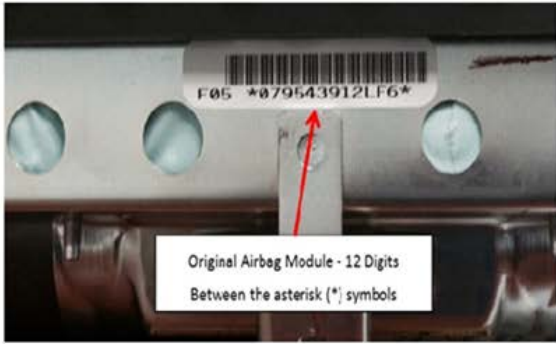
Original Airbag Module - 12 Digits  
Between the asterisk (\*) symbols

The Airbag module Assembly serial number is a 12 digit code. It can be found along with a bar code on opening the Airbag assembly unit. To manually enter these details into the application, the technician has to identify the 12 digit code between two Asterisks (\*) inside the Airbag assembly unit. The first seven characters of this 12 digit code are numbers and the 10<sup>th</sup> digit is either 'K' or 'L' always.

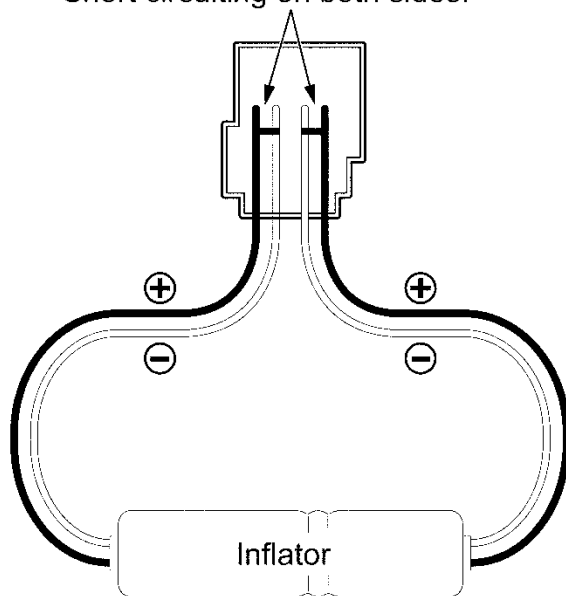
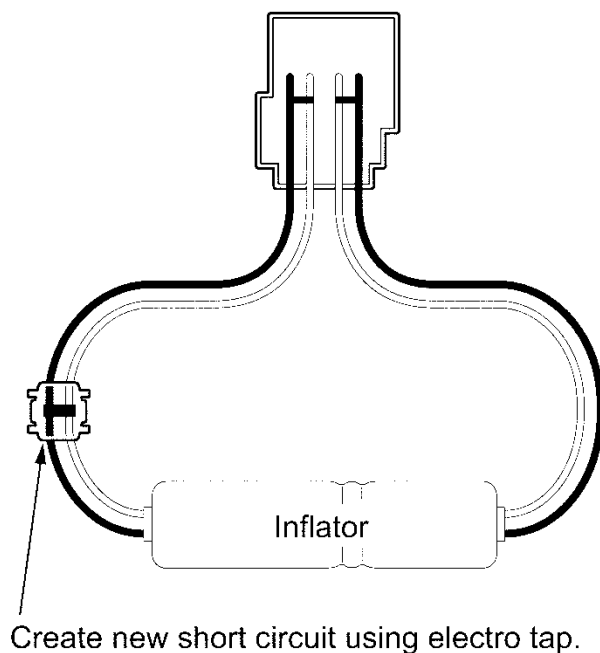
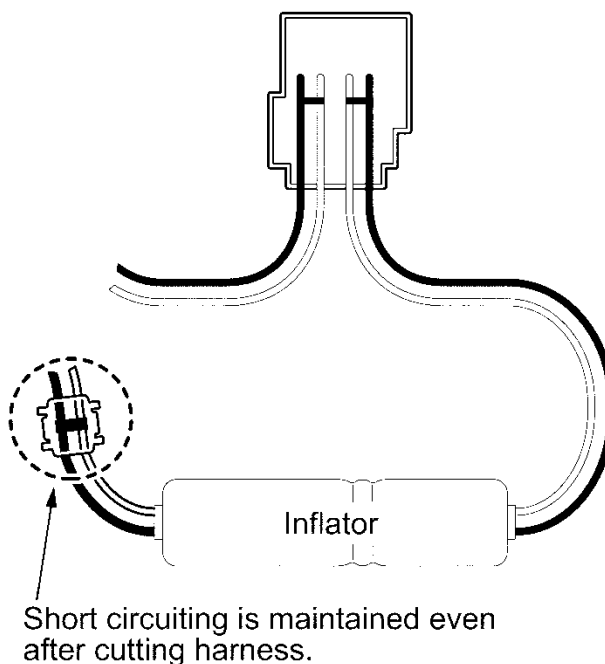
The connector of the inflator module contains a short circuiting mechanism to eliminate voltage variances when the connector(1) is disconnected. To allow for the replacement of the inflator module, a new short circuit(2) **MUST** be created before cutting the wires(3) and removing the inflator. The following steps **MUST** be followed exactly as described to ensure the work is completed correctly and safely.

Short circuiting on both sides.

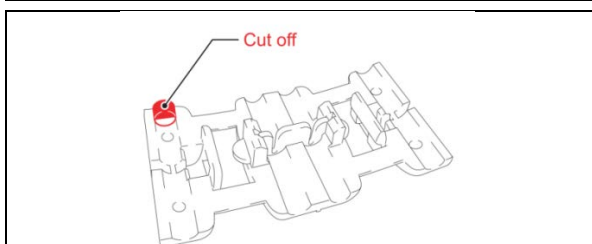
- Cut the yellow corrugated tube on the harness approximately 4 inches (10 cm) using nippers.

- DO NOT** damage the wires in the tube.
- DO NOT** use a knife or razor blade to cut the tube to avoid damaging the wires.
- This may be performed on either end of the inflator.

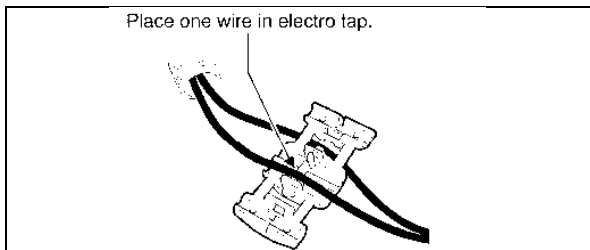
- Cut off the tab of the electro tap shown in the illustration.

This tab **MUST** be removed to ensure a good short.

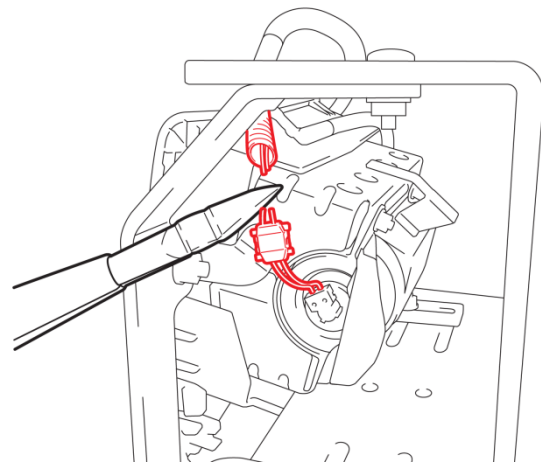
a) Cut the 2 wires at the side of the electro tap that is farthest away from the inflator.

**Cut the wires opposite the inflator**

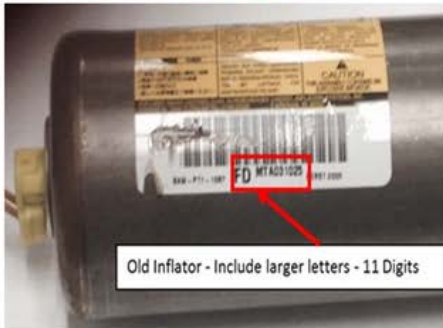
Old Inflator - Include larger letters - 11 Digits

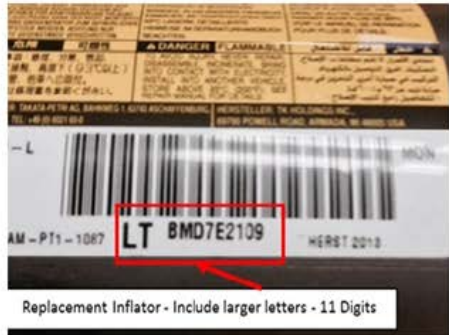
Replacement Inflator - Include larger letters - 11 Digits

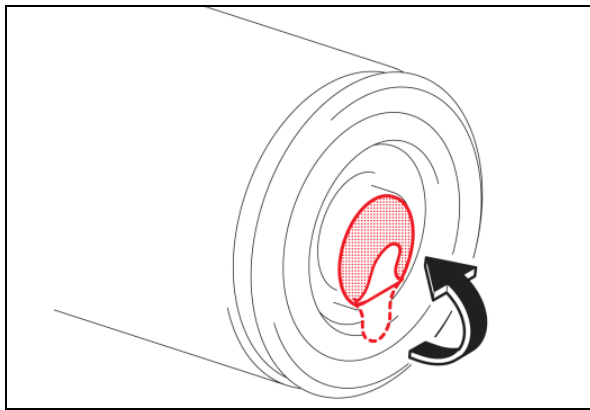
- a) Confirm the identification of the stopper plate and the position determining plate, **THEY ARE DIFFERENT**.

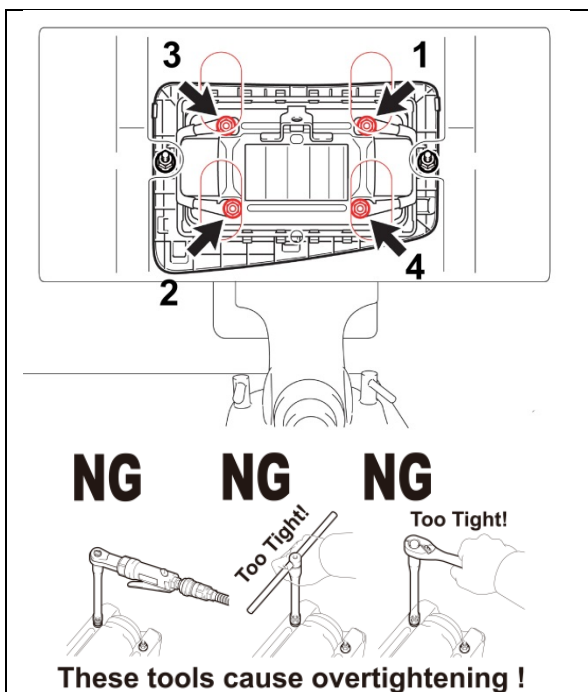
- Tighten the nuts evenly in two increments following the sequence shown in the illustration. Use a socket driver or torque wrench to tighten the nuts.

- There will be some resistance when tightening the nuts because they are self-locking, confirm the nuts are tightened correctly.
- DO NOT** use a power tool, T-handle, or ratchet when tightening the nuts to avoid over torqueing.

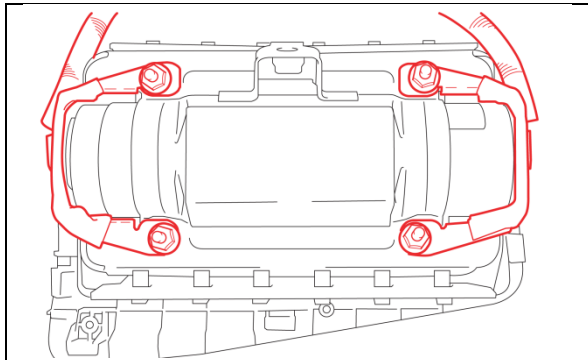
- Confirm that the 4 **NEW** plate nuts are installed and tight.
- Confirm the **NEW** stopper and position determining plates are installed.
- Confirm the flats on the position determining plate and inflator are aligned.
- Confirm the orientation of the inflator wire harness.
