SAFETY RECALL DSC and ELG

FRONT PASSENGER AIRBAG INFLATOR MODULE

CERTAIN 2002 – 2010 MODEL YEAR SC 430

Updated 01-14-2021

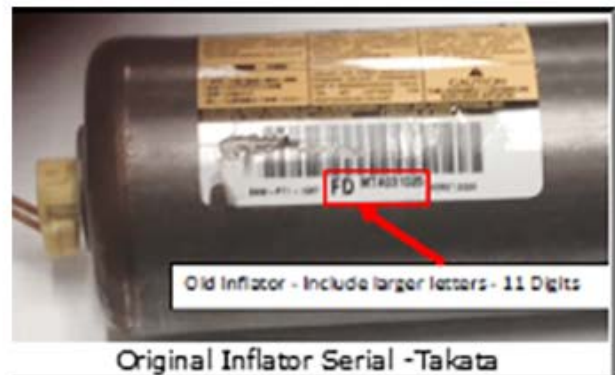
Check if the inflator serial number is missing or not visible, OR if installing a new airbag assembly

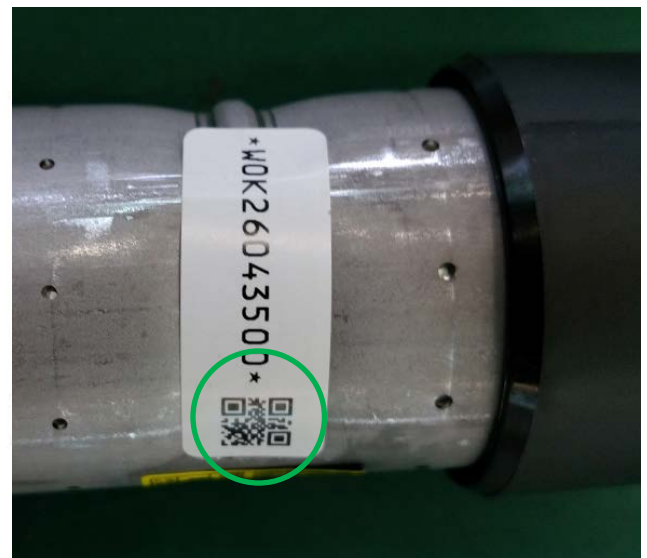
REPLACEMENT Inflator Serial Number

Scan or enter the **replacement** Inflator serial number into the website.

* Serial Number of *Replacement* Inflator:

* Re-confirm the Serial Number of *Replacement* Inflator:

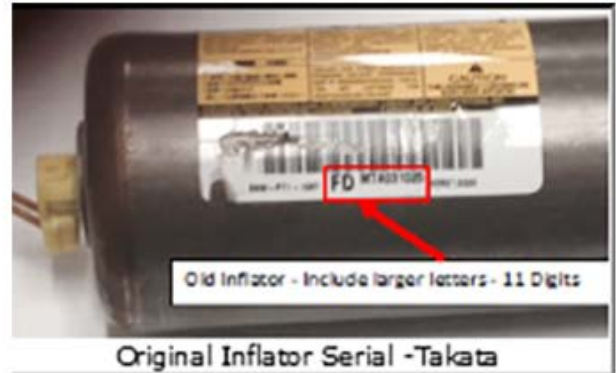
ORIGINAL Inflator Serial Number

c) If the inflator serial number cannot be scanned or is not present check the box as shown below.

Check if the inflator serial number is missing or not visible. OR if installing a new airbag assembly

Checking this box requires Air Bag Assembly replacement.

****Note** Contact your region in the event that you are unable to read the serial number.**
