## SAFETY RECALL DSF and E04

## FRONT PASSENGER AIRBAG INFLATOR MODULE

## CERTAIN 2003 – 2006 MODEL YEAR TUNDRA

**Updated 01-14-2021**

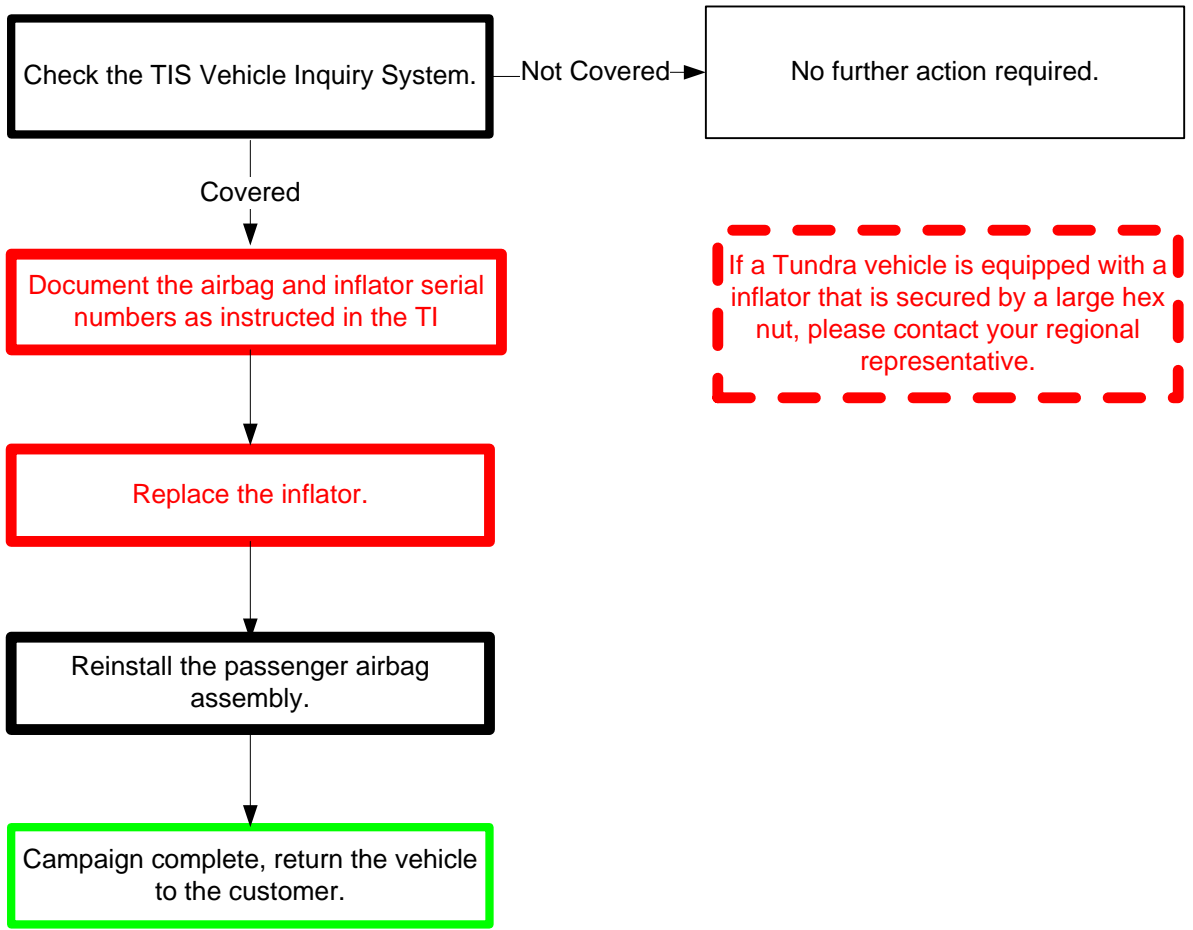
# I. OPERATION FLOW CHART

The flow chart is for reference only. **DO NOT** use it in place of the full technical instructions. Follow **ALL** steps as outlined in the full technical instructions to confirm the campaign is completed correctly.

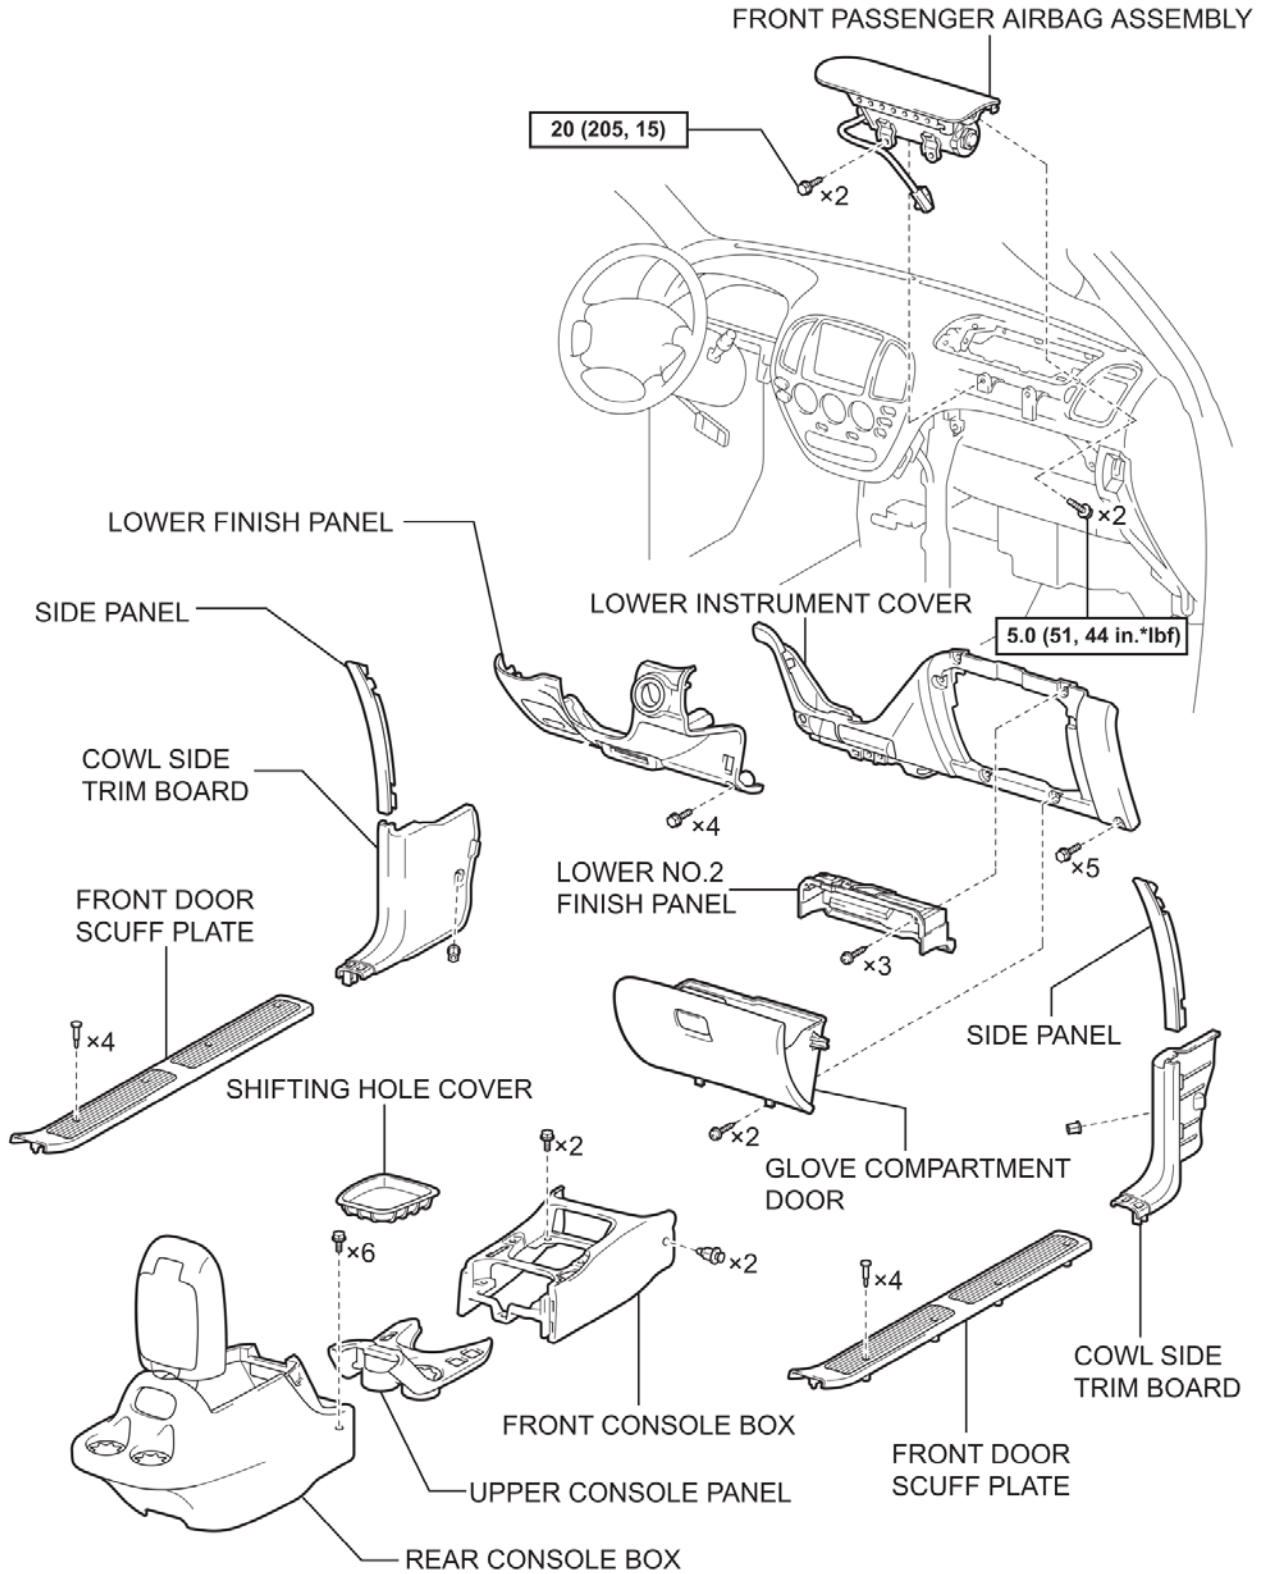
Double cab:

N\*m (kgf\*cm, ft.\*lbf) : Specified torque

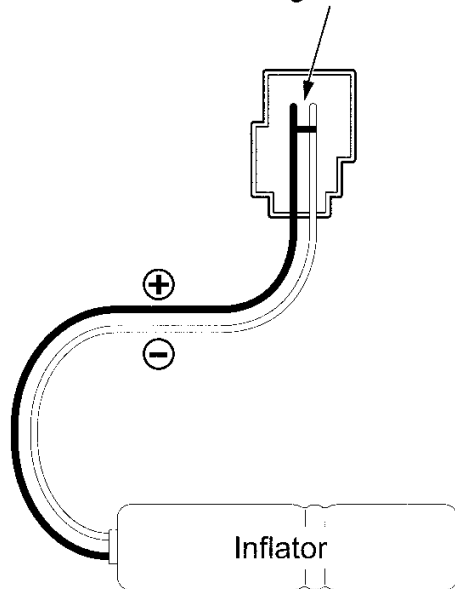
(1)

Short circuiting on both sides.

The connector of the inflator module contains a short circuiting mechanism to eliminate voltage variances when the connector(1) is disconnected. To allow for the replacement of the inflator module, a new short circuit(2) *MUST* be created before cutting the wires(3) and removing the inflator. The following steps *MUST* be followed exactly as described to ensure the work is completed correctly and safely.

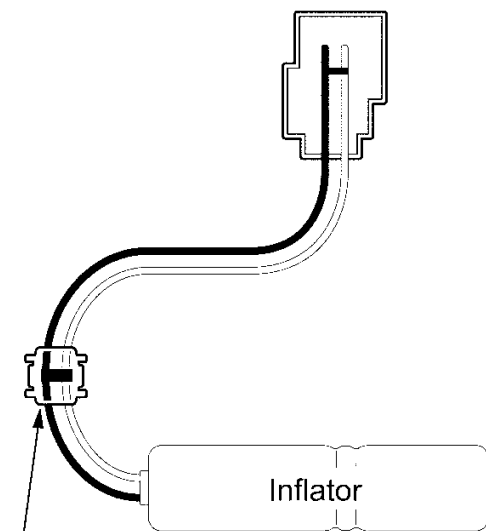
(2)

Create new short circuit using electro tap.

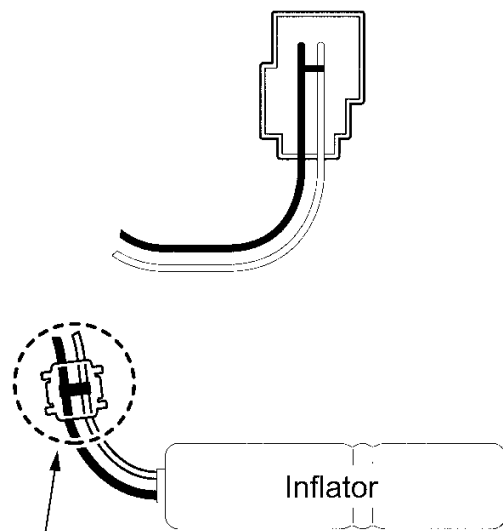
(3)

Short circuiting is maintained even after cutting harness.

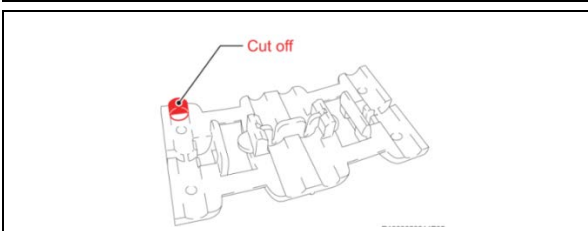
- b) Cut off the tab of the electro tap shown in the illustration.

This tab **MUST** be removed to ensure a good short.

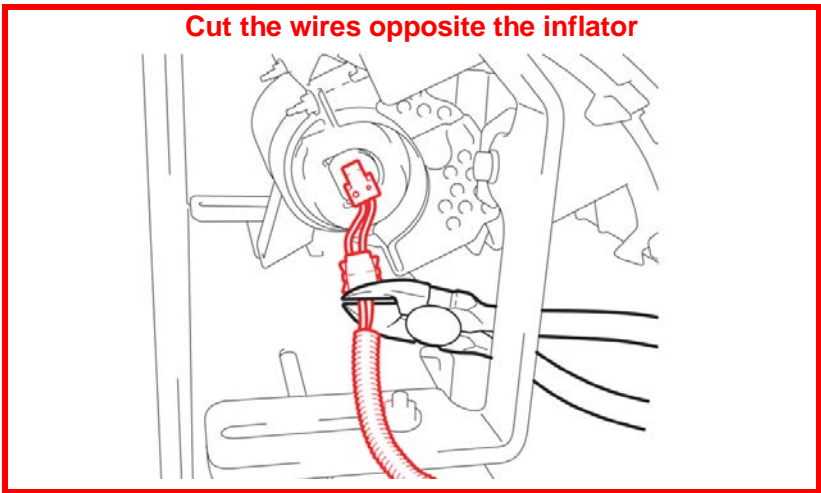
### 4. CUT THE INFLATOR WIRES

- a) Cut the 2 wires at the side of the electro tap that is farthest away from the inflator.

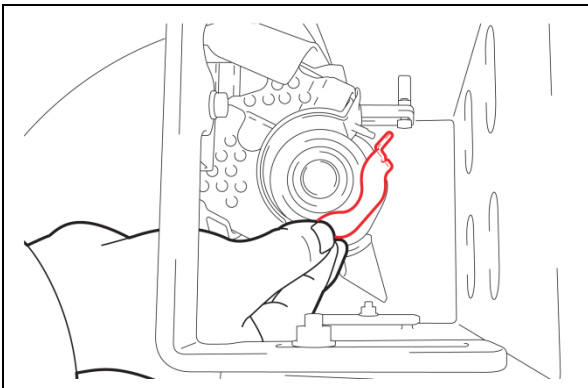
## 5. REMOVE THE SELF LOCKING NUTS

a) Use the access holes in the bracket to remove the 4 nuts.

- **DO NOT** use power tools.
- The bracket support bars may need to be repositioned to remove the nuts through the access holes.

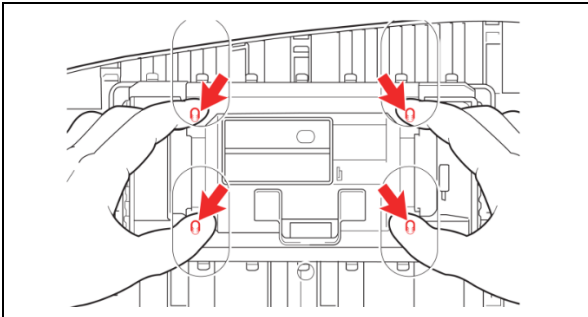
b) Remove the stopper plate and place in a secure location because it will be reused.

c) Discard the 4 nuts as they are not to be reused.

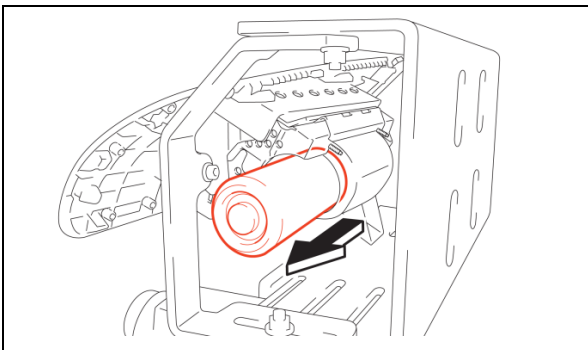
## 6. REMOVE THE INFLATOR

a) Gently push in the 4 studs to loosen the inflator for removal.

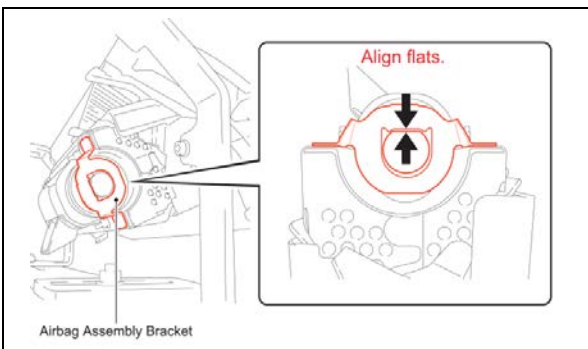
**9. INSTALL THE NEW INFLATOR**

- a) Carefully slide the new inflator into the airbag assembly.

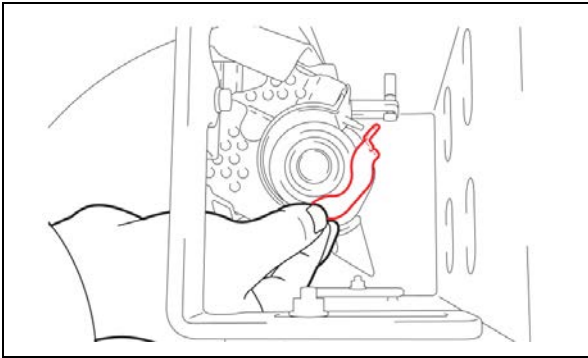
**10. CONFIRM THE INFLATOR ALIGNMENT**

- a) Align the flat on the inflator with the flat on the airbag assembly bracket.

**STOP** Confirm the flats on the airbag assembly and inflator are aligned.

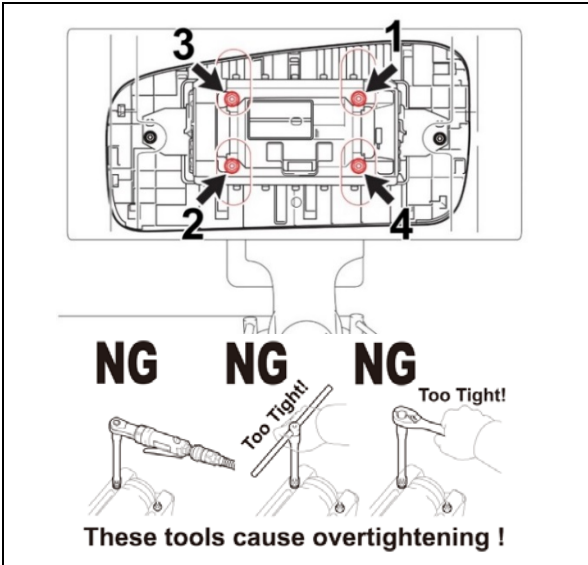
### 11. REINSTALL THE STOPPER PLATE.

- a) Place the stopper plate on the airbag assembly.

- b) Install stopper plate nuts (**NEW**) by hand. They will be torqued on a later step.
- c) Install the **NEW** nuts on the airbag assembly bracket by hand. They will be torqued on a later step.
