TECHNICAL INSTRUCTIONS

SAFETY RECALL DSF and E04

FRONT PASSENGER AIRBAG “MODULE” REPLACEMENT ONLY

CERTAIN 2003 – 2004 MODEL YEAR MATRIX

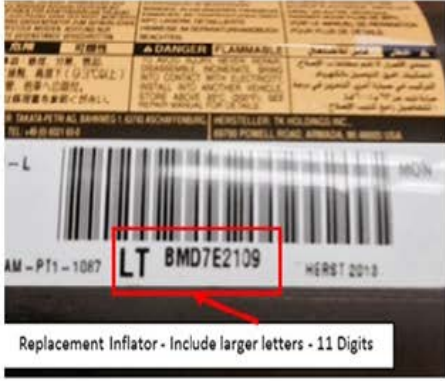
Replacement Inflator - Include larger letters - 11 Digits

How to Identify the Inflator serial code on the Original and Replacement Inflator can?
The Inflator serial code is an 11 digit code on the Inflator can. It can be found with a bar code on removing the Inflator can from the Airbag Assembly unit.
The first two characters of the Original Inflator Serial code will be from [AA, AB, AJ, FD or JD].
The first two characters of the Replacement Inflator Serial code will be either 'LT' or 'LR'.
