RECALL CAMPAIGN BULLETIN

VOLUNTARY SAFETY RECALL CAMPAIGN 2001 I30 AND 2002 – 2004 I35 FRONT PASSENGER AIR BAG INFLATOR

CAMPAIGN ID #:
 R1622, R1704, R1706, R1713

APPLIED VEHICLES:
 2001 I30 (CA33)

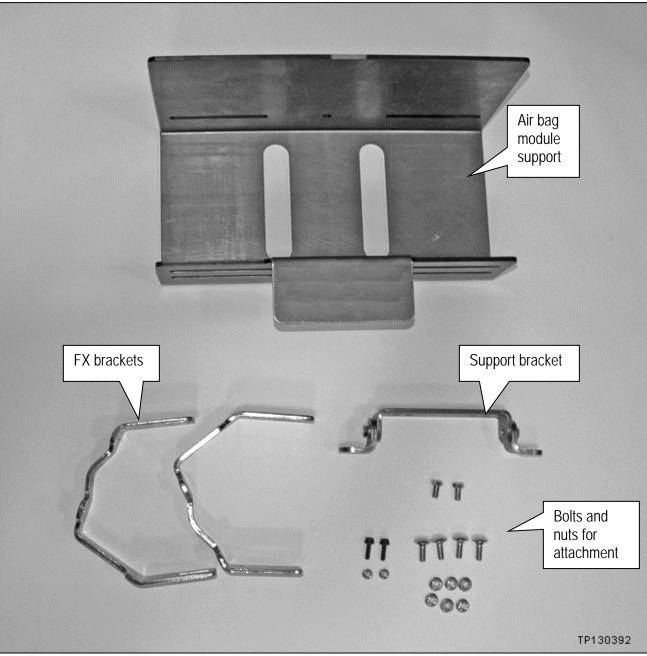
Figure A

Air Bag Module Support (J-51315-KIT)

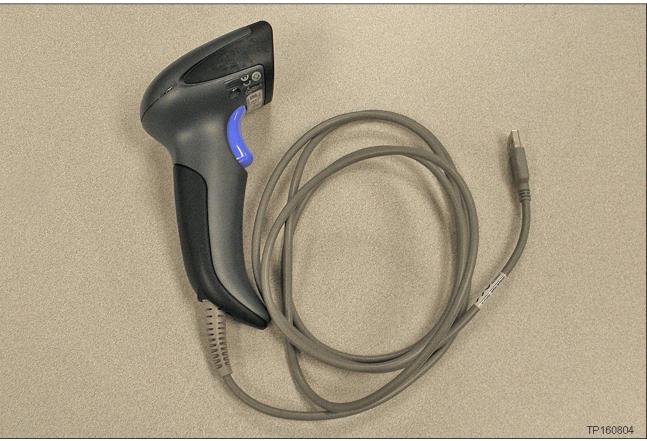
Figure B

Quick Scan Tool (J-52352)

- Each retailer has been shipped one Quick Scan Tool (J-52352).
- Additional tools can be obtained from Tech•Mate at 1-800-662-2001.

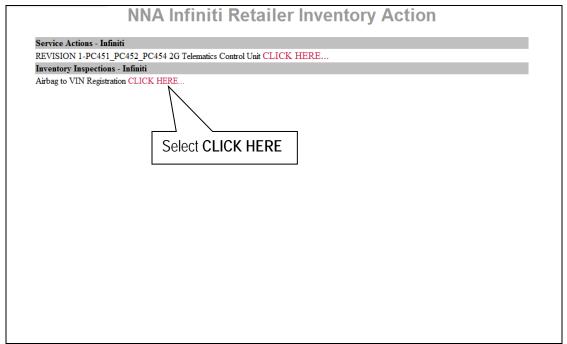
c. Select **CLICK HERE** (Air Bag to VIN Registration).

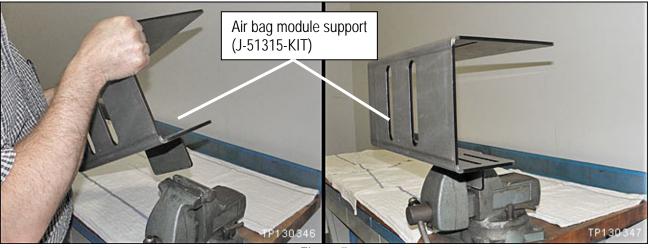
8. Securely mount the air bag module support (support) in a vice (see Figure 7).

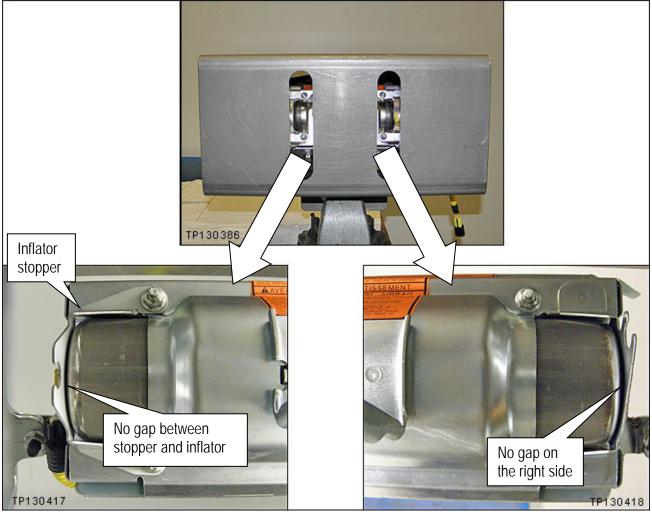
Figure M15

- 18. Install the inflator stopper and 4 inflator securing nuts finger tight (see Figure M15).
 - Make sure to **use new nuts**.
 - New nuts are included with the new inflator.
- 19. Make sure the inflator is pushed all the way into its housing no gap on the right side (see Figure M15).
- 20. Make sure there is no gap between the inflator stopper and the inflator on the left side (see Figure M15).

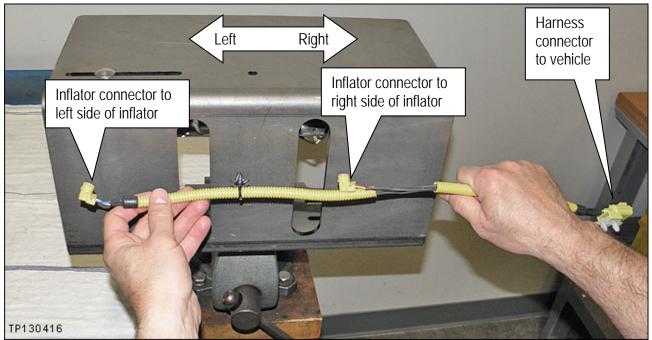
- In the next step you will be attaching the new harness to the new inflator.
- Once the inflator connector is attached to the inflator, it <u>cannot</u> be disconnected.
- Make sure to attach the connectors to the correct ends of the inflator (see Figure M17).
 - o Left / Right orientation is as shown in Figure M17.

- 22. Attach the new harness to each end of the inflator.
 - Remove the dust proof stickers covering the ends of the inflator.
 - A new harness is included with the new inflator.
 - Make sure to attach the correct ends (see Figure M17 on the previous page).
 - Refer to Figures M17, M18, M19, and M20.

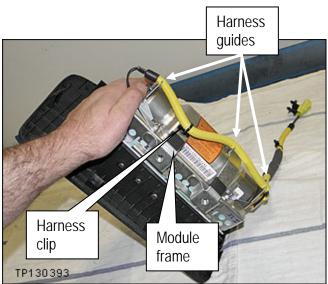
Figure M22

- 25. Attach the harness clip to the module frame.
- 26. Route/attach the harness to the harness guides.
