September 16, 2015

02025 Version 3

Safety Recall: Driver's Airbag Inflator Can Be Over-Pressurized

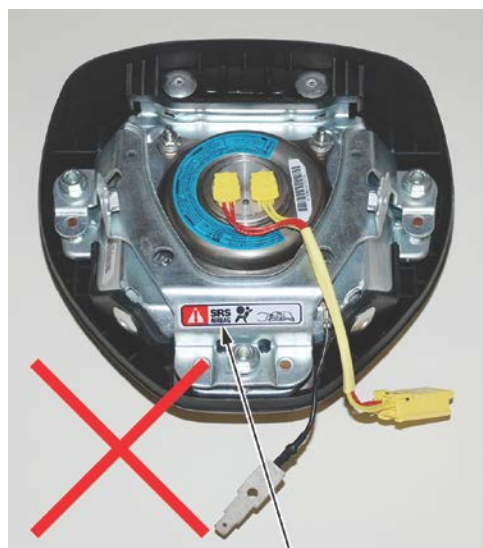
NON-STANDARD
SAFETY LABEL

- If there are any unusual markings, like an incorrect label or a model year written in marker, the airbag and inflator may not be the correct airbag and/or inflator for the vehicle or it may be a counterfeit part. For more information about counterfeit airbags, you can refer to safercar.gov, enter keywords **MANAGING COUNTERFEIT**, and select **Recommended Dealer Guidance for Managing Counterfeit Air Bags** from the list. **If you suspect that the airbag or inflator is counterfeit, do not continue this procedure.** Contact your DPSM for assistance.

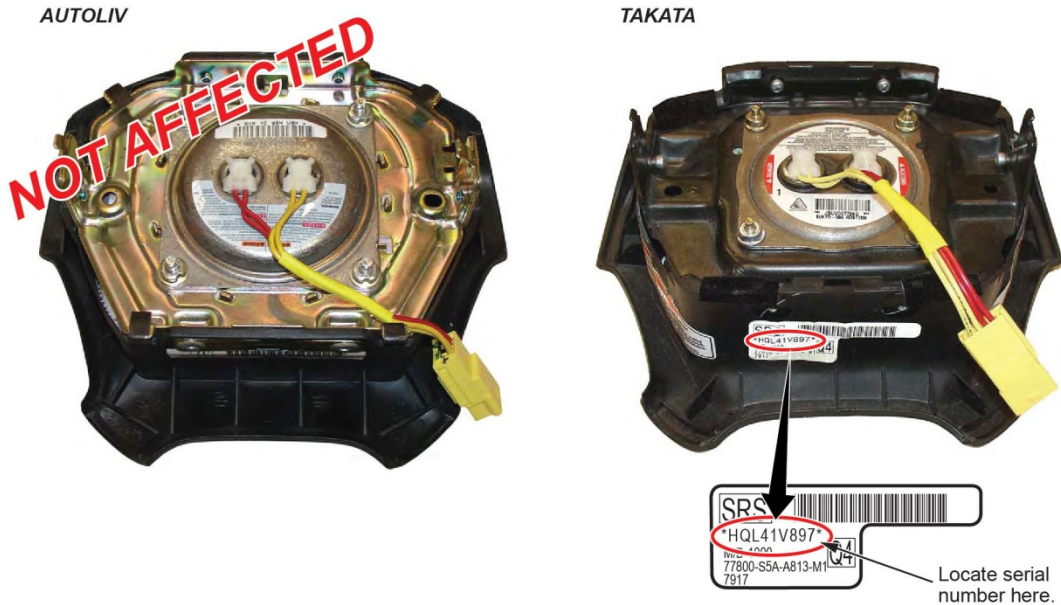
6. **Civic only** - Determine if the airbag is made by Autoliv or Takata by comparing the inflators to those in the images below.

NOTE: The Autoliv serial number label is different from the Takata label; the Autoliv has 11 characters, the Takata has 9.

- If the airbag is made by Autoliv, the airbag is OK. Reinstall the airbag using new Torx bolts. Torque the bolts to **9.8 N-m (7.2 lb-ft)**. If you already received a replacement inflator, return the unopened kit to American Honda.
- If the airbag is made by Takata, go to step 7.

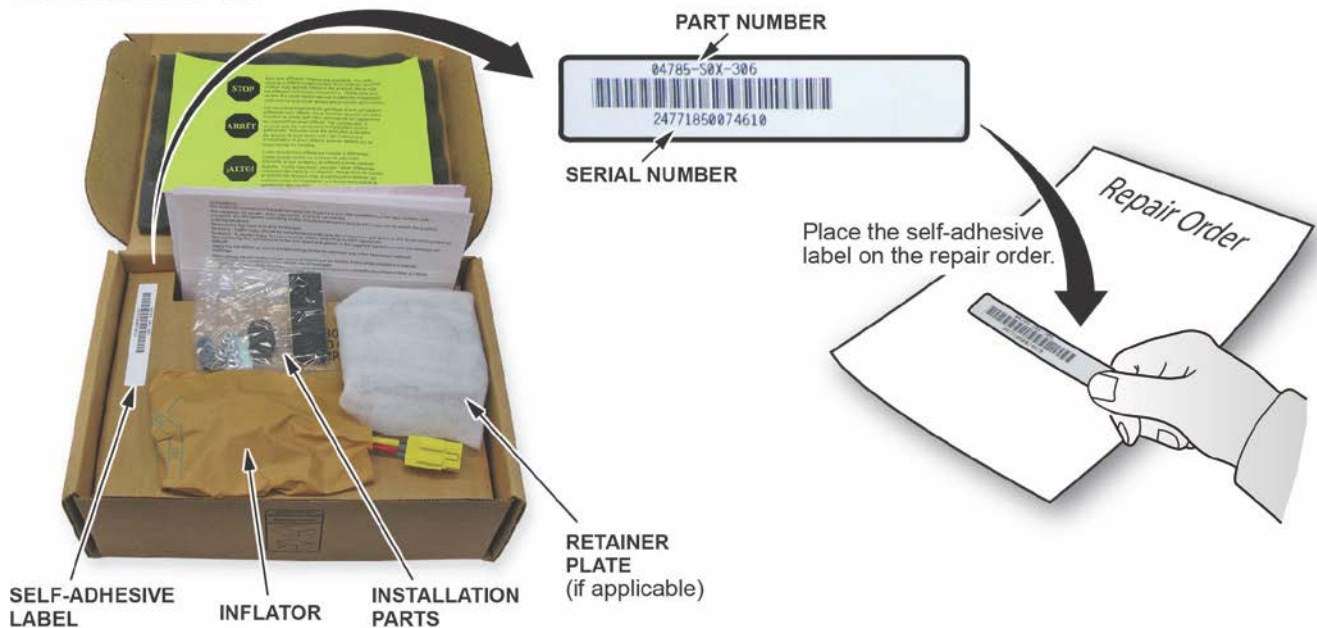
INFLATOR PARTS BOX

7. Peel the label located inside the inflator box from its backing and attach it to the RO. For the warranty claim to be paid, the **replacement inflator part number that you received** must be included in the warranty claim.

- The replacement part number is printed on the top part of the label and the serial number is printed on the bottom. **Make sure you attach the label to the RO and give it to the warranty clerk.**
- There may also be a colored sticker located in the kit, ignore it because it is not used.
- Not all inflator kits have a label included. In those cases, write the serial number and part number from the side of the inflator box on the RO. The part number always starts with 047.

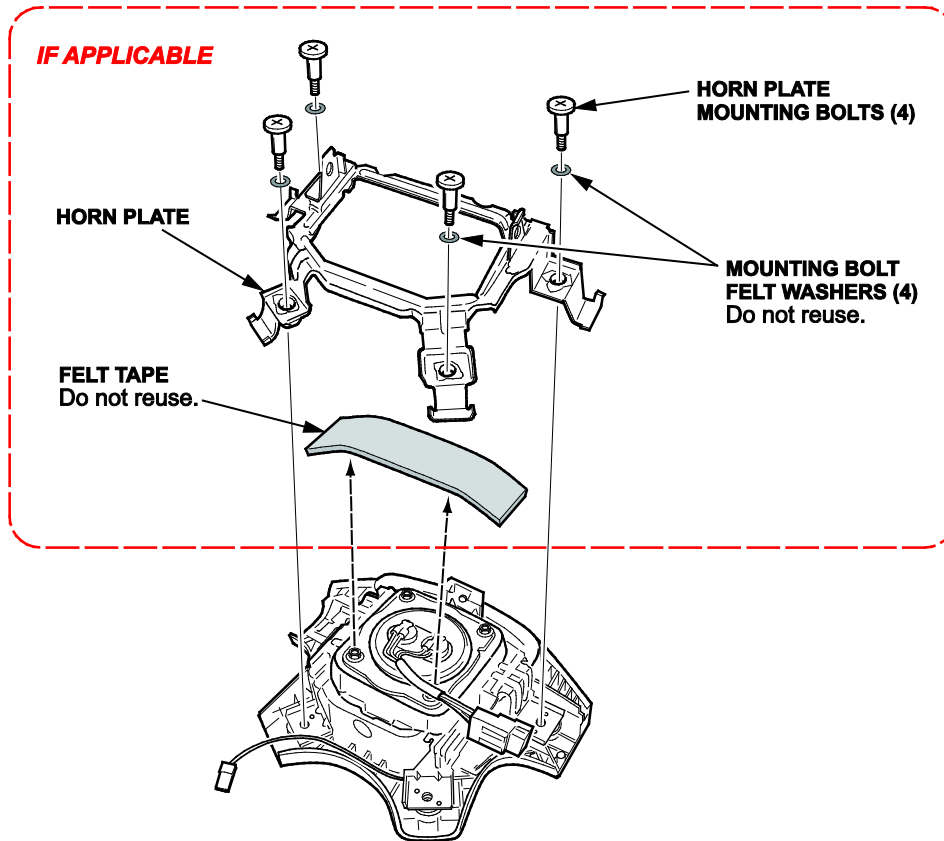
8. If there is no horn plate installed, go to step 9. If there is a horn plate installed, remove the four horn plate mounting bolts, the mounting bolt felt washers, the horn plate, and remove the felt tape covering the lower two inflator locknuts. The felt washers and felt tape will not be reused.

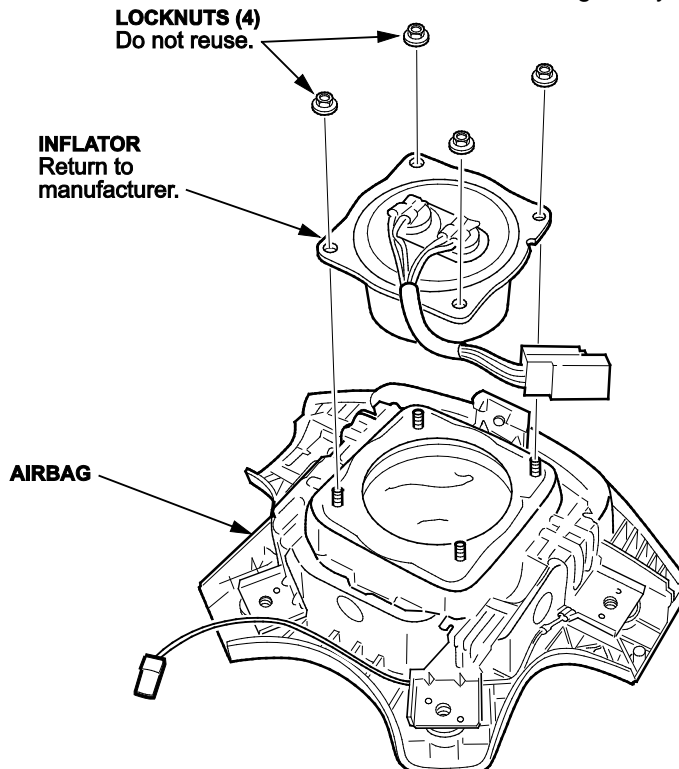
9. Using needle-nose vise grips or a 3/8 in. 6-point socket, remove the four locknuts from the inflator. The locknuts will not be reused.

NOTE: Do not remove the inflator from the airbag until you complete step 10.

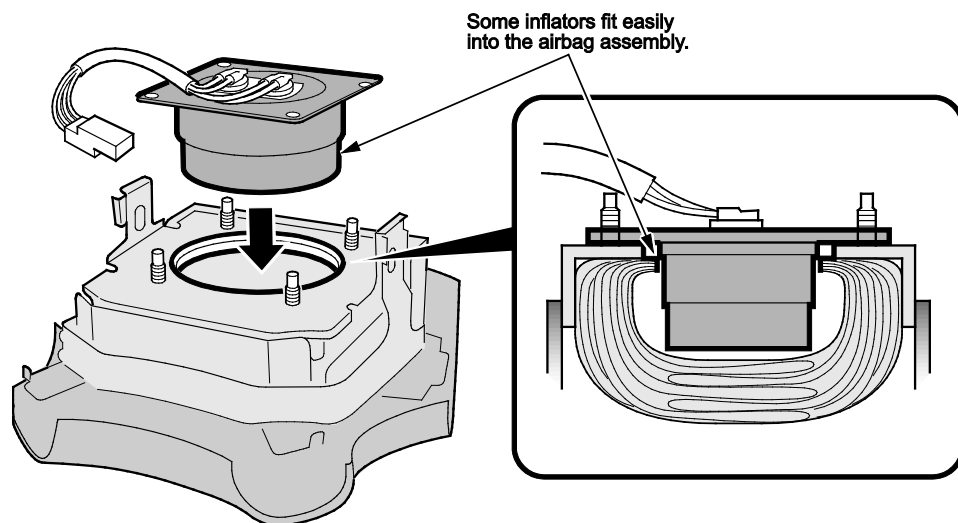
- Insert the inflator into the opening.

NOTE: Make sure the inflator wires are positioned toward the bottom of the airbag. If you install the inflator incorrectly, you may not be able to reconnect the SRS airbag harness.

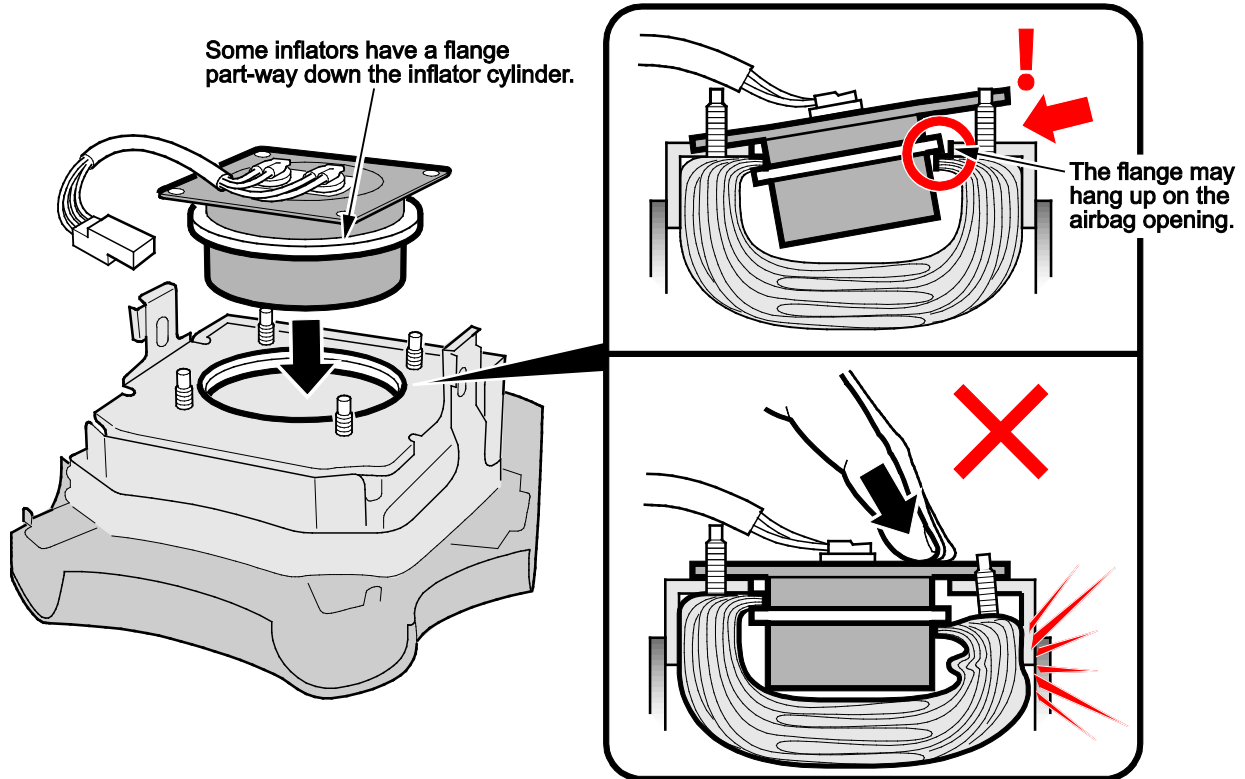
- Insert the airbag inflator into the opening. Do not force it into the airbag module.

NOTE: Make sure the inflator wires are positioned toward the bottom of the airbag. If you install the inflator incorrectly, you may not be able to reconnect the SRS airbag harness.

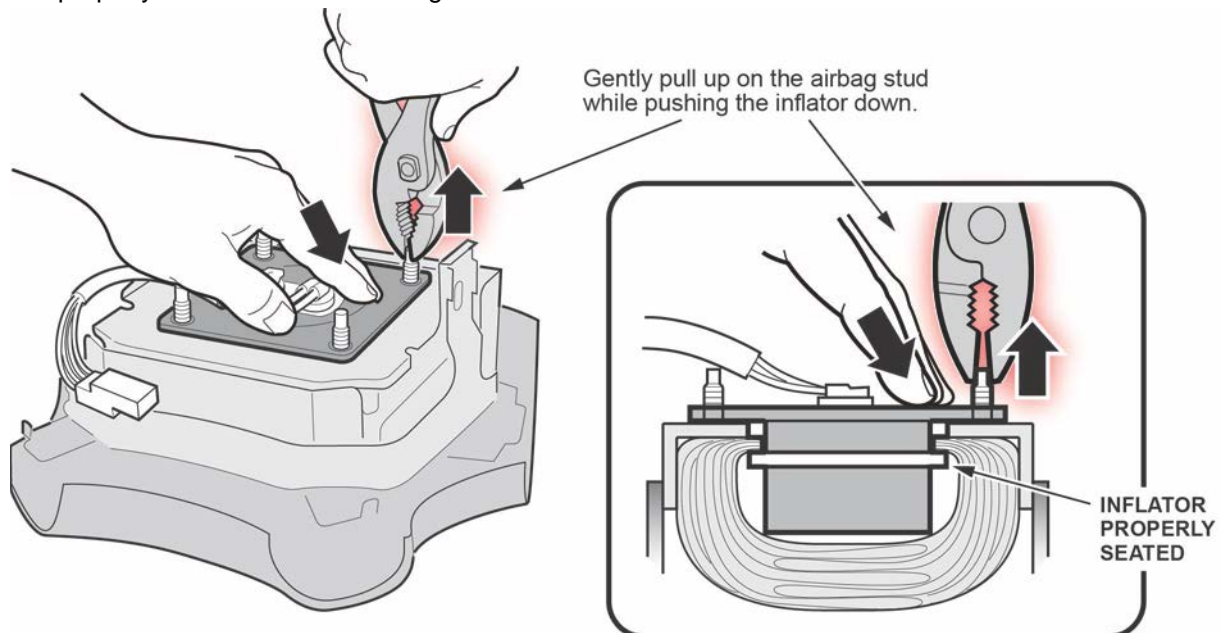
- Using a pair of pliers, gently pull up on each stud up while pushing the inflator module down until the airbag is properly seated within the airbag module.

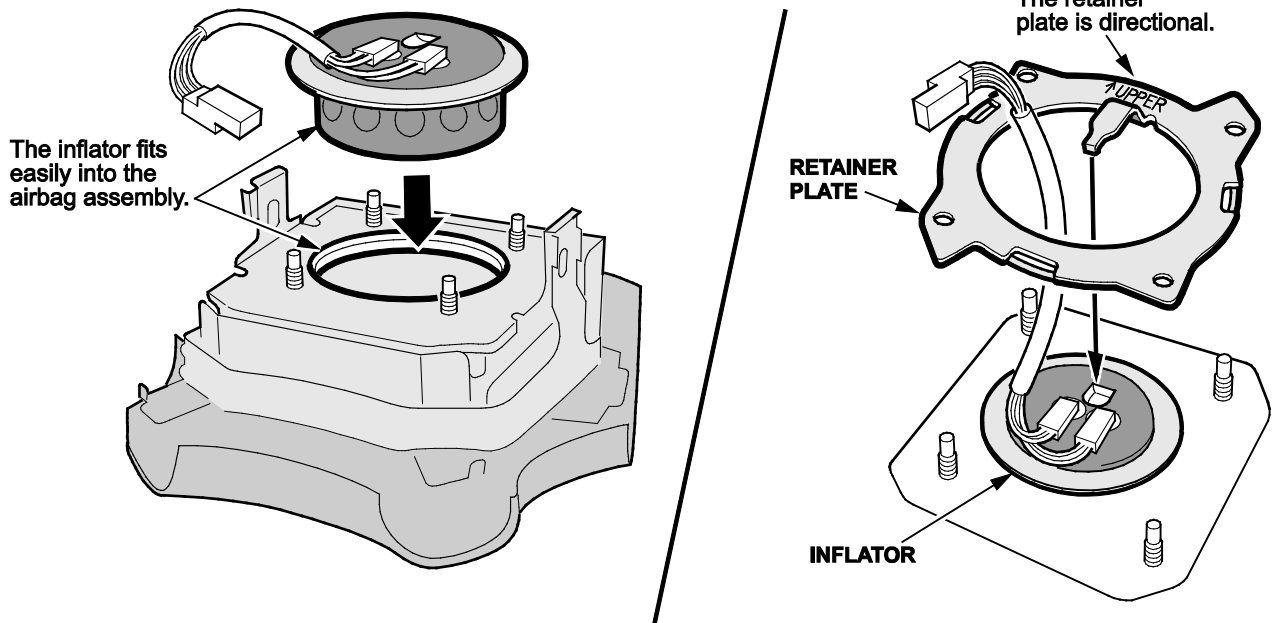
- Install the bracket onto the studs. Make sure the locator tab fits into the locator hole as shown.
NOTE: Make sure the harness comes out through the center opening. Do not install the bracket over the harness wires.

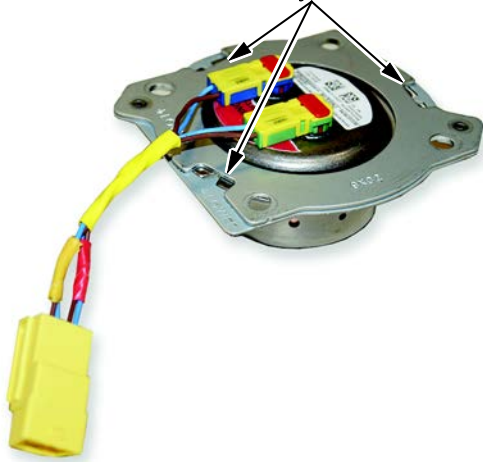
The inflator is held down by a directional retainer that is keyed to the inflator.

- Place the inflator into the opening with the inflator harness toward the bottom of the airbag.

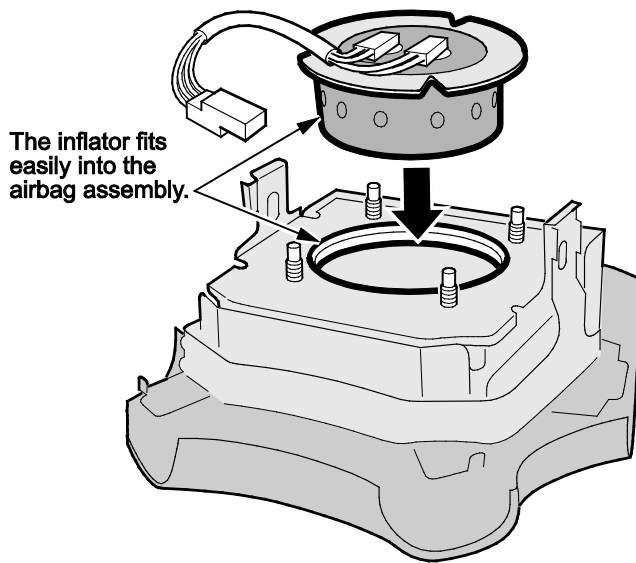
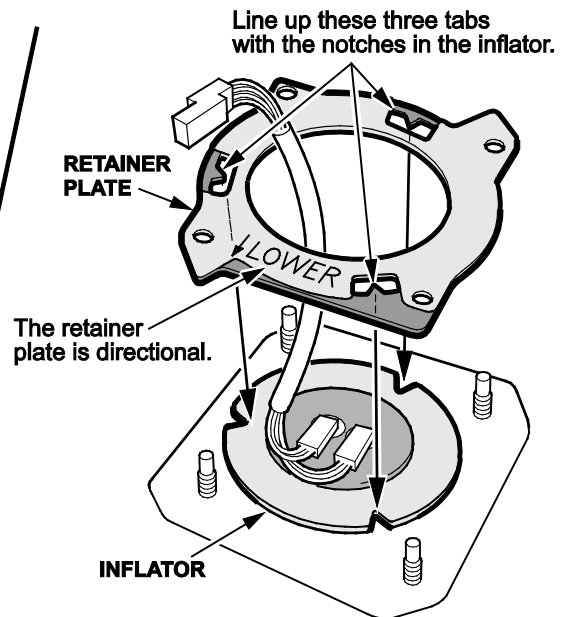
- Install the bracket onto the studs with the stamp **LOWER** at the bottom of the airbag.
- Make sure the three tabs and notches are properly aligned.

- The tabs and notches are designed to align in one direction only. If the tabs and notches are not aligned, the inflator and bracket are not installed correctly.
- Make sure the harness comes out through the center opening. Do not install the bracket over the harness wires.
