September 16, 2015

02024 Version 3

Safety Recall: Driver's Airbag Inflator Can Be Over-Pressurized

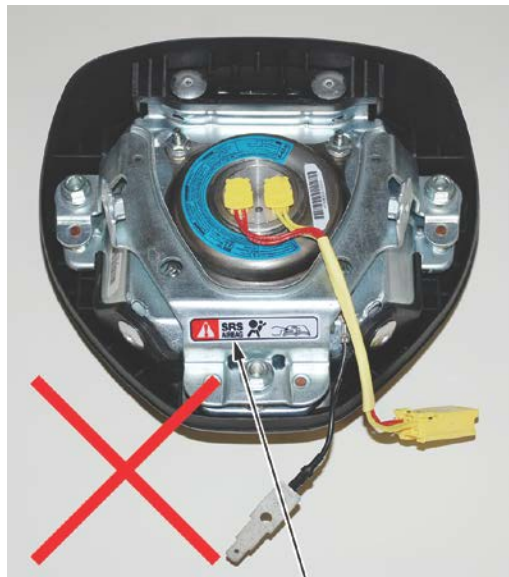
- If there are any unusual markings, like an incorrect label or a model year written in marker, the airbag and inflator may not be the correct airbag and/or inflator for the vehicle or it may be a counterfeit part. For more information about counterfeit airbags, you can refer to safercar.gov, enter keywords **MANAGING COUNTERFEIT**, and select **Recommended Dealer Guidance for Managing Counterfeit Air Bags** from the list. **If you suspect that the airbag or inflator is counterfeit, do not continue this procedure.** Contact your DPSM for assistance.

NON-STANDARD
SAFETY LABEL

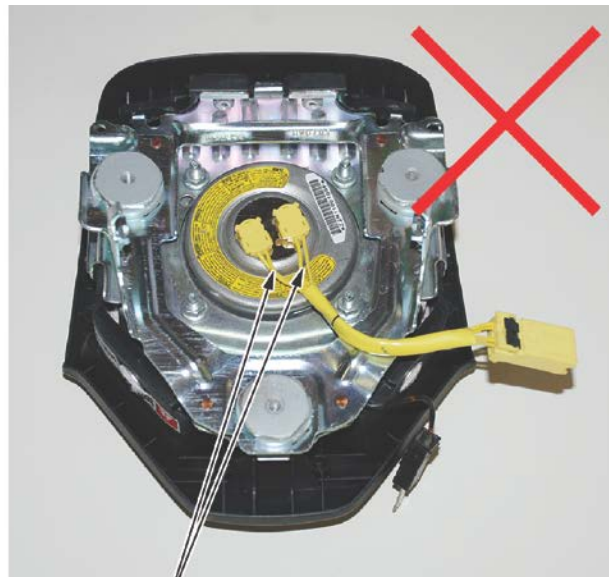
NON-STANDARD
WIRES

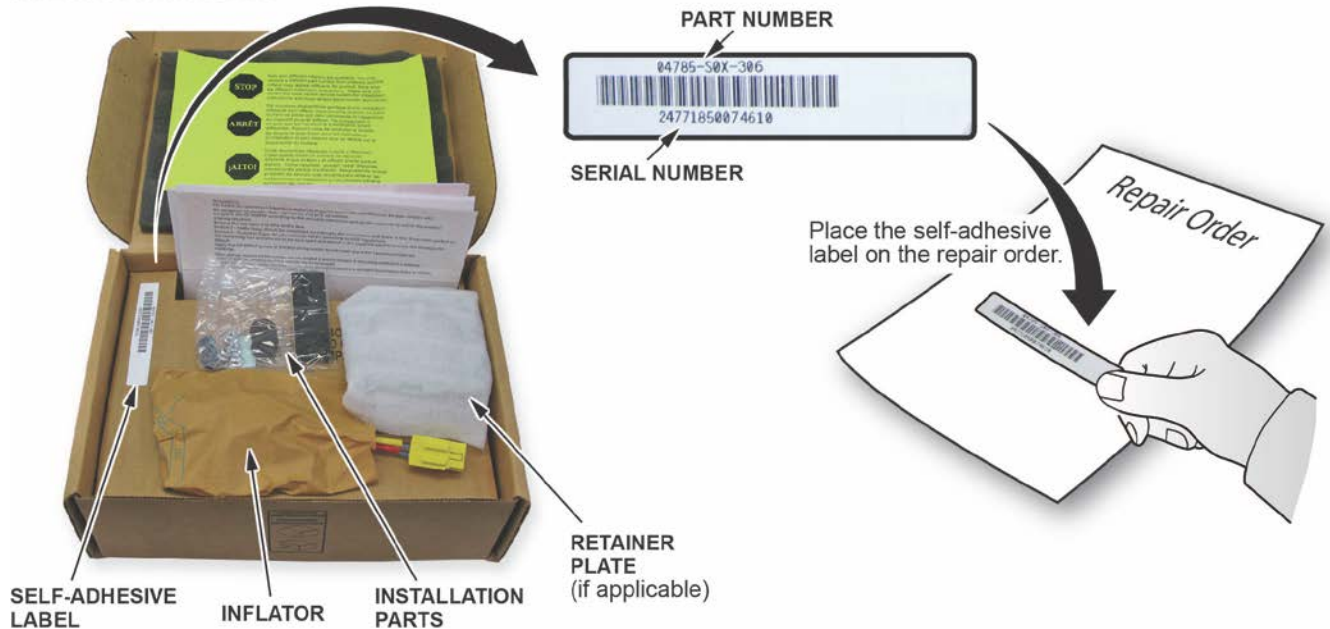
INFLATOR PARTS BOX

6. Peel the label located inside the inflator box from its backing and attach it to the RO. For the warranty claim to be paid, the **replacement inflator part number that you received** must be included in the warranty claim.

- The replacement part number is printed on the top part of the label and the serial number is printed on the bottom. **Make sure you attach the label to the R.O. and give it to the warranty clerk.**
- There may also be a colored sticker located in the kit, ignore it because it is not used.
- Not all inflator kits have a label included. In those cases, write the serial number and part number from the side of the inflator box on the R.O. The part number always starts with 047.

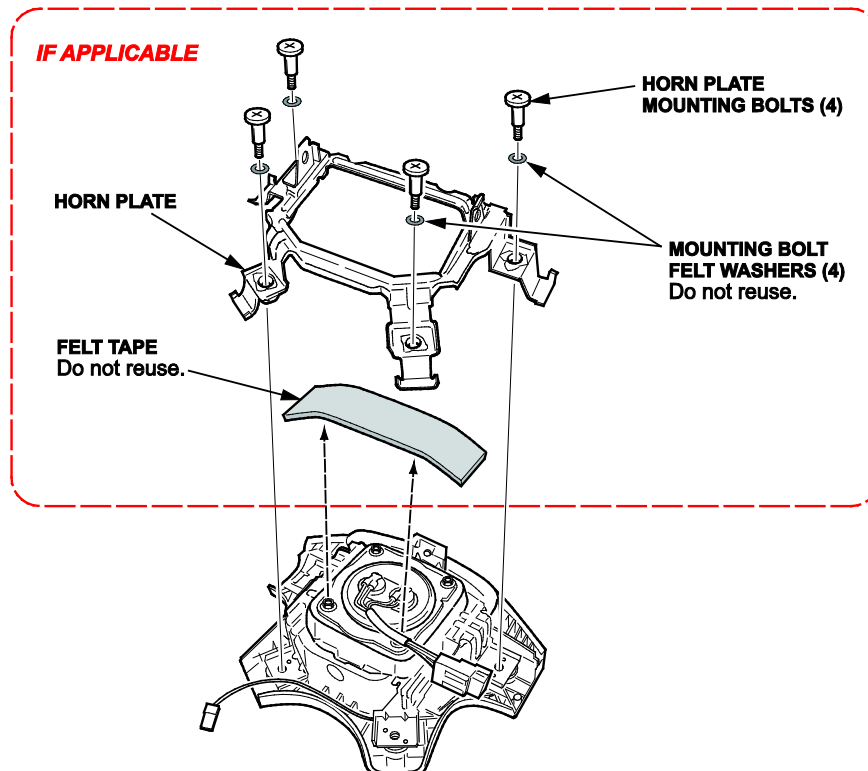
7. If there is no horn plate installed, go to step 8. If there is a horn plate installed, remove the four horn plate mounting bolts, the mounting bolt felt washers, the horn plate, and remove the felt tape covering the lower two inflator locknuts. The felt washers and felt tape will not be reused.

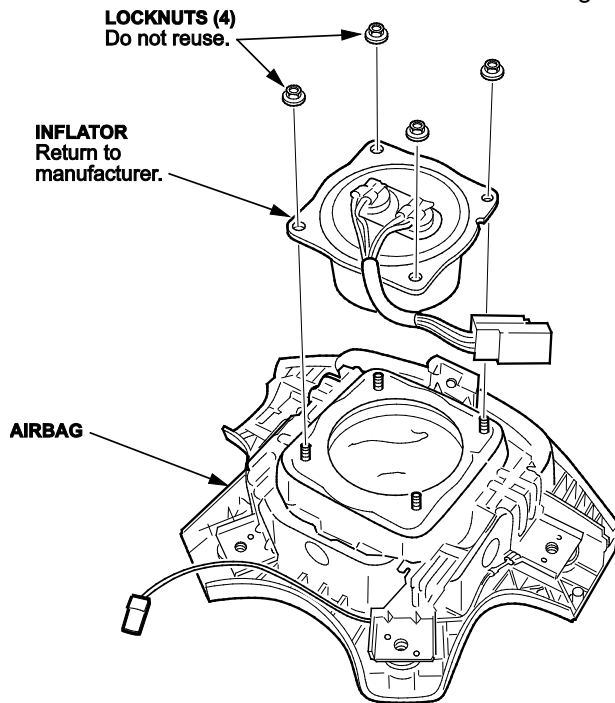
- Using needle-nose vise grips or a 3/8 in. 6-point socket, remove the four locknuts from the inflator. The locknuts will not be reused.

NOTE: Do not remove the inflator from the airbag until you complete step 9.

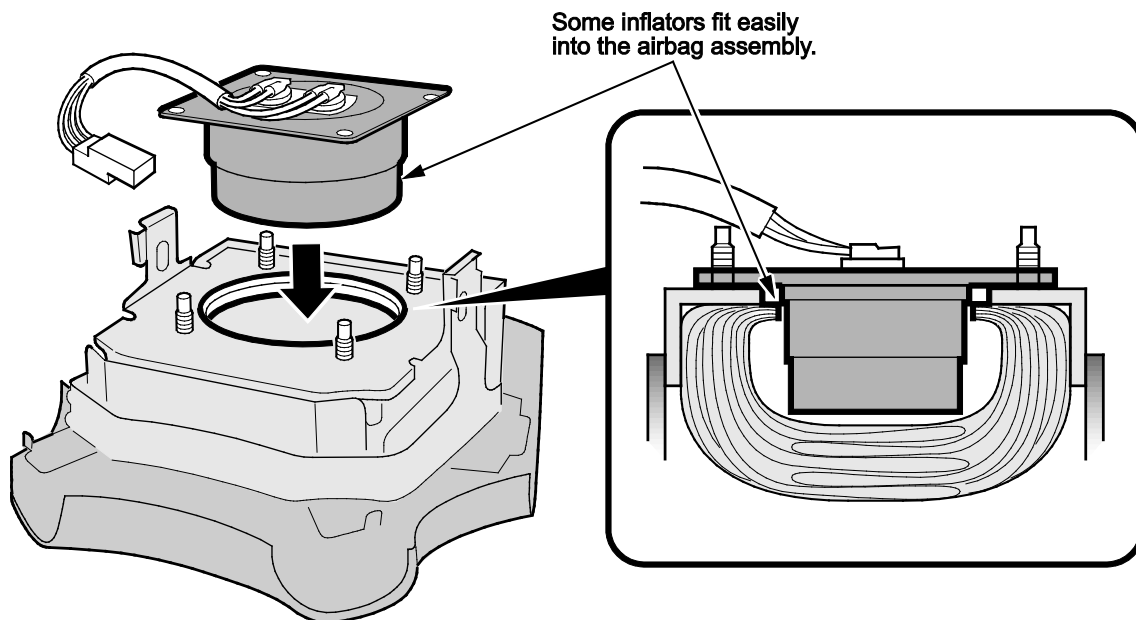
- Insert the inflator into the opening.

NOTE: Make sure the inflator wires are positioned toward the bottom of the airbag. If you install the inflator incorrectly, you may not be able to reconnect the SRS airbag harness.

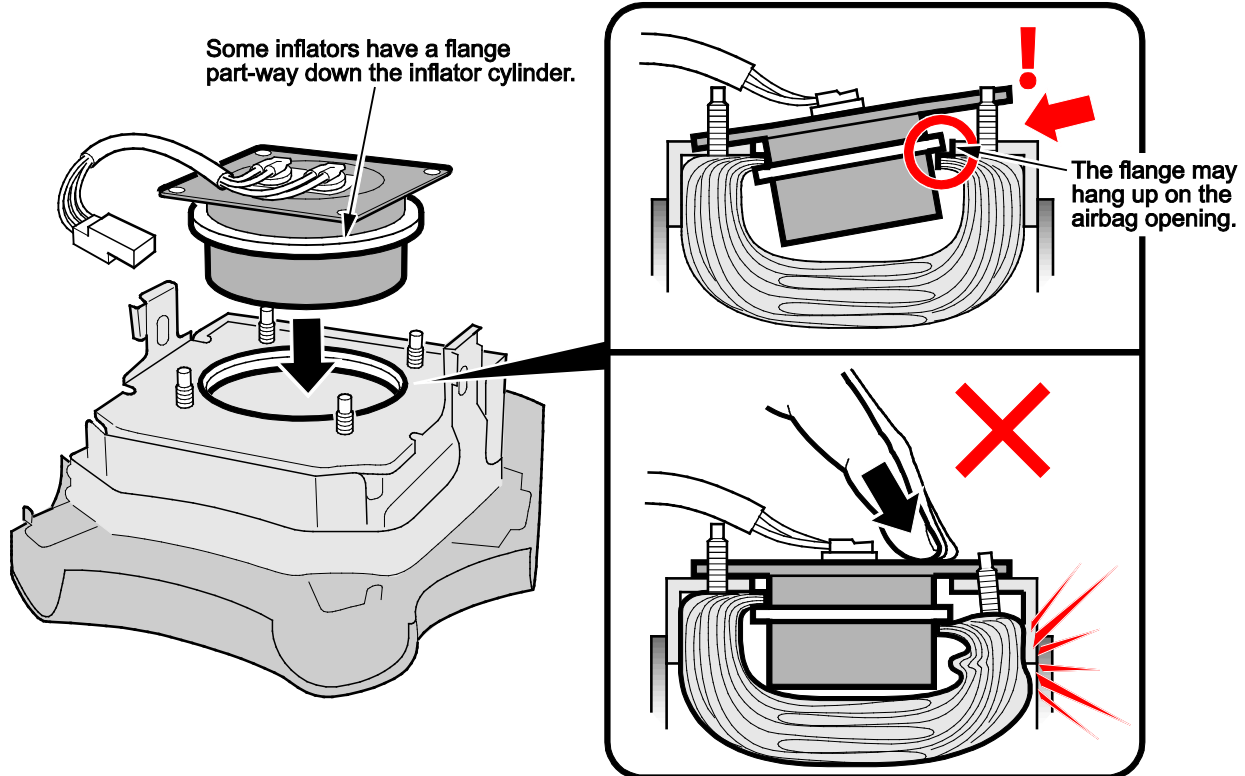
- Insert the airbag inflator into the opening. Do not force it into the airbag module.

NOTE: Make sure the inflator wires are positioned toward the bottom of the airbag. If you install the inflator incorrectly, you may not be able to reconnect the SRS airbag harness.

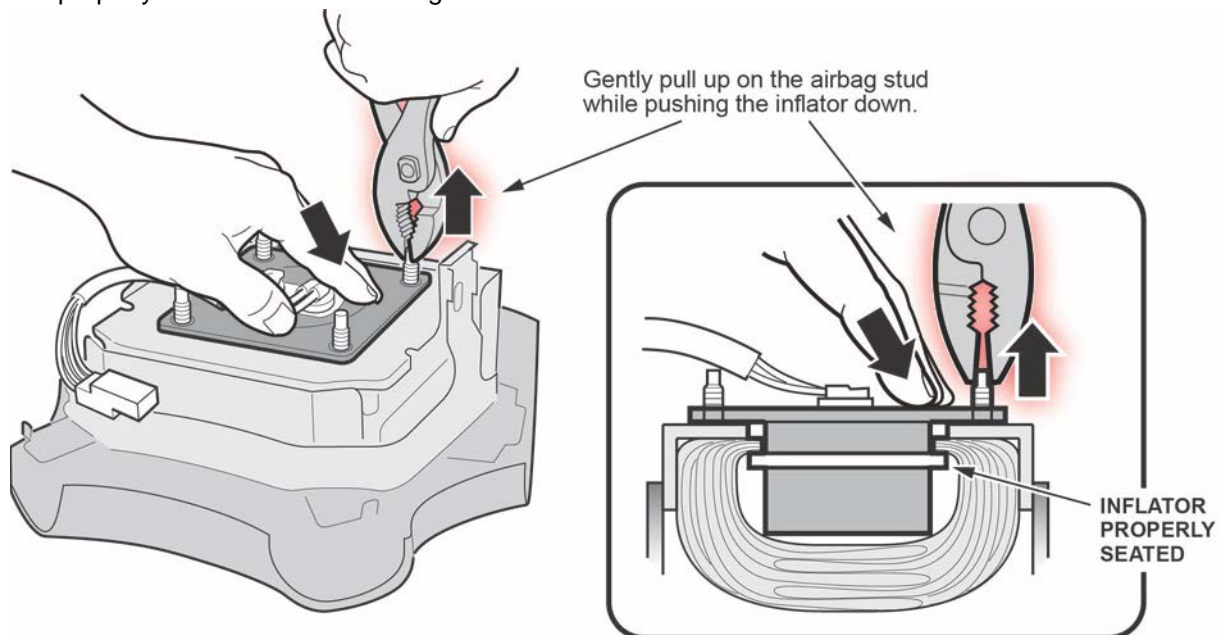
- Using a pair of pliers, gently pull up on each stud up while pushing the inflator module down until the airbag is properly seated within the airbag module.

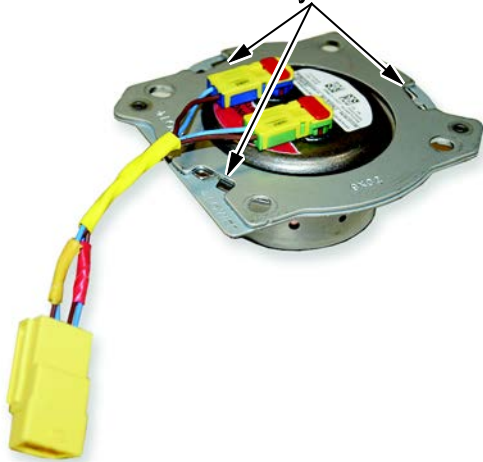
The inflator is held down by a directional retainer that is keyed to the inflator.

- Place the inflator into the opening with the inflator harness toward the bottom of the airbag.

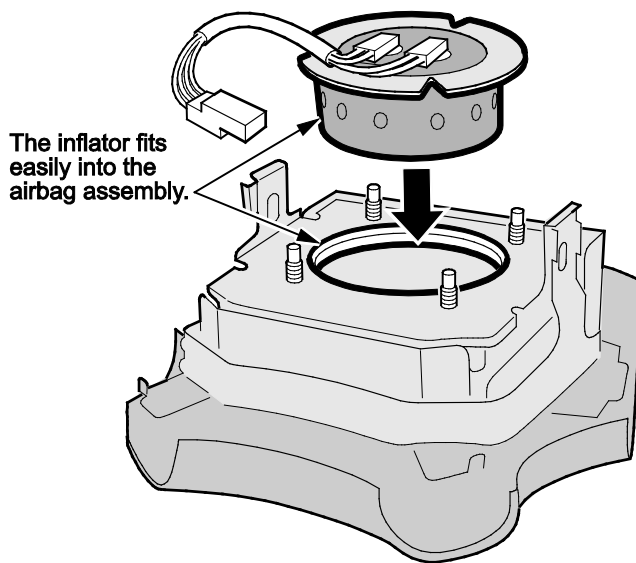
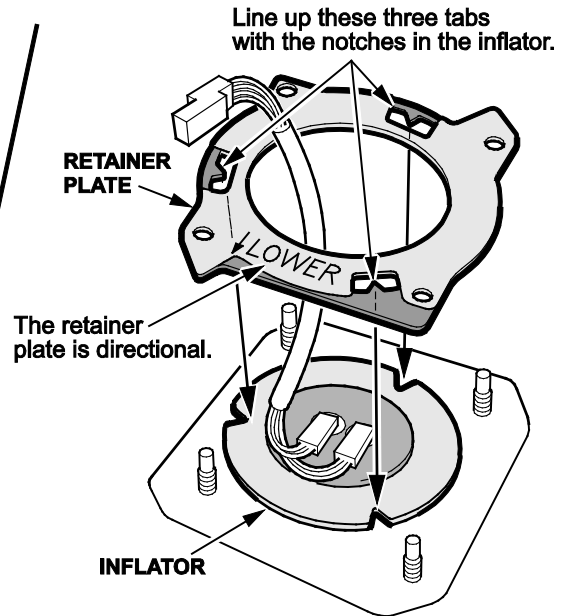
- Install the bracket onto the studs with the stamp **LOWER** at the bottom of the airbag.
- Make sure the three tabs and notches are properly aligned.

- The tabs and notches are designed to align in one direction only. If the tabs and notches are not aligned, the inflator and bracket are not installed correctly.
- Make sure the harness comes out through the center opening. Do not install the bracket over the harness wires.
