June 9, 2015

02025 Version 1

Safety Recall: Driver's Airbag Inflator Can Be Over-Pressurized

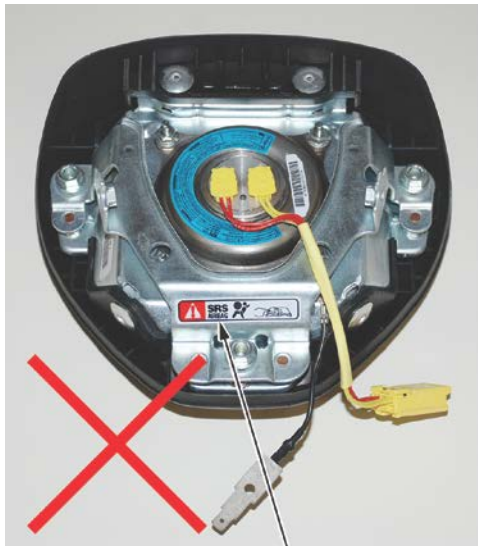
NON-STANDARD
SAFETY LABEL

- If there are any unusual markings, like an incorrect label or a model year written in marker, the airbag and inflator may not be the correct airbag and/or inflator for the vehicle or it may be a counterfeit part. For more information about counterfeit airbags, you can refer to safercar.gov, enter keywords **MANAGING COUNTERFEIT**, and select **Recommended Dealer Guidance for Managing Counterfeit Air Bags** from the list. **If you suspect that the airbag or inflator is counterfeit, do not continue this procedure.** Contact your DPSM for assistance.

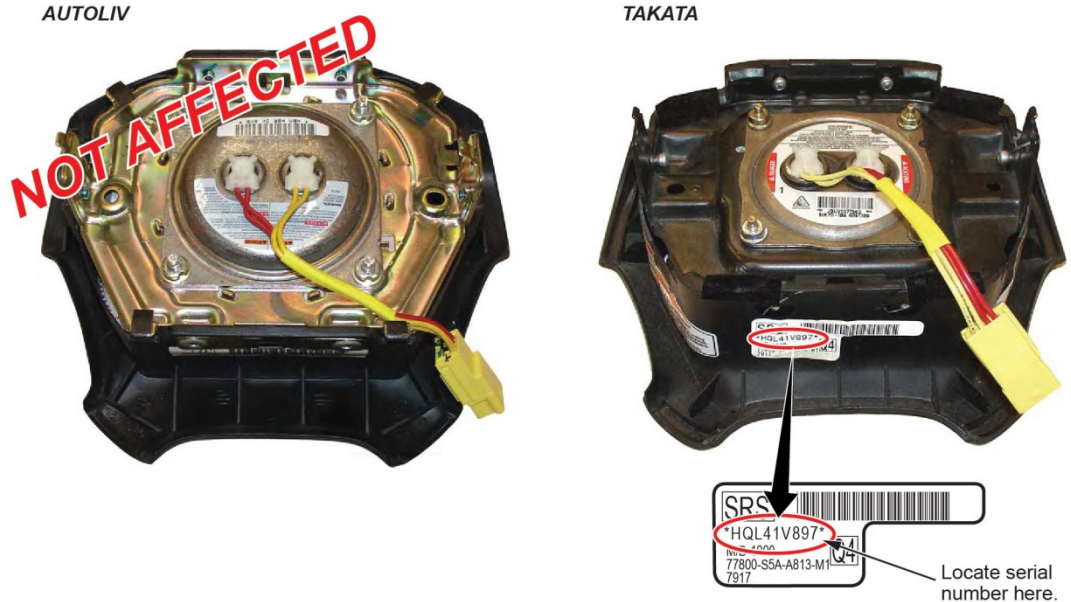
6. **Civic only** - Determine if the airbag is made by Autoliv or Takata by comparing the inflators to those in the images below.

NOTE: The Autoliv serial number label is different from the Takata label; the Autoliv has 11 characters, the Takata has 9.

- If the airbag is made by Autoliv, the airbag is OK. Reinstall the airbag using new Torx bolts. Torque the bolts to **9.8 N-m (7.2 lb-ft)**. If you already received a replacement inflator, return the unopened kit to American Honda.
- If the airbag is made by Takata, go to step 8.

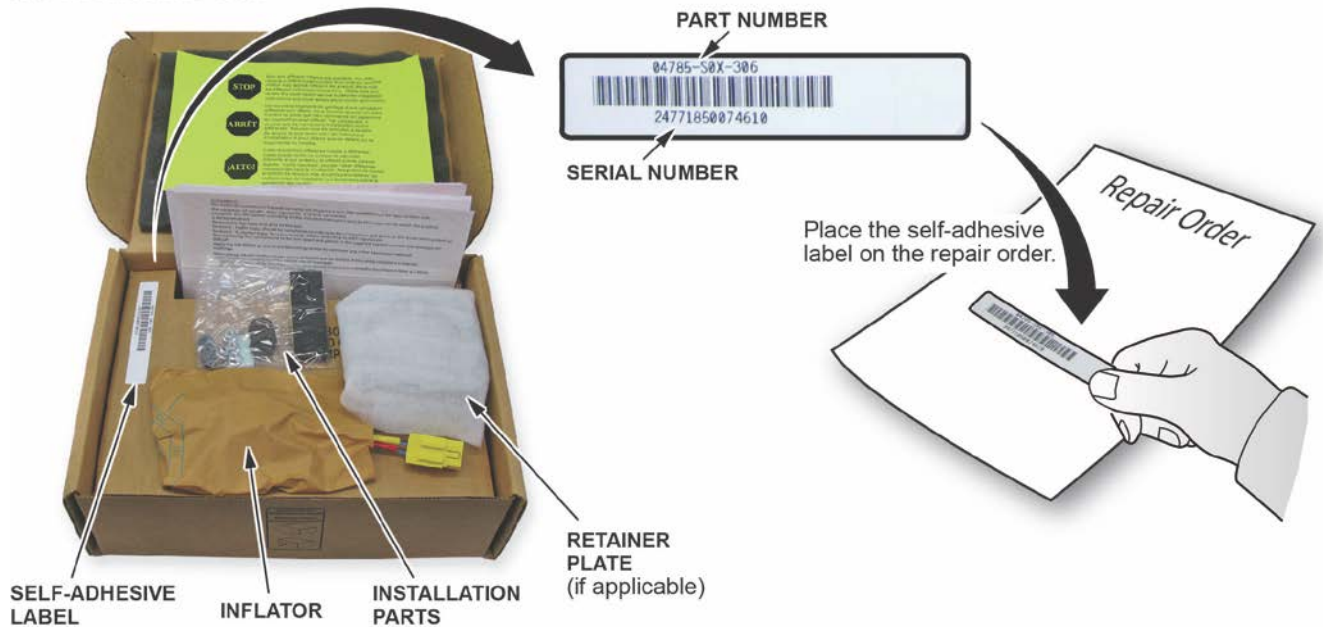
INFLATOR PARTS BOX

7. Peel the label located inside the inflator box from its backing and attach it to the R.O. For the warranty claim to be paid, the **replacement inflator part number that you received** must be on the warranty claim and your warranty clerk must enter the serial number in the Diagnostic Trouble Codes field.

- The replacement part number is printed on the top part of the label and the serial number is printed on the bottom. **Make sure you attach the label to the R.O. and give it to the warranty clerk.**
- There may also be a colored sticker located in the kit, ignore it because it is not used.
- Not all inflator kits have a label included. In those cases, write the serial number and part number from the side of the inflator box on the R.O. The part number always starts with 047.

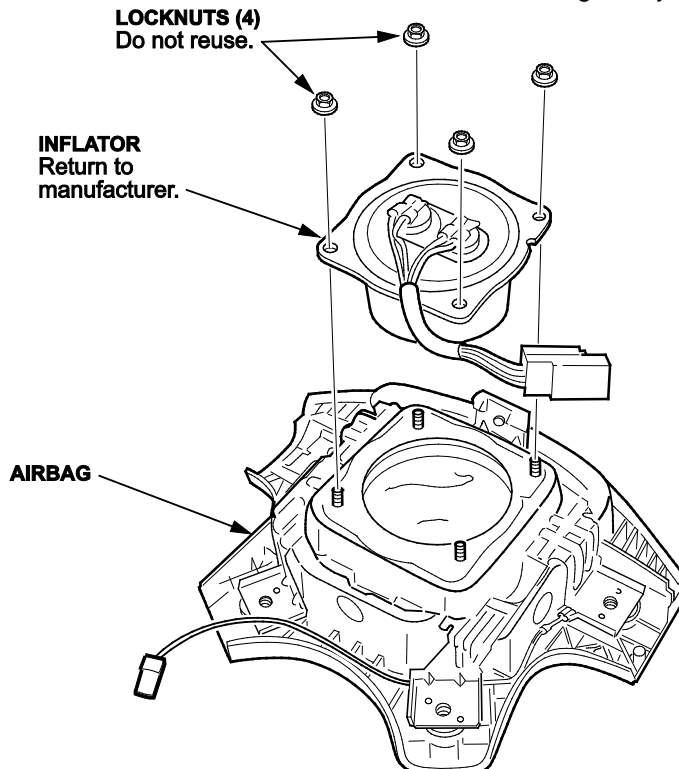
9. Using needle-nose vise grips or a 3/8 in. 6-point socket, remove the four locknuts from the inflator. The locknuts will not be reused.

NOTE: Do not remove the inflator from the airbag until you complete step 10.

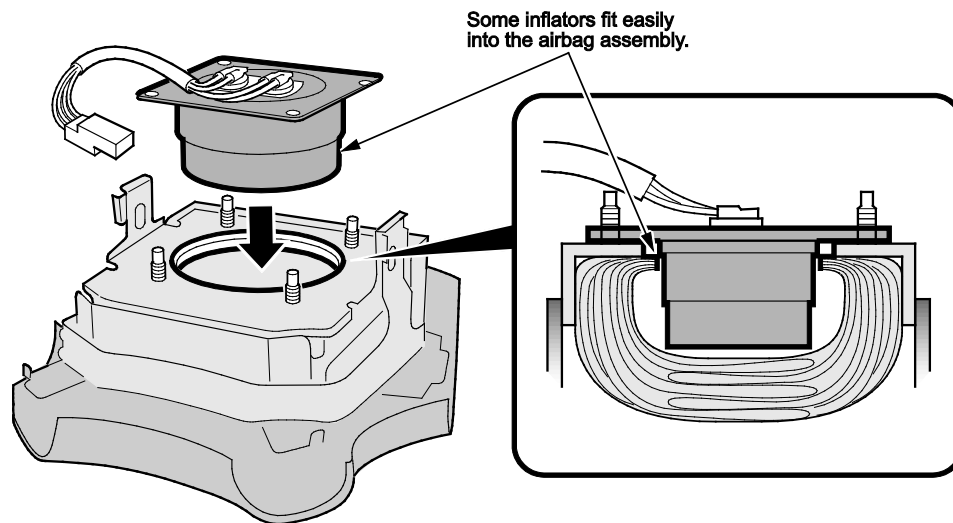
- Insert the inflator into the opening.

NOTE: Make sure the inflator wires are positioned toward the bottom of the airbag. If you install the inflator incorrectly, you may not be able to reconnect the SRS airbag harness.

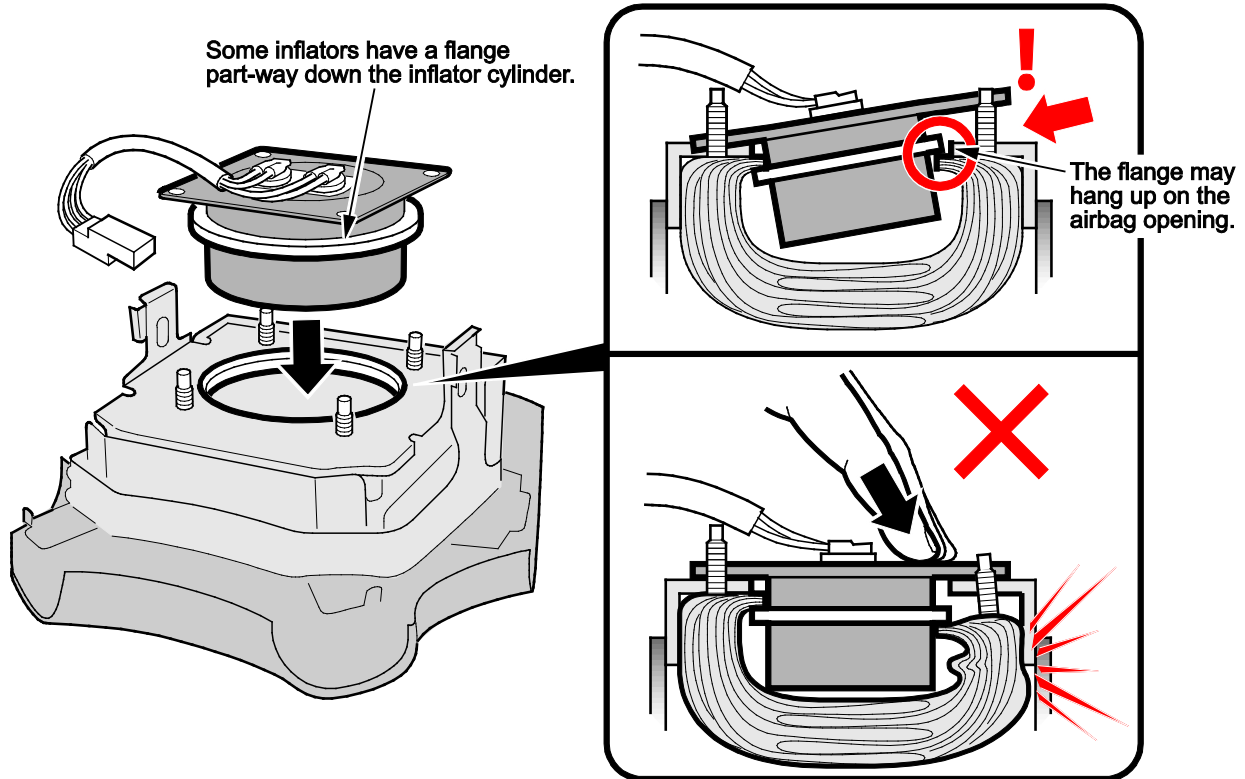
- Insert the airbag inflator into the opening. Do not force it into the airbag module.

NOTE: Make sure the inflator wires are positioned toward the bottom of the airbag. If you install the inflator incorrectly, you may not be able to reconnect the SRS airbag harness.

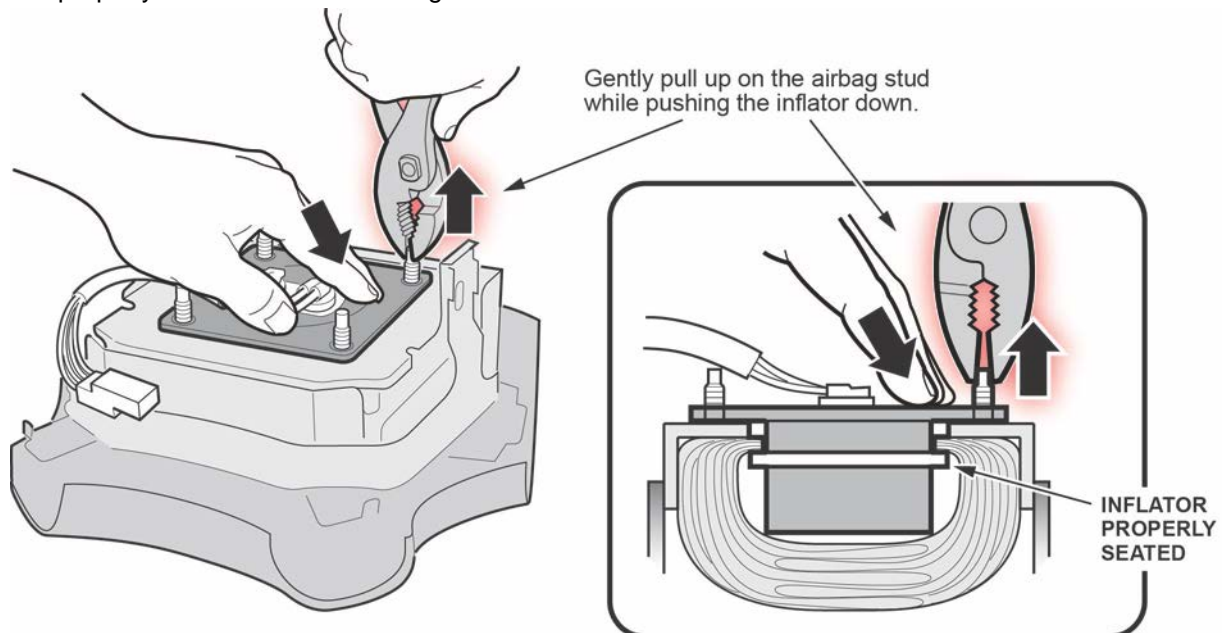
- Using a pair of pliers, gently pull up on each stud up while pushing the inflator module down until the airbag is properly seated within the airbag module.

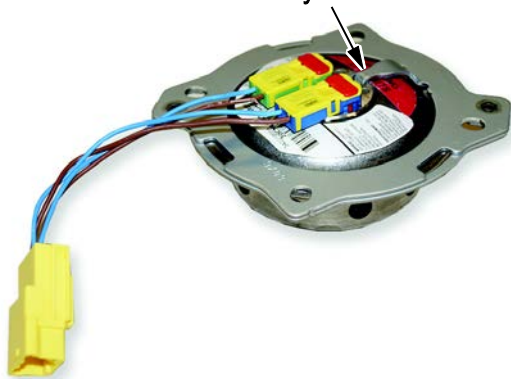
The inflator is held down by a directional retainer that is keyed to the inflator.

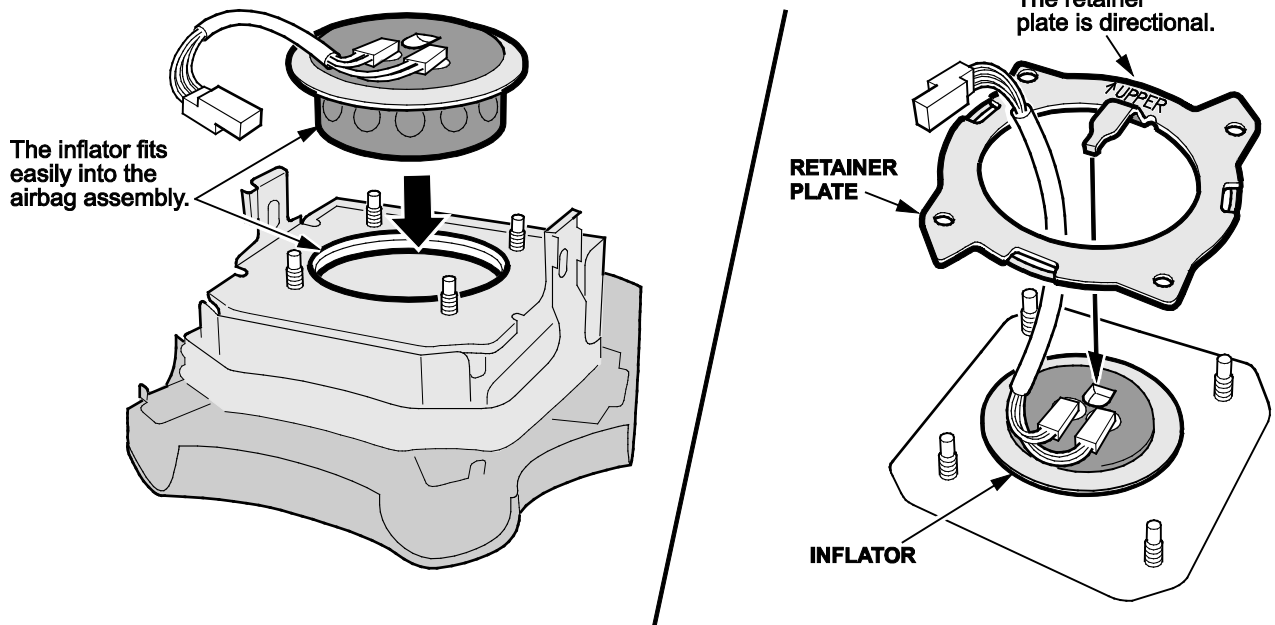
- Place the inflator into the opening with the inflator harness toward the bottom of the airbag.

- Install the bracket onto the studs. Make sure the locator tab fits into the locator hole as shown.
NOTE: Make sure the harness comes out through the center opening. Do not install the bracket over the harness wires.

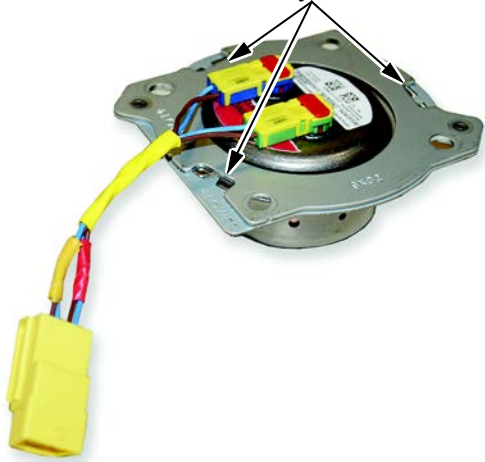
The inflator is held down by a directional retainer that is keyed to the inflator.

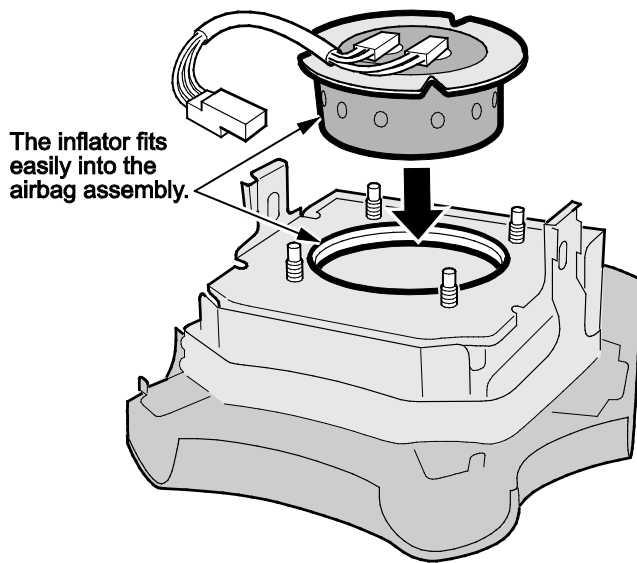
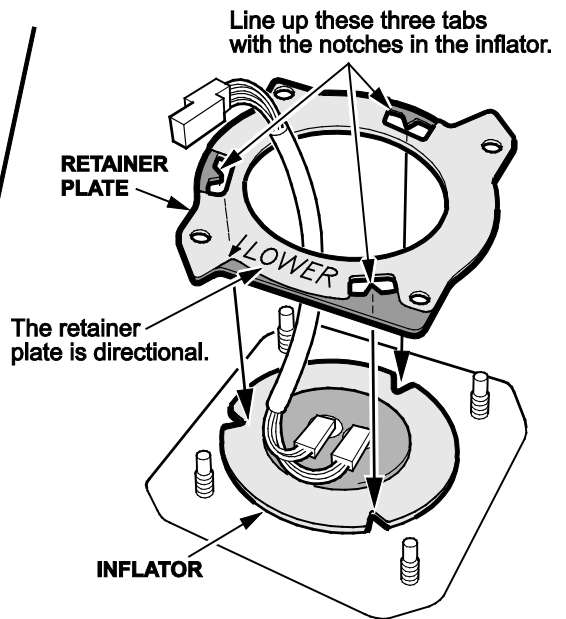
- Place the inflator into the opening with the inflator harness toward the bottom of the airbag.

- Install the bracket onto the studs with the stamp **LOWER** at the bottom of the airbag.
- Make sure the three tabs and notches are properly aligned.

- The tabs and notches are designed to align in one direction only. If the tabs and notches are not aligned, the inflator and bracket are not installed correctly.
- Make sure the harness comes out through the center opening. Do not install the bracket over the harness wires.
