02040 Version 3

## Safety Recall: Front Passenger's Airbag Inflator Can Be Over-Pressurized

Supersedes 15-041, dated July 14, 2015, to revise the information highlighted in **yellow**

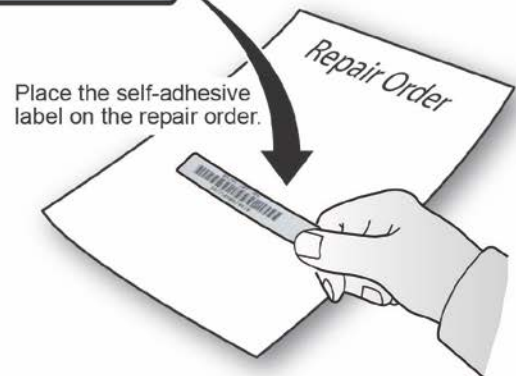
PASSENGER INFLATOR PARTS BOX

6. Peel the label located inside the inflator box from its backing and attach it to the RO. For the warranty claim to be paid, the **replacement inflator part number that you received** must be on the warranty claim and your warranty clerk must enter the serial number in the Diagnostic Trouble Codes field.

- The replacement part number is printed on the top part of the label and the serial number is printed on the bottom. **Make sure you attach the label to the RO and give it to the warranty clerk.**
- There may also be a colored sticker located in the kit; ignore it because it is not used.
- Not all inflator kits have a label included. In those cases, write the serial number and part number from the side of the inflator box on the RO. The part number always starts with 047.
