December 22, 2015

02024 Version 4

## Safety Recall: Driver's Airbag Inflator Can Be Over-Pressurized

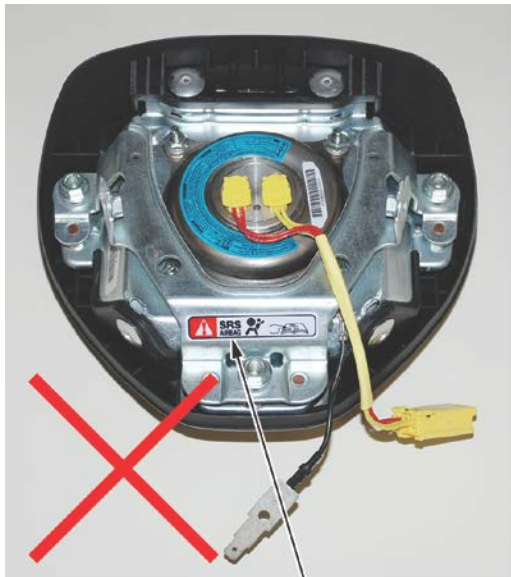
- If there is nothing unusual about the airbag or the inflator, go to step 6.
- If there are any unusual markings, like an incorrect label or a model year written in marker, the airbag and inflator may not be the correct airbag and/or inflator for the vehicle or it may be a counterfeit part. For more information about counterfeit airbags, you can refer to [safercar.gov](http://safercar.gov), enter keywords **MANAGING COUNTERFEIT**, and select **Recommended Dealer Guidance for Managing Counterfeit Air Bags** from the list. **If you suspect that the airbag or inflator is counterfeit, do not continue this procedure.** Contact your DPSM for assistance.

**NON-STANDARD  
SAFETY LABEL**

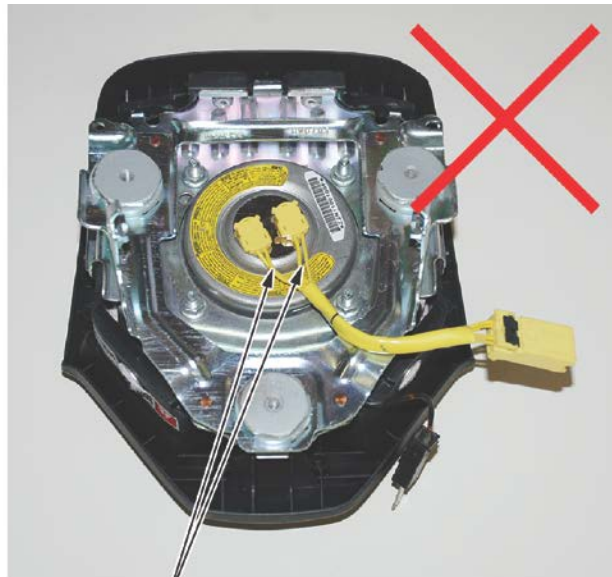
**NON-STANDARD  
WIRES**

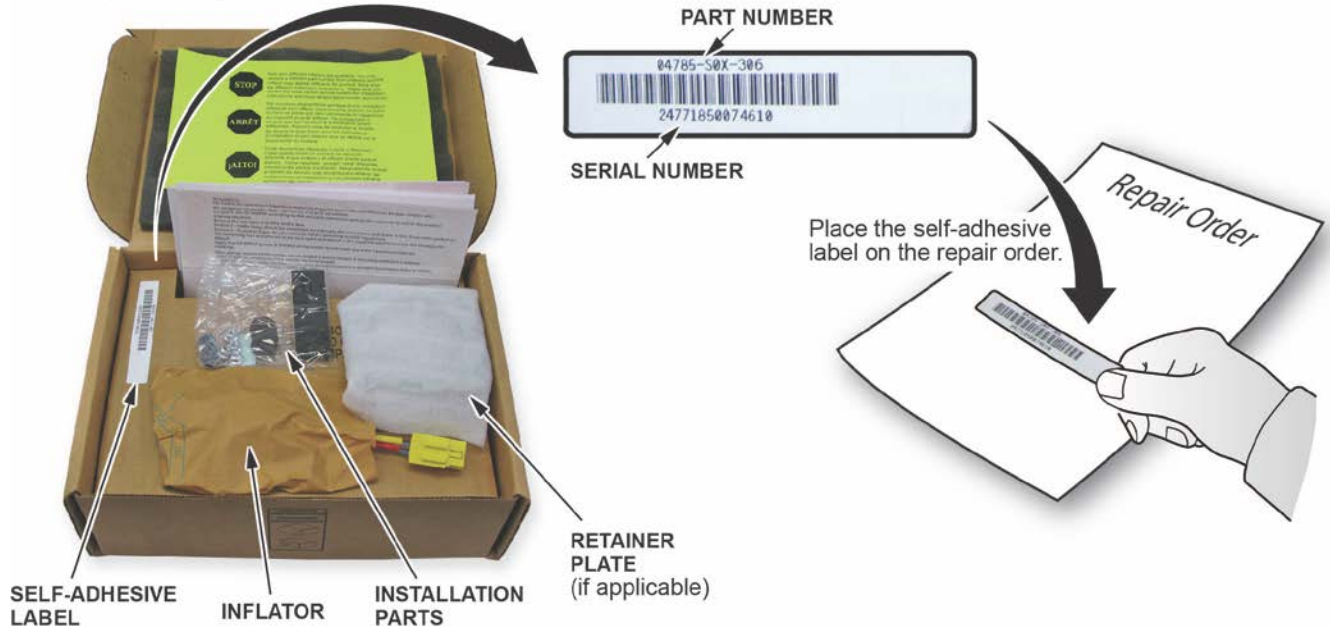
**INFLATOR PARTS BOX**

- The replacement part number is printed on the top part of the label and the serial number is printed on the bottom. **Make sure you attach the label to the R.O. and give it to the warranty clerk.**
- There may also be a colored sticker located in the kit, ignore it because it is not used.
- Not all inflator kits have a label included. In those cases, write the serial number and part number from the side of the inflator box on the R.O. The part number always starts with 047.

- Peel the label located inside the inflator box from its backing and attach it to the RO. For the warranty claim to be paid, the **replacement inflator part number that you received** must be included in the warranty claim.

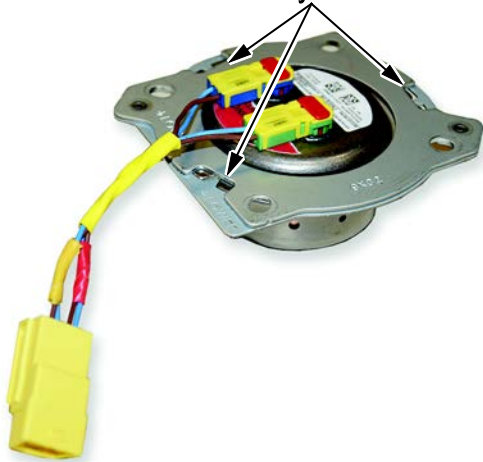
The inflator is held down by a directional retainer that is keyed to the inflator.

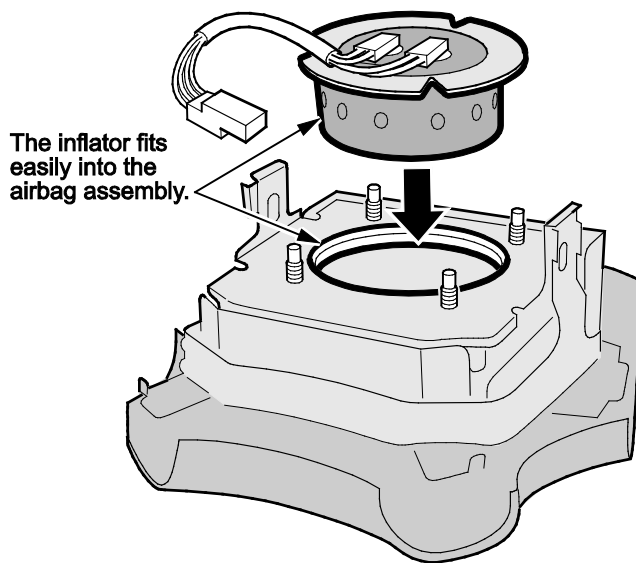
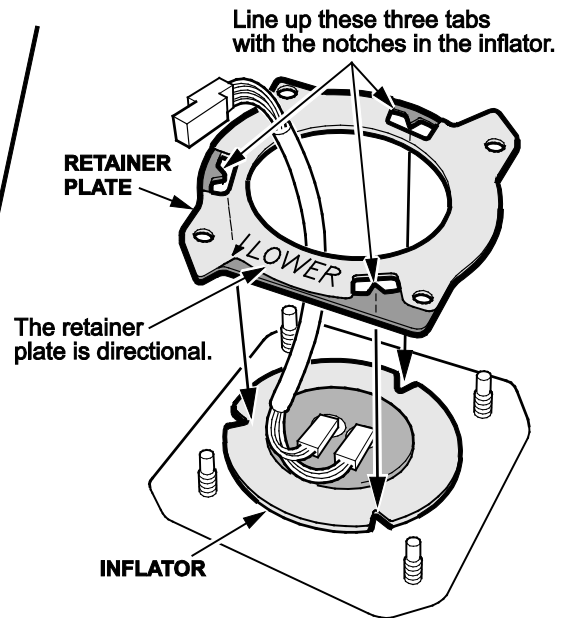
- Place the inflator into the opening with the inflator harness toward the bottom of the airbag.

- Install the bracket onto the studs with the stamp **LOWER** at the bottom of the airbag.
- Make sure the three tabs and notches are properly aligned.

- The tabs and notches are designed to align in one direction only. If the tabs and notches are not aligned, the inflator and bracket are not installed correctly.
- Make sure the harness comes out through the center opening. Do not install the bracket over the harness wires.
