February 1, 2017

05586 Version 5

Safety Recall: Front Passenger's Airbag Inflator Can Be Over-Pressurized

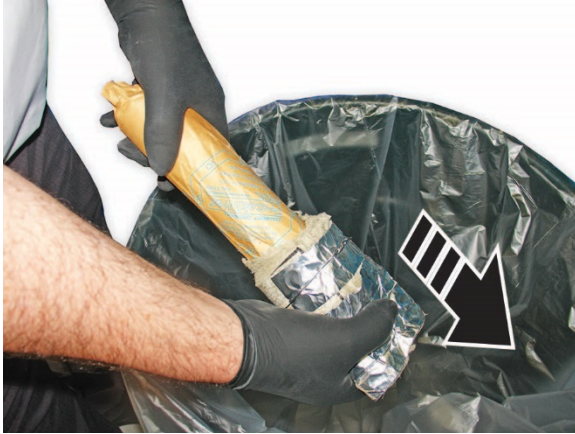
- Hold the paper wrapping the inflator with one hand and slide the insulation off into the trash.
NOTE: The insulation is securely wrapped around the inflator. You may have to use some force to slide the insulation off. Do not cut the insulation and be careful that you do not move the white or orange plastic ends.

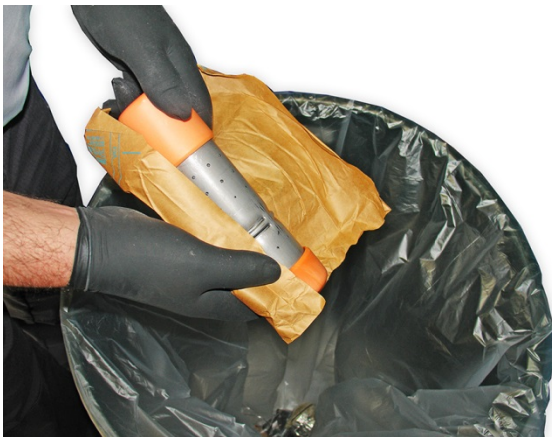
- Remove the wrapping paper and drop it into the trash.

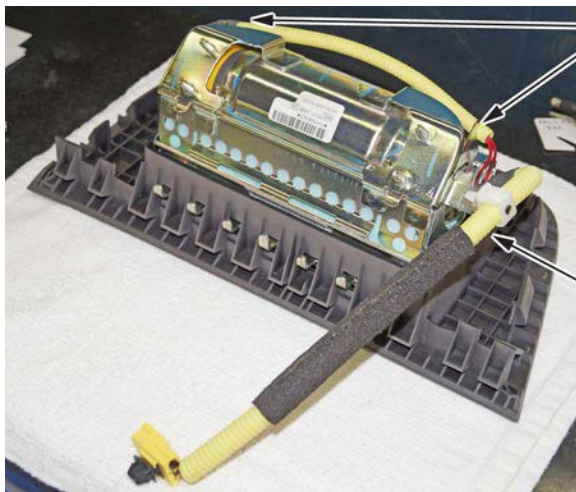
INFLATOR BRACKETS

8. Remove the harness from both ends of the inflator brackets.

Disconnect and remove the harness clip if applicable.

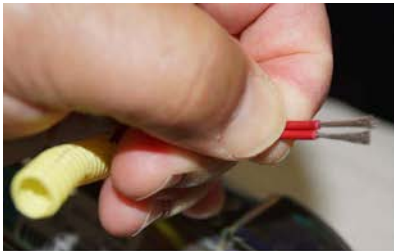
- Strip away about 1 inch of the wire insulation, then twist the wires together.

- Tape the twisted ends with electrical tape.

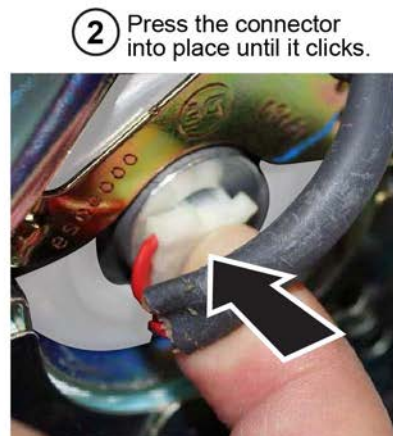
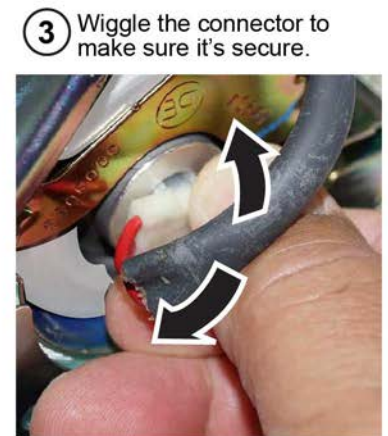
- Connect the two connectors. Align the "T" shape in the inflator harness connector with the T-shaped inflator connector, then press the connector into place.

- After you hear each connector click, wiggle it to make sure it is secure.

NOTE: If the connector is not properly aligned, it will come out.
