September 16, 2015

02040 Version 4

## Safety Recall: Front Passenger's Airbag Inflator Can Be Over-Pressurized

Supersedes 15-041, dated July 15, 2015, to revise the information highlighted in **yellow**

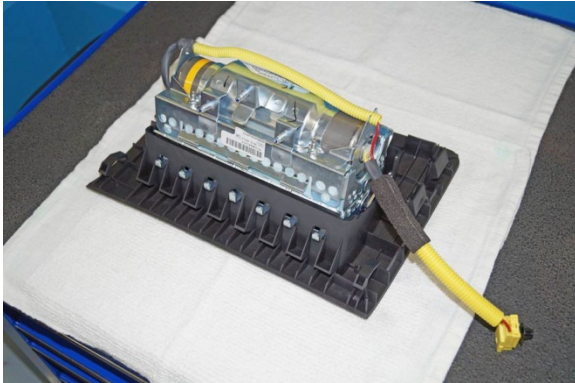
4. Place the airbag, face-down, on a clean shop towel.

- The orientation of the airbag is critical because if the inflator is installed incorrectly, the harness will be too short when you reinstall the airbag.
- The brackets between the various models are similar but may differ from the example shown.

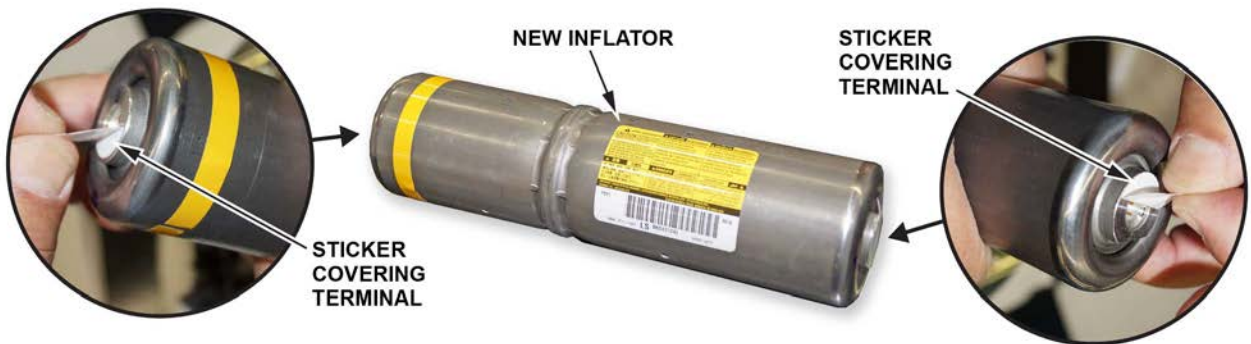
15. Remove the stickers covering the terminals on both sides of the new inflator.
