December 7, 2018

Version 5

## Safety Recall: Front Passenger's Airbag Inflator Can Be Over-Pressurized

### AFFECTED VEHICLES

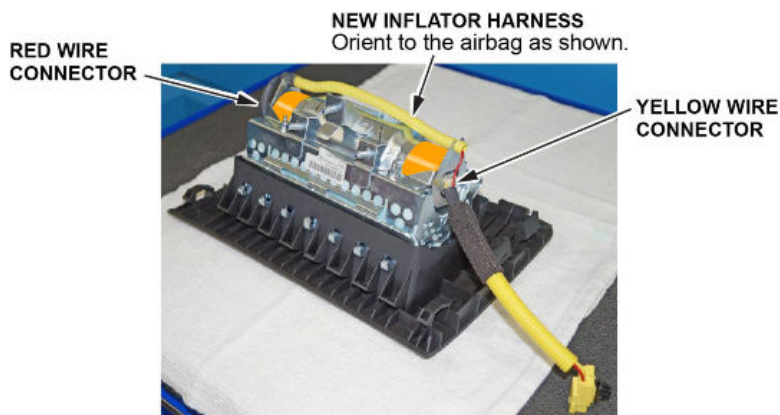
15.1. Make sure the airbag and harness are aligned as shown.

- **Make sure you have the orientation correct as shown below.** If you connect the harness incorrectly, the harness cannot be removed, and you will not be able to reinstall the airbag because the harness will be too short.
- Connect the red wire connector to the short side of the inflator with the red dot.

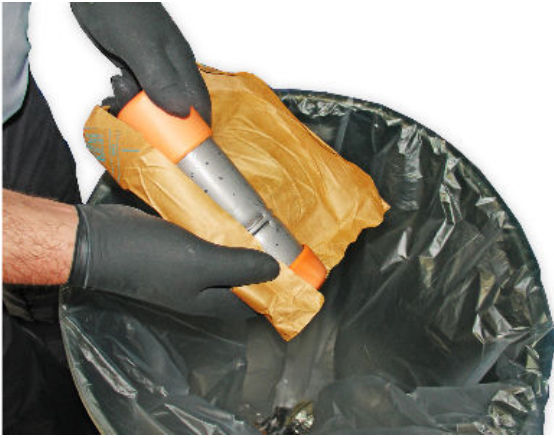
3. Remove the wrapping paper and drop it into the trash.
