**June 13, 2015**

02040 Version 1

## Safety Recall: Front Passenger's Airbag Inflator Can Be Over-Pressurized

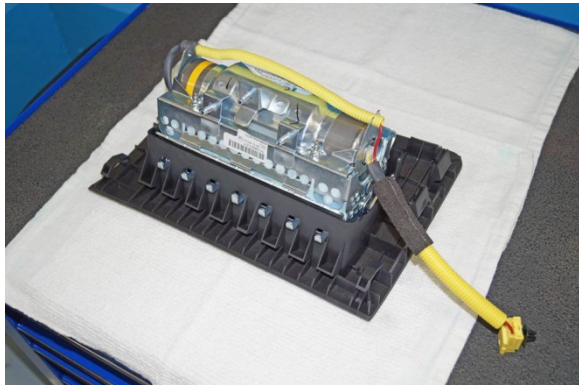
4. Place the airbag, face-down, on a clean shop towel.

- The orientation of the airbag is critical because if the inflator is installed incorrectly, the harness will be too short when you reinstall the airbag.
- The brackets between the various models are similar but may differ from the example shown.

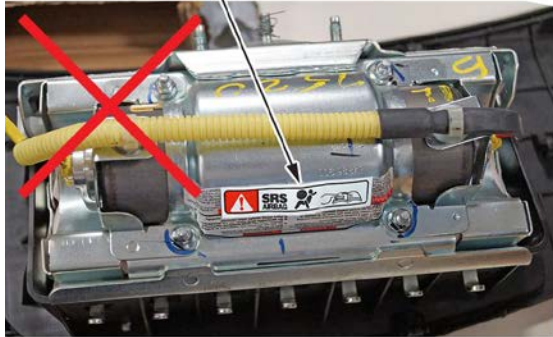
NON-STANDARD SAFETY LABEL

- If there is nothing unusual about the airbag or the inflator, go to step 5.
- If there are any unusual markings, like an incorrect label or a model year written in marker, the airbag and inflator may not be the correct airbag and/or inflator for the vehicle or it may be a counterfeit part. For more information about counterfeit airbags, you can refer to [safercar.gov](http://safercar.gov), enter keywords **MANAGING COUNTERFEIT**, and select **Recommended Dealer Guidance for Managing Counterfeit Air Bags** from the list. **If you suspect that the airbag or inflator is counterfeit, do not continue this procedure.** Contact your DPSM for assistance.

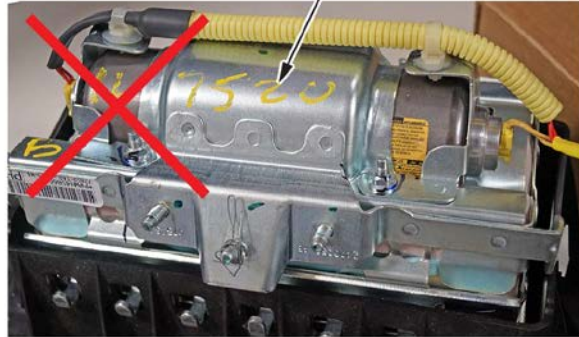
GREASE PENCIL OR PAINT MARKINGS

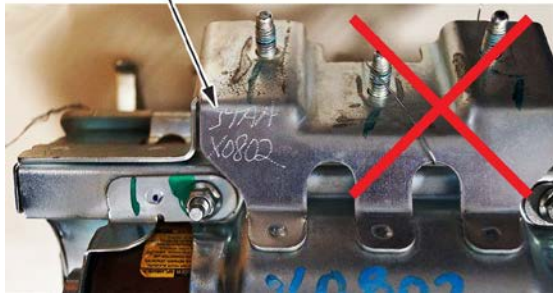
HAND ENGRAVING

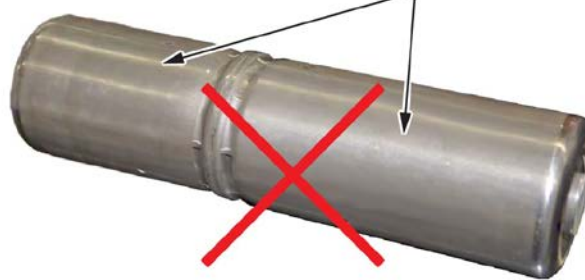
NO LABELS ON INFLATOR

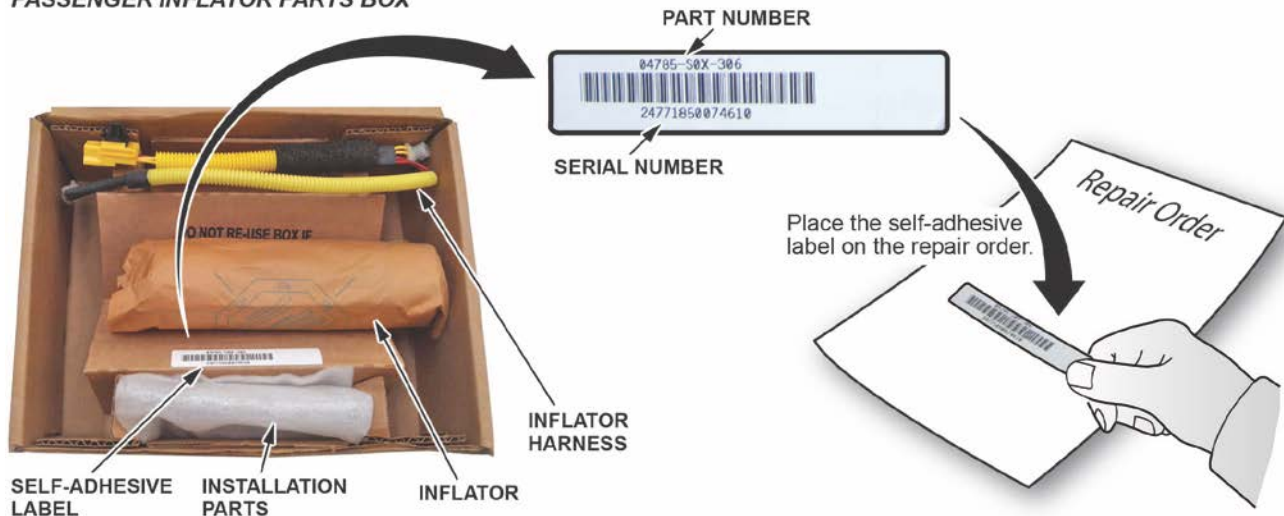
PASSENGER INFLATOR PARTS BOX

6. Peel the label located inside the inflator box from its backing and attach it to the RO For the warranty claim to be paid, the **replacement inflator part number that you received** must be on the warranty claim and your warranty clerk must enter the serial number in the Diagnostic Trouble Codes field.

- The replacement part number is printed on the top part of the label and the serial number is printed on the bottom. **Make sure you attach the label to the RO and give it to the warranty clerk.**
- There may also be a colored sticker located in the kit, ignore it because it is not used.
- Not all inflator kits have a label included. In those cases, write the serial number and part number from the side of the inflator box on the RO The part number always starts with 047.

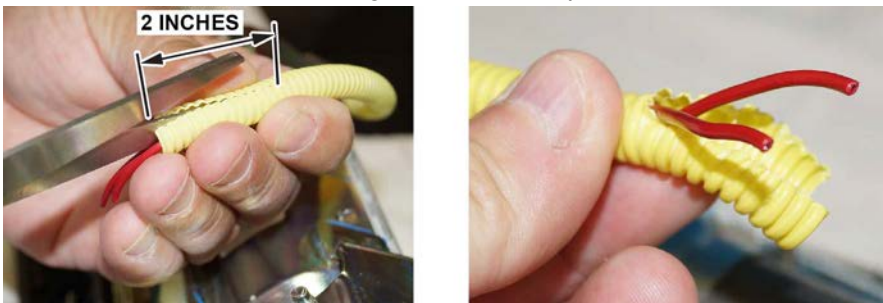
- Cut about 2 inches of the corrugated tube, then pull out the two red wires.

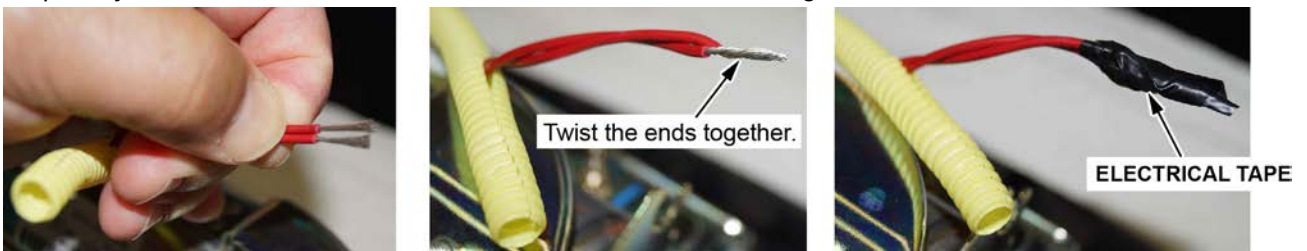
- Strip away about 1 inch of the wire insulation, then twist the wires together.

- Tape the twisted ends with electrical tape.

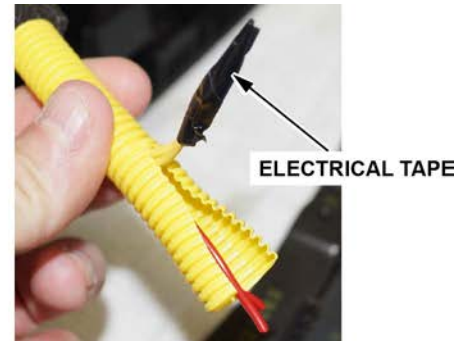
- Strip away about an inch of the wire insulation, then twist the wire ends together.

- Tape the twisted ends with electrical tape.

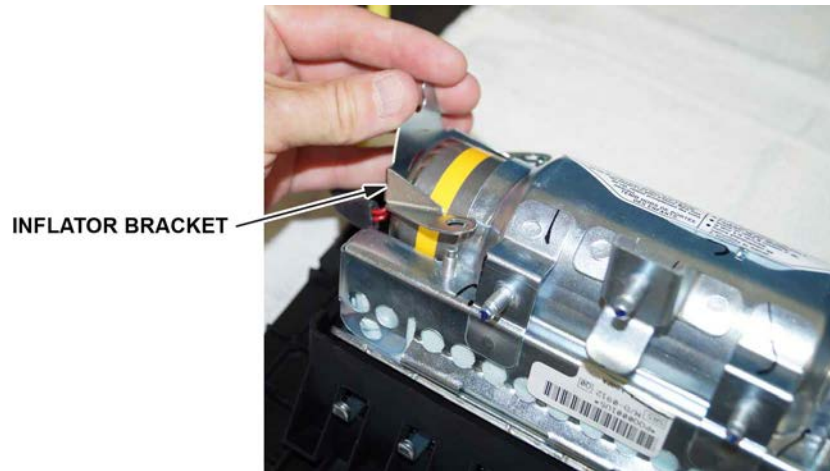
11. Remove the inflator bracket.

NOTE: You can only remove one of the brackets, as the other is welded to the airbag housing.

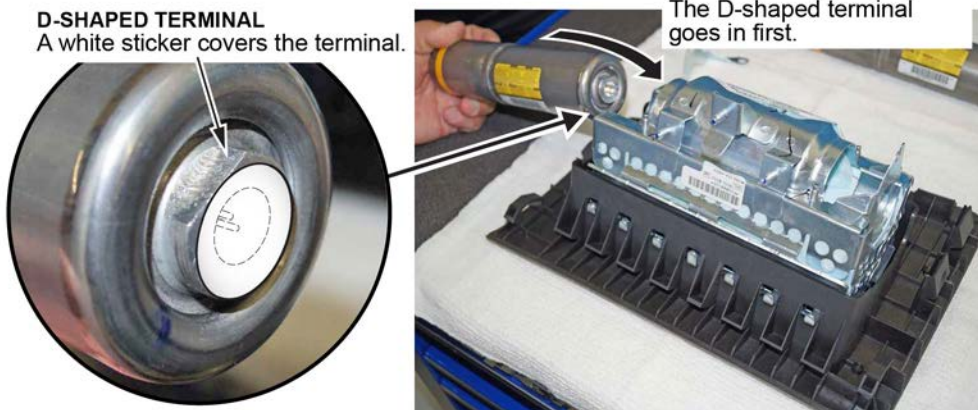
- One connector looks like a “D” whereas the other connector is a circle. Make sure you insert the “D” shaped terminal into the airbag first.

NOTE: There is a yellow band marking on the circle side.

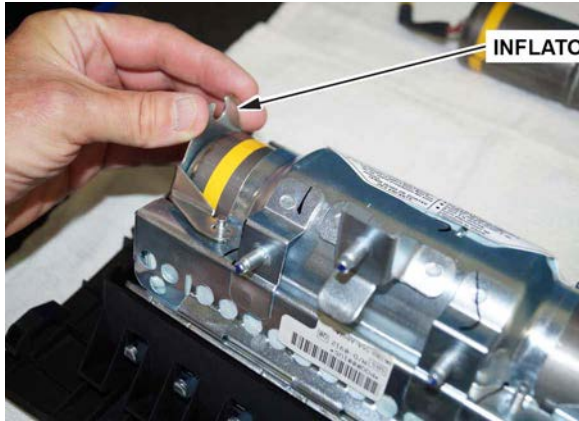
- Reinstall the inflator bracket. There should be no space or gap between the bracket and inflator.

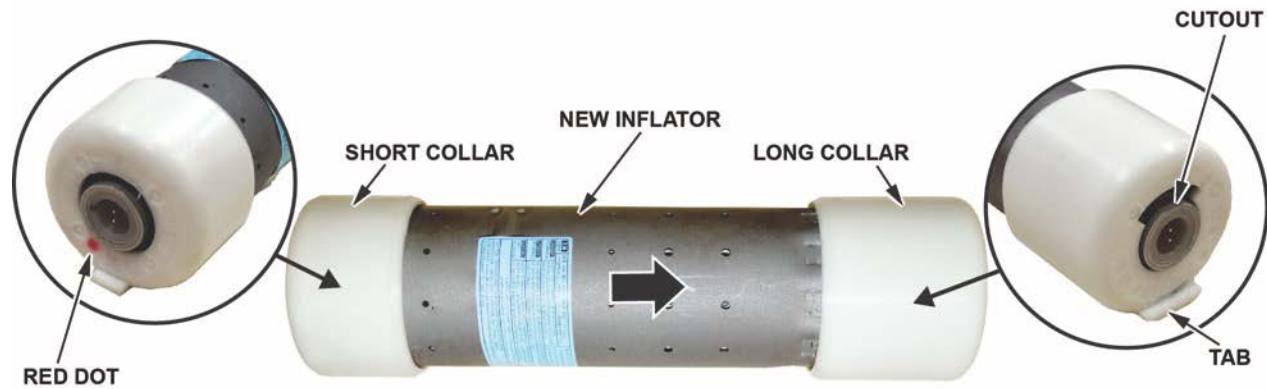
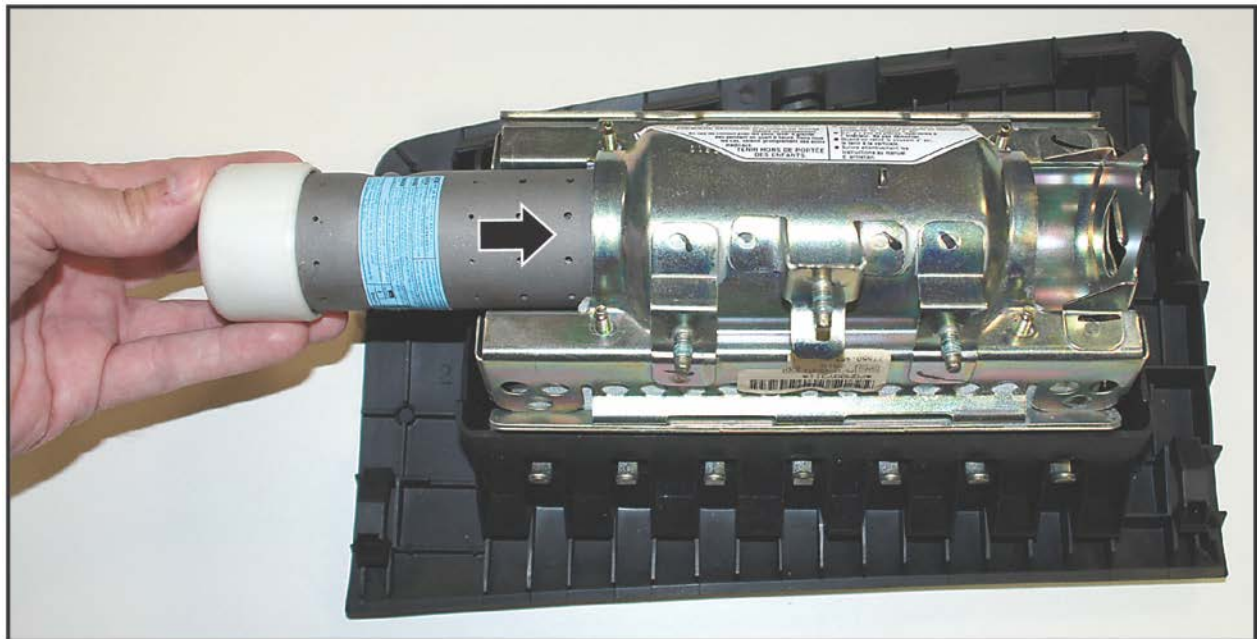
- One side of the inflator has a longer collar, a longer tab, a plastic cutout, and a small flat spot on the connector. The other side of the inflator has a shorter collar, a shorter tab, and a red dot. Make sure you insert the end with the longer collar into the airbag first.

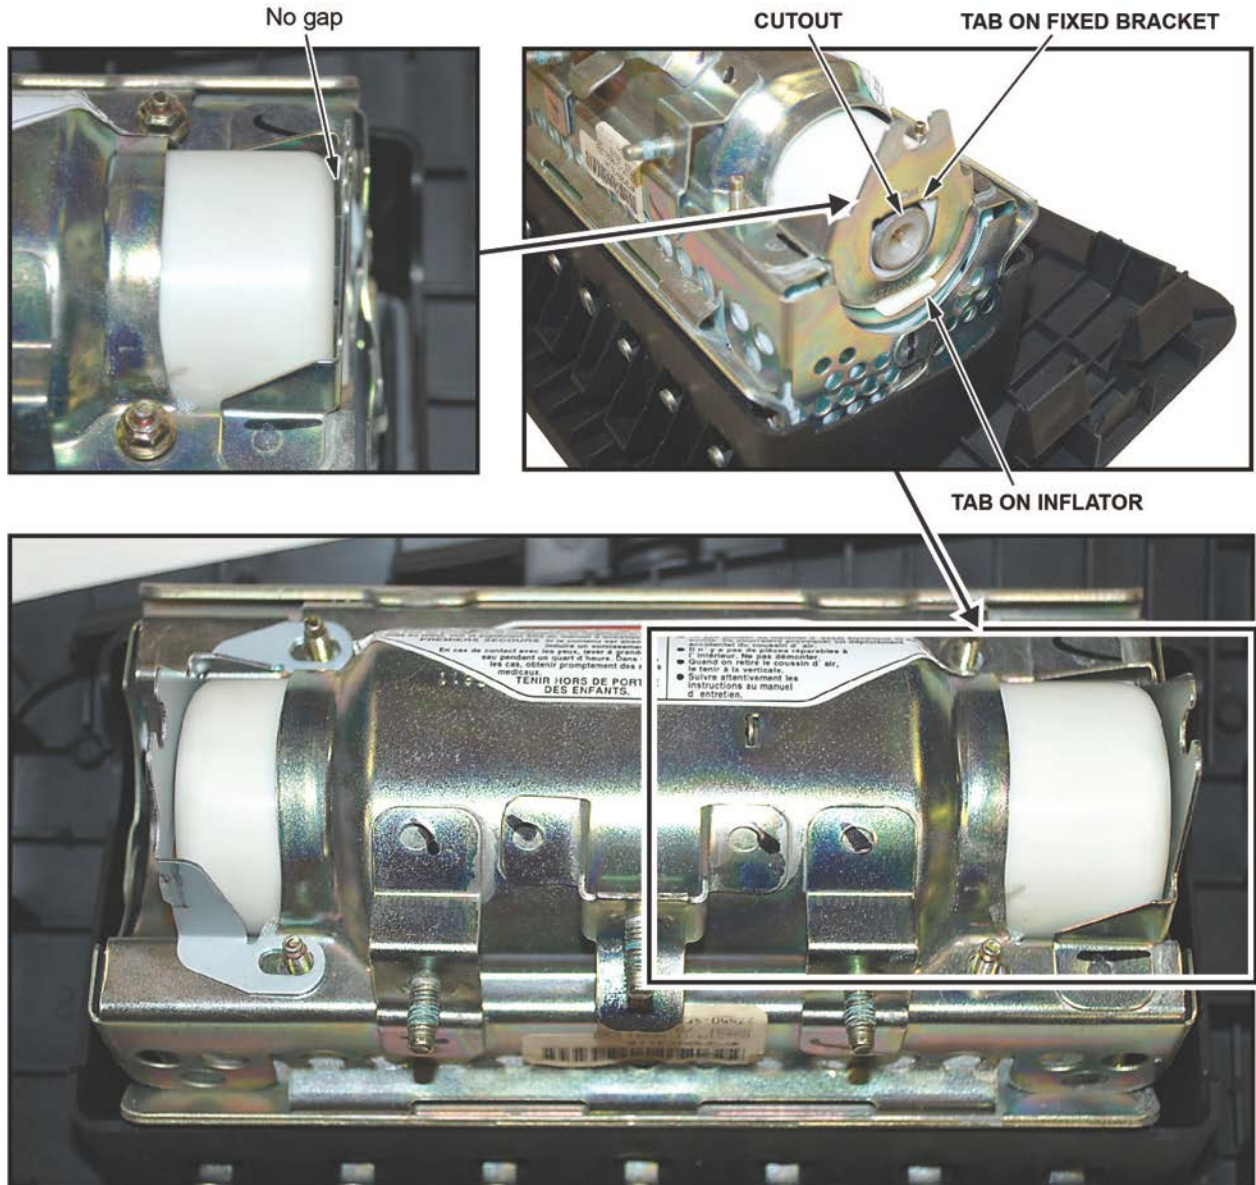
#### FIXED BRACKET END

- Slide the inflator in until the plastic cutout and the small flat spot align with the tab on the bracket. There should be no space or gap between the inflator and bracket.

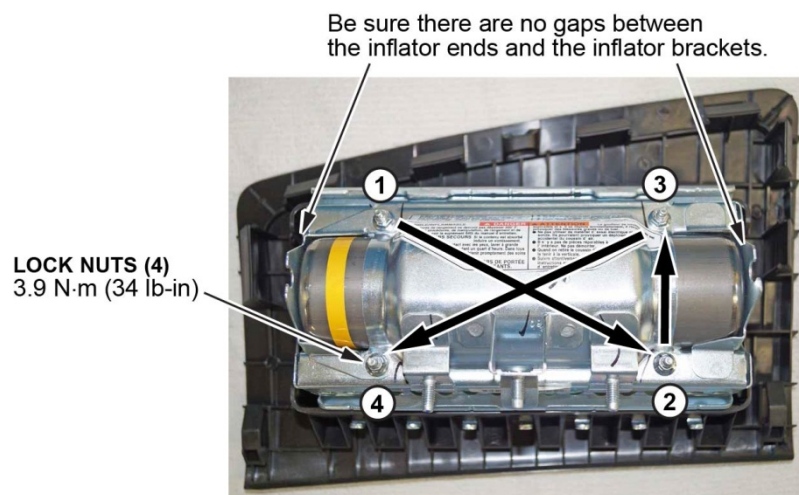
14. Install the new 5 mm locknuts and torque them in sequence to **3.9 N•m (34 lb-in)**.

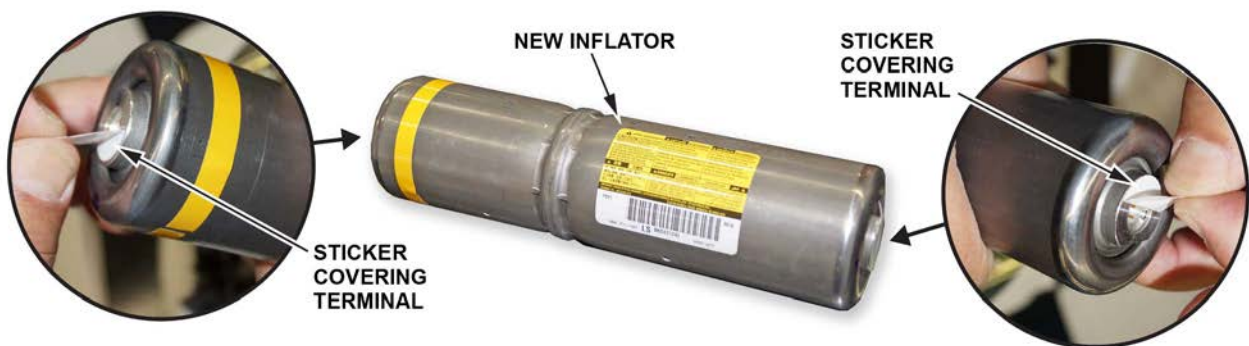
15. Remove the stickers covering the terminals on both sides of the new inflator.

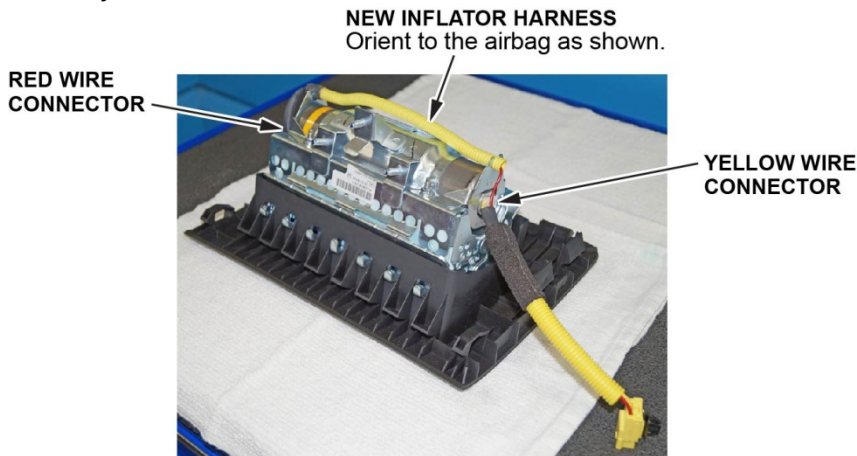
16. Install the new inflator harness.

- Make sure the airbag and harness are aligned as shown.

- **Make sure you have the orientation correct as shown below.** If you connect the harness incorrectly, the harness cannot be removed, and you will not be able to reinstall the airbag because the harness will be too short.
- On the replacement inflators with plastic collars, connect the red wire connector to the connector with the red dot.
- On the replacement inflators without plastic collars, connect the red wire connector to the connector nearest the yellow band.

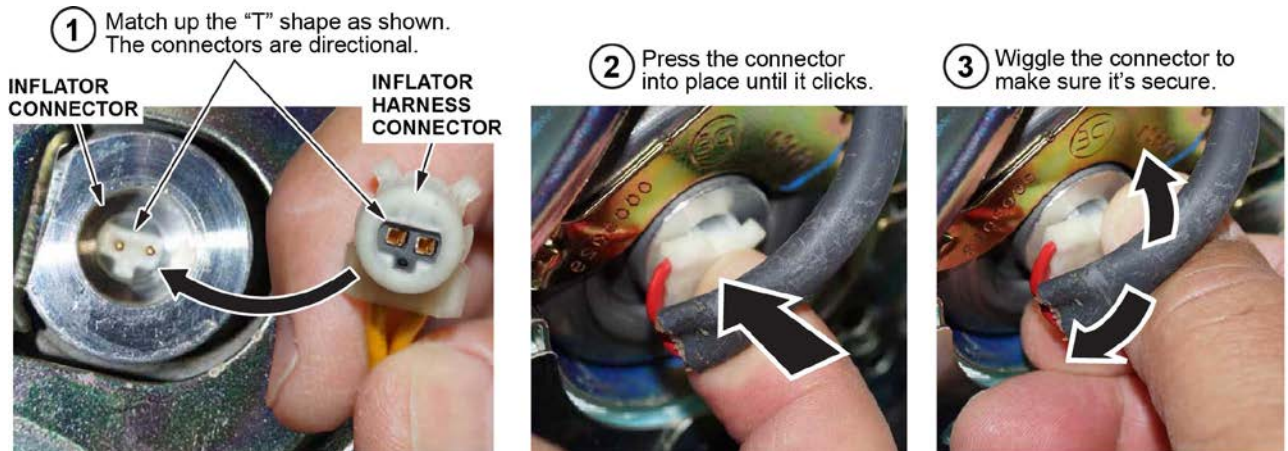
- Connect the two connectors. Align the “T” shape in the inflator harness connector with the T-shaped inflator connector, then press the connector into place.

- After you hear each connector click, wiggle it to make sure it is secure.

NOTE: If the connector is not properly aligned, it will come out.

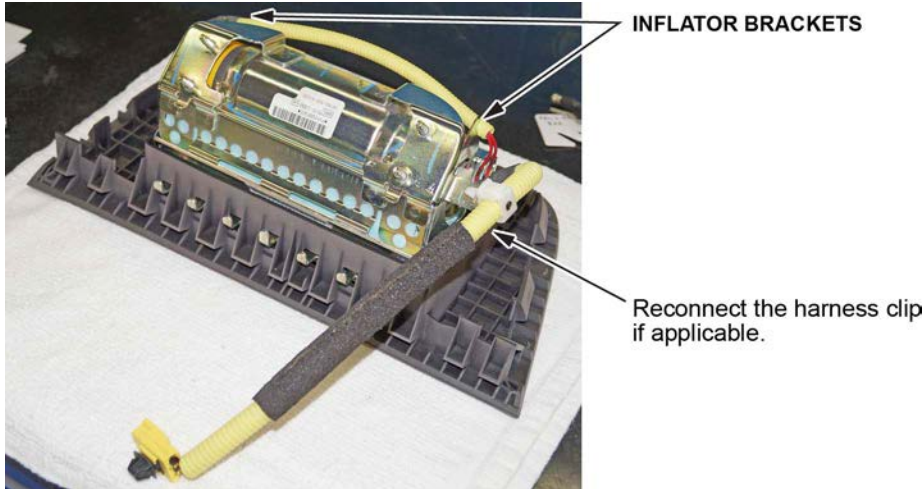
17. Connect the harness to the inflator brackets.

- Insert the side without the shrink-wrap tubing first. Insert the harness at the third “valley” in the corrugated tube.
- Insert the side of the harness with the shrink-wrap tubing into the inflator bracket. Make sure the harness is securely inserted and that it does not sag.
