February 1, 2017

05582 Version 4

Safety Recall: Front Passenger's Airbag Inflator Can Be Over-Pressurized

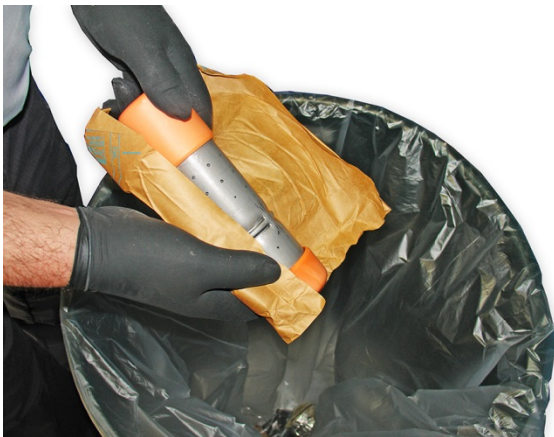
- Remove the wrapping paper and drop it into the trash.

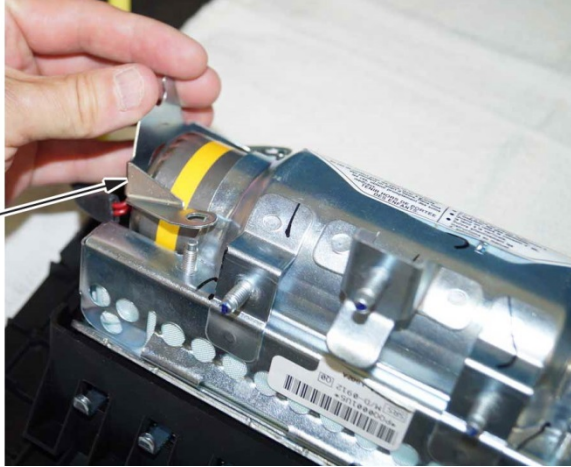
INFLATOR BRACKET

12. Remove the inflator bracket.

NOTE: You can only remove one of the brackets, as the other is welded to the airbag housing.
