December 19, 2015

02517 Version 2

## Safety Recall: Front Passenger's Airbag Inflator Can Be Over-Pressurized

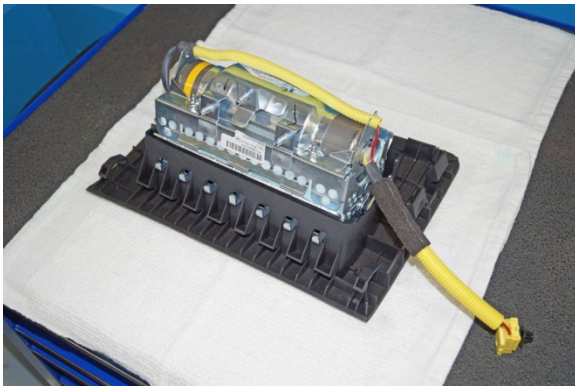
4. Place the airbag, face-down, on a clean shop towel.

- The orientation of the airbag is critical because if the inflator is installed incorrectly, the harness will be too short when you reinstall the airbag.
- The brackets between the various models are similar but may differ from the example shown.

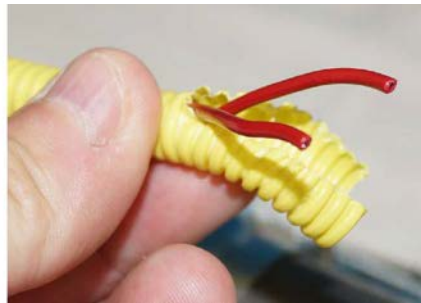
- Cut about 2 inches of the corrugated tube, then pull out the two red wires.

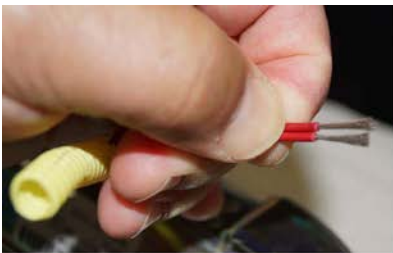
- Strip away about 1 inch of the wire insulation, then twist the wires together.

- Tape the twisted ends with electrical tape.

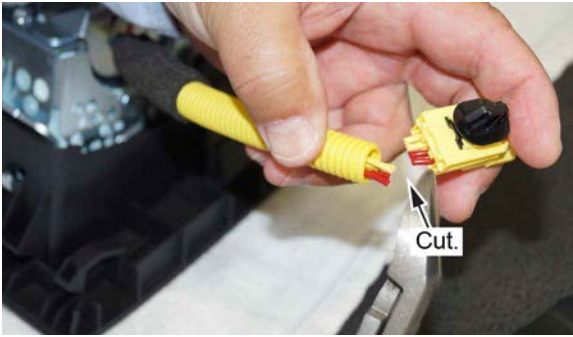
9. Cut off the connector and short the yellow wires.

- Cut all four wires to remove the connector.

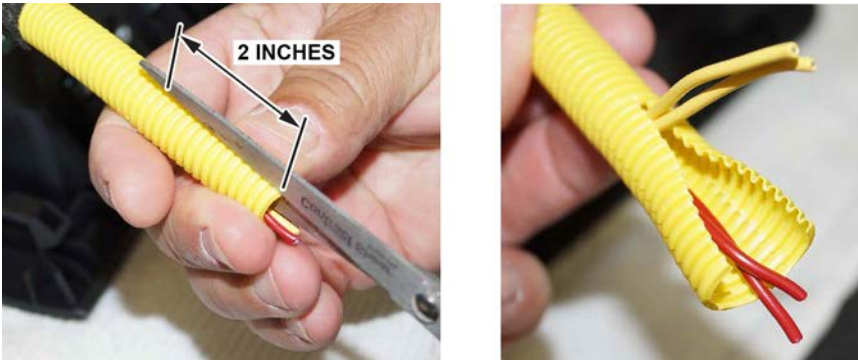
- Cut about 2 inches of the corrugated tube, then pull out the yellow wires.

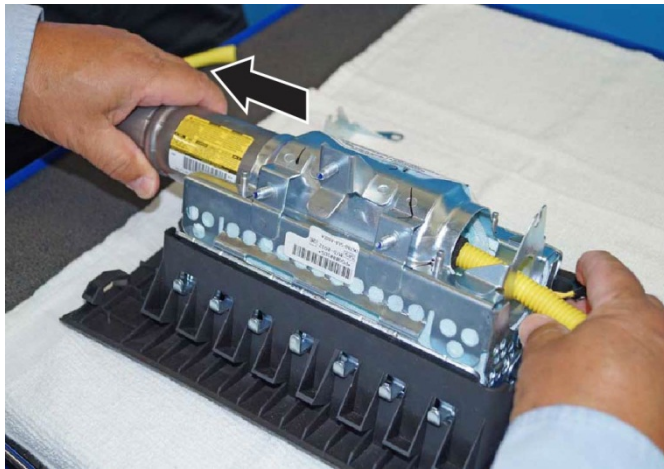
12. Remove the inflator by pushing it out.

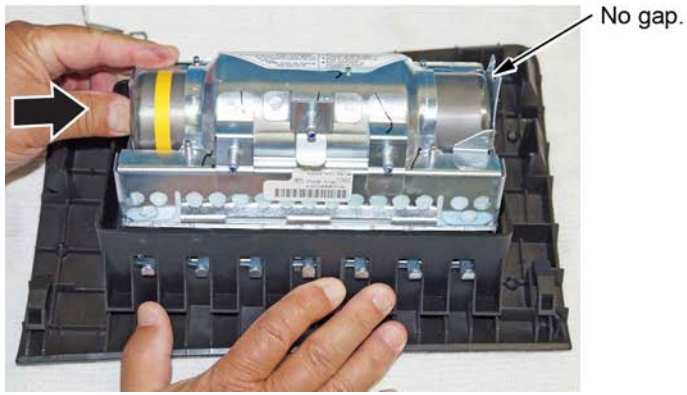
- Slide the inflator in until the “D” aligns with the tab on the inflator bracket. There should be no space or gap between the inflator and bracket.

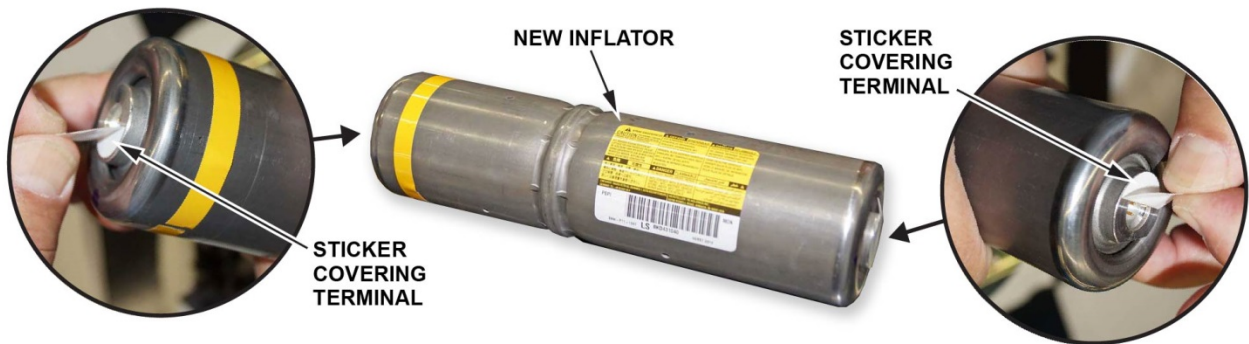
15. Remove the stickers covering the terminals on both sides of the new inflator.
