September 4, 2019

Version 7

## Safety Recall: Front Passenger's Airbag Inflator Can be Over-Pressurized

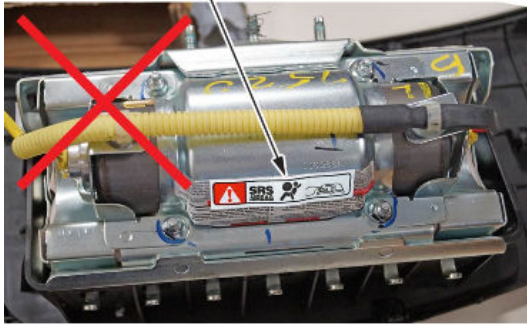
NON-STANDARD SAFETY LABEL

- If there is nothing unusual about the airbag or the inflator, continue with the inflator replacement procedure.
- If there are any unusual markings, like an incorrect label or a model year written in marker, the airbag and inflator may not be the correct airbag and/or inflator for the vehicle or it may be a counterfeit part. For more information about counterfeit airbags, you can refer to [safercar.gov](http://safercar.gov), enter keywords **MANAGING COUNTERFEIT**, and select **Recommended Dealer Guidance for Managing Counterfeit Air Bags** from the list. **If you suspect that the airbag or inflator is counterfeit, do not continue this procedure.** Contact your DPSM for assistance

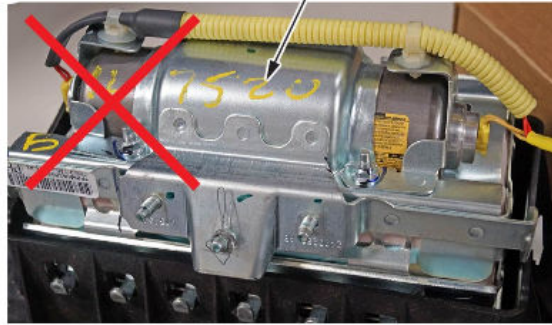
GREASE PENCIL OR PAINT MARKINGS

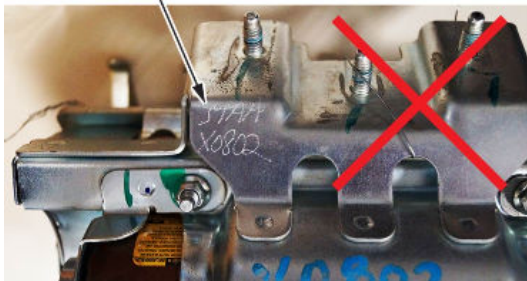
HAND ENGRAVING

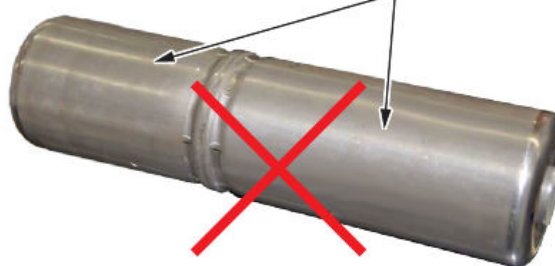
NO LABELS ON INFLATOR

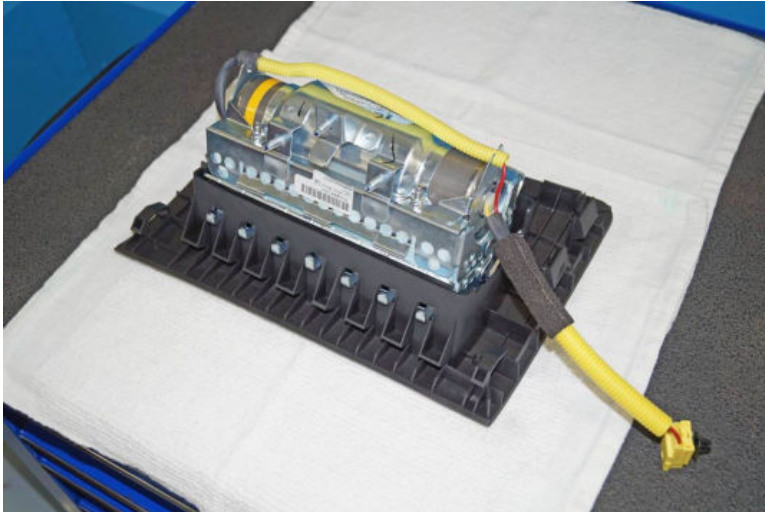
- The orientation of the airbag is critical because if the inflator is installed incorrectly, the harness will be too short when you reinstall the airbag.
- The brackets between the various models are similar but may differ from the example shown.

2. Disconnect the battery negative cable and wait at least 3 minutes before continuing.
3. Remove the front passenger's airbag. Refer to the applicable vehicle's service information.
4. Place the airbag, face-down, on a clean shop towel.

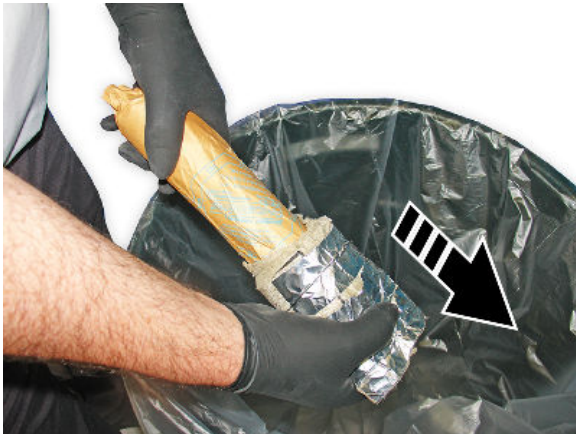
The insulation is securely wrapped around the inflator. You may have to use some force to slide the insulation off. Do not cut the insulation and be careful that you do not move the white or orange plastic ends.

2. Hold the paper wrapping the inflator with one hand and slide the insulation off into the trash.
