# Service Bulletin

## SAFETY RECALL

### MULTIPLE MODELS - STARTER RELAY SWITCH INSPECTION/REPLACEMENT

*(This supersedes Starter Relay Switch #1, dated July 2015)*

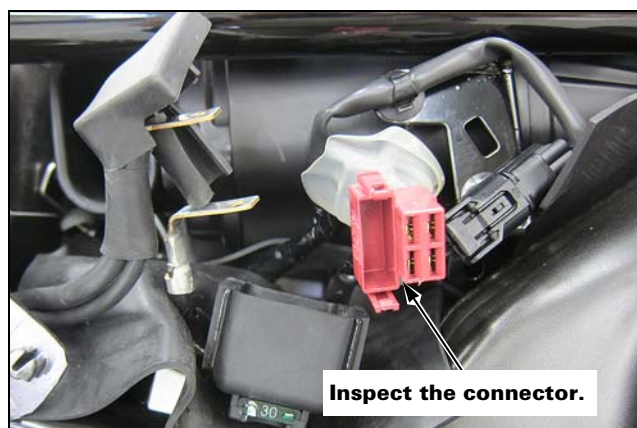
1. Refer to the [CLAIM and PARTS INFORMATION](#) section of this bulletin to find the correct replacement part number for the model being repaired.
2. Refer to the ELECTRIC STARTER section of the Service Manual and remove the starter relay switch.
3. Carefully inspect the starter relay switch 4P (Red) connector (wire harness side) for any damage (melted, burned).

- If the connector is damaged, call Tech-Line for further instructions.
  - If the connector is OK, proceed to Step 4.
4. Replace the starter relay switch with the new part.  
Make sure the 30 A (Green) fuse is installed in the top of the relay switch assembly. *Do not use the 20 A or 15 A fuses supplied in the repair parts kit.*
  5. Reconnect the battery negative (-) cable.
  6. Confirm the repair by turning the ignition switch to ON and starting the engine.
    - If there is a problem, check that the correct starter relay switch repair kit was used.
  7. Proceed to the [IDENTIFICATION](#) section of this bulletin.

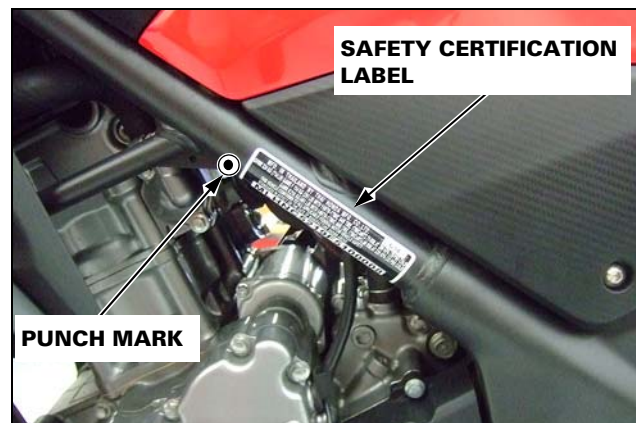
#### CB300F

Place a punch mark on the frame, next to the Safety Certification Label, nearby the VIN as shown.
