Service Bulletin

15-054

Noncompliance Recall: HR-V Emission (Trim and Year), Tire, and A/C Labels

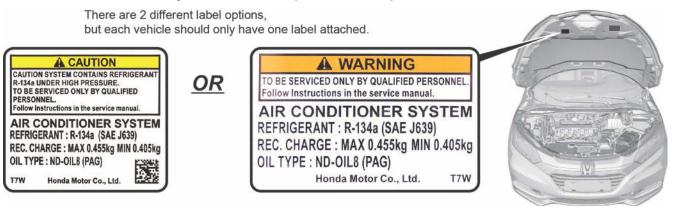
NOTE: **Each vehicle should only have 1 A/C label attached to the hood,** but because of a change during production, there are 2 different options.

- 1. Open the hood.
- 2. Make sure one of the two A/C labels shown below is present on the hood.
 - If the label is present, go to **Tire Label Inspection and Replacement**.
 - If the label is missing, apply a new label:
 - Using alcohol and a clean shop towel, clean the hood area where the A/C label is placed. Allow the surface to dry.
 - Peel off the backing from the A/C label, and apply it to the hood. Press the label firmly to make sure it sticks, then go to **Tire Label Inspection and Replacement**.

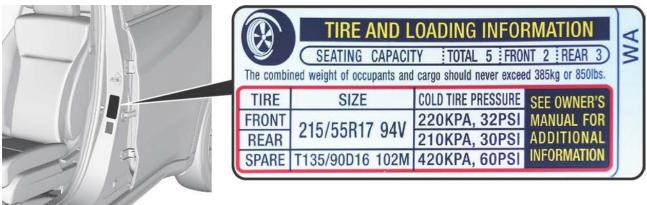
- 1. Open the driver's door.
- 2. Make sure the tire label is present on the doorjamb.
 - If the label is present, all the labels are correct. Return the vehicle to the customer.
 - If the label is missing, apply a new label:
 - Using alcohol and a clean shop towel, clean the doorjamb area where the certification label is placed. Allow the surface to dry.
 - Peel off the backing from the tire label, and apply it to the driver's doorjamb. Press the label firmly to make sure it sticks. The labels are correct. Return the vehicle to the customer.
