Dealer Service Instructions for:

## **Safety Recall R46 / NHTSA 15V-541**

### **Front Suspension Track Bar Frame Bracket**

- 2013 – 2014 (D2) RAM Truck (3500 series)
- 2014 (DD) RAM Cab Chassis (3500 series)
- (DJ) RAM Truck (2500 series)

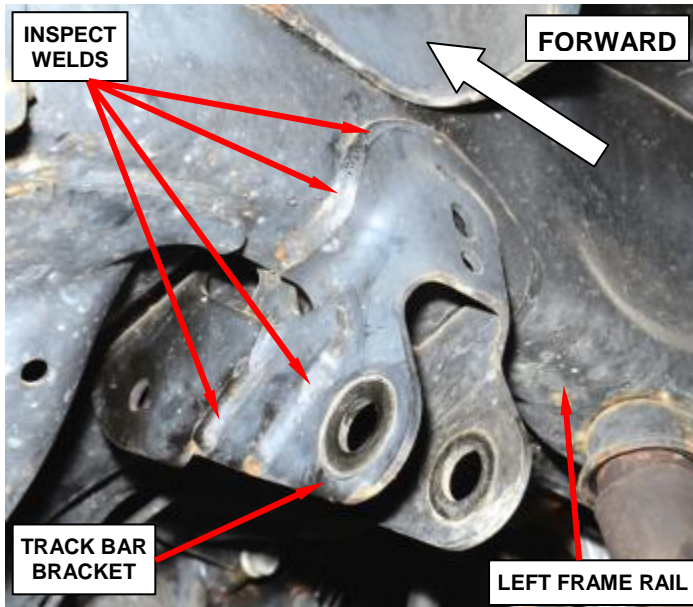
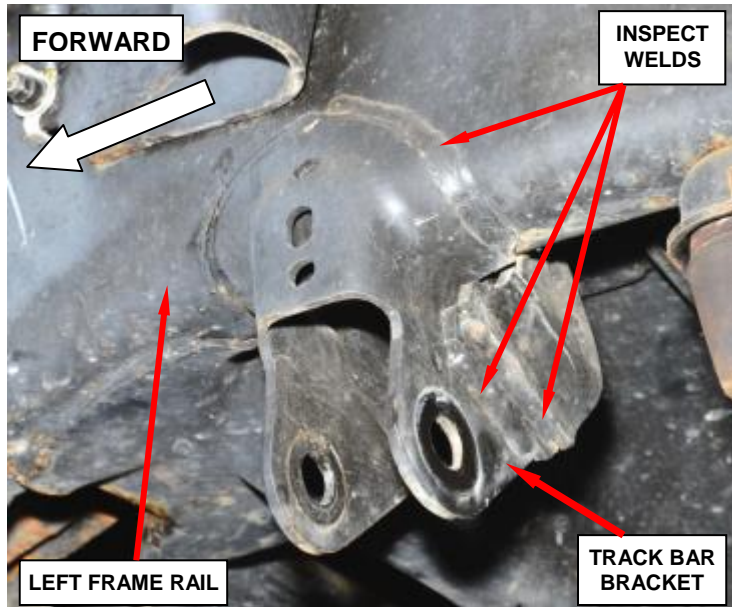
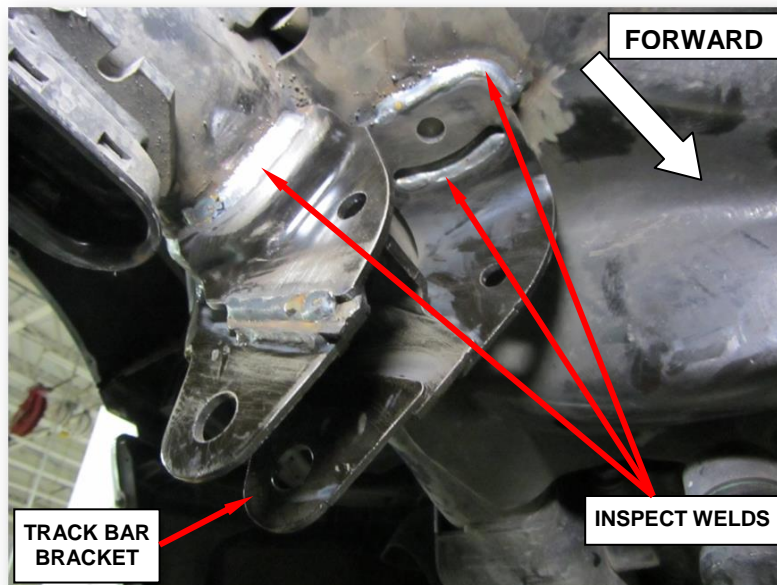
**Figure 1 – Suspect Weld Locations on Front and Back Side of Track Bar Bracket  
(Track Bar Removed for Photographic Purposes Only)**

- **For 4x4 trucks**, if there are no cracked weld(s), fractured weld(s) and/or the bracket separation from the left frame rail, continue with **Section B. Front Suspension Track Bar Reinforcement Bracket Installation**.
- **For 4x2 trucks**, track bar reinforcement brackets are presently not available. If there are no cracked weld(s), fractured weld(s) and/or the bracket separation from the left frame rail, no further action is required at this time. Return the vehicle to the customer.
- **For 4x2 and 4x4 trucks**, if the front suspension track bar bracket is found to have cracked weld(s), fractured welds and/or the bracket is separated from the frame, use the following procedure:
  - a. Using a digital camera, photograph the track bar bracket and the surrounding area. Images should at minimum, mirror the three images shown in Figure 1. Make sure all the pictures are clear and in focus.

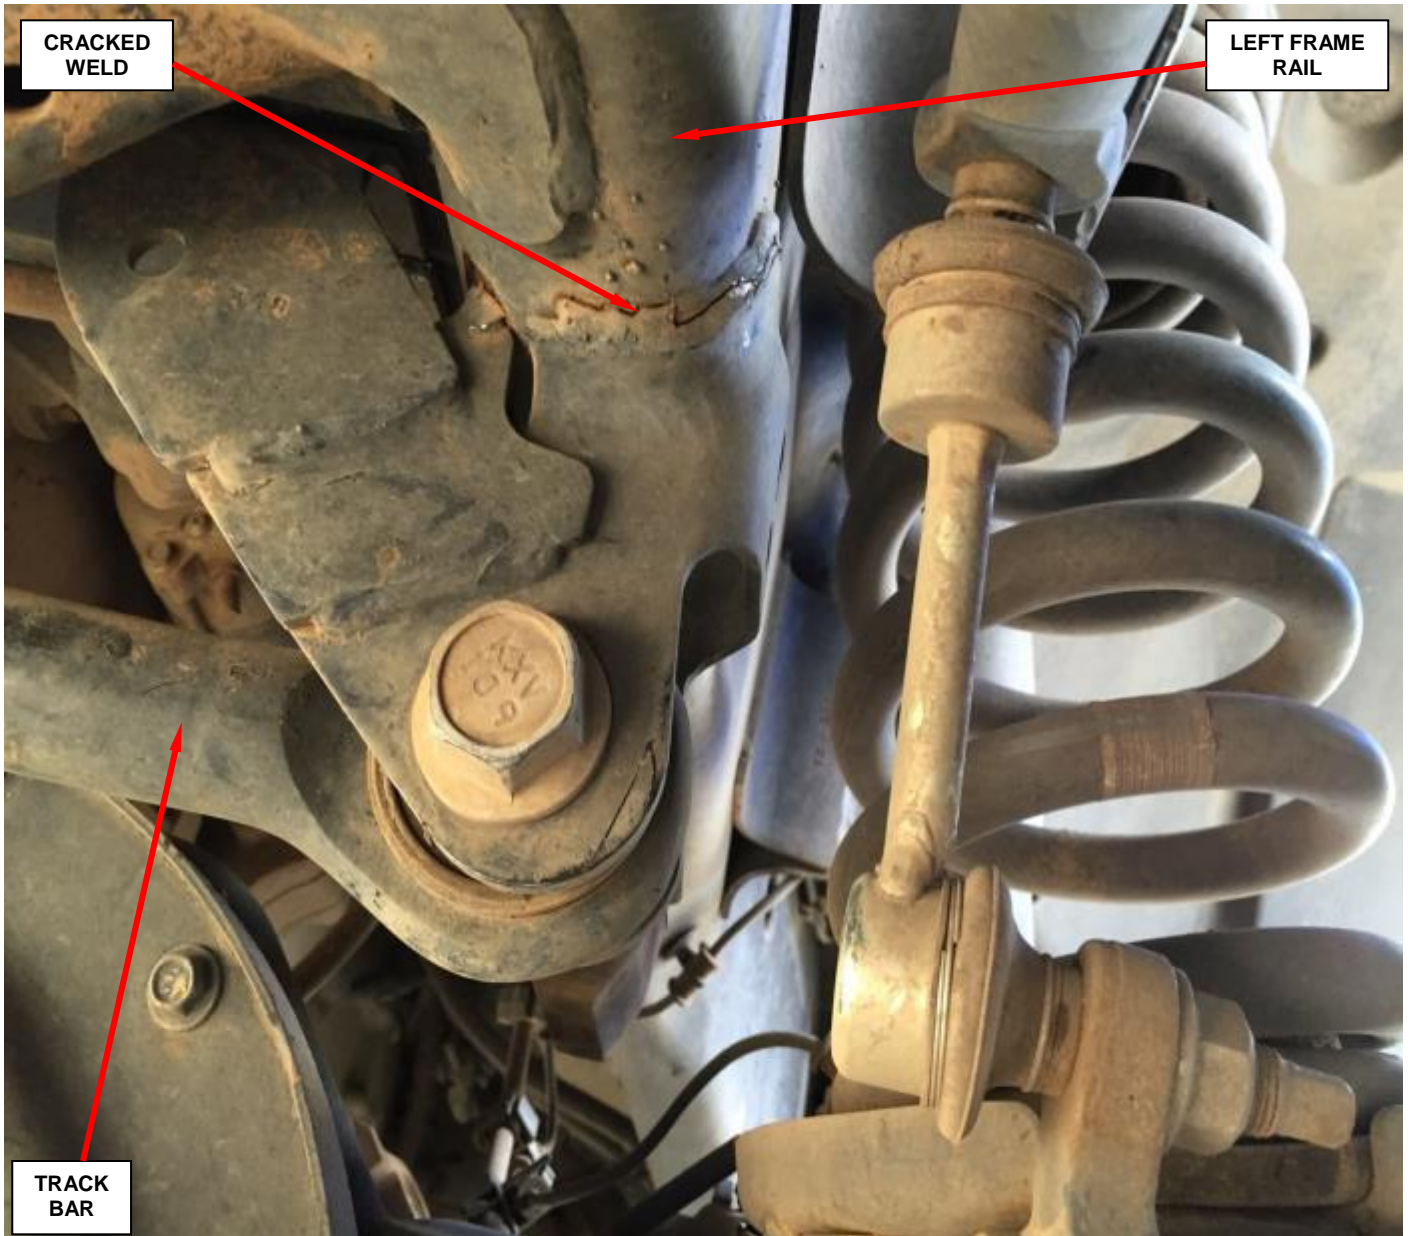
**Figure 2 – Example of a Cracked Track Bar Bracket Weld**

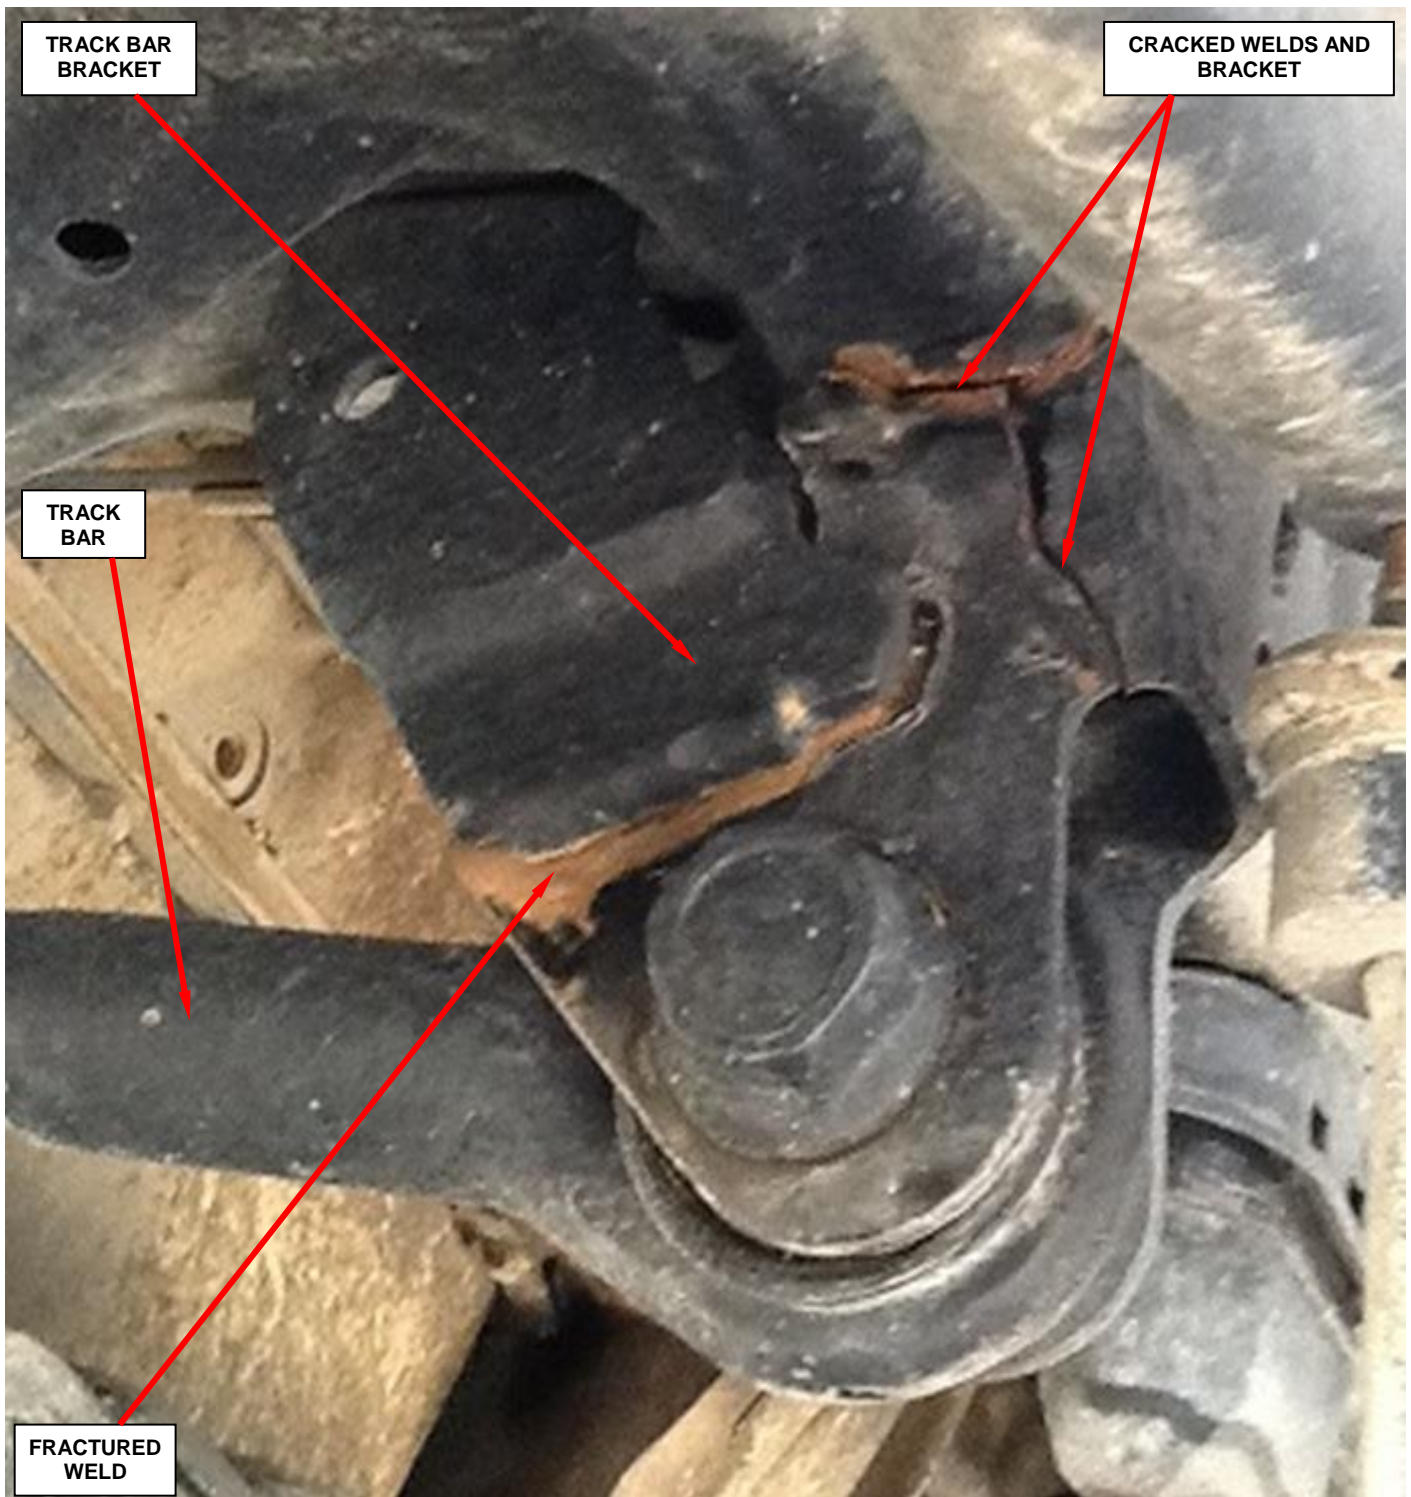
**Figure 3 – Example of a Fractured Weld at Track Bar Bracket**

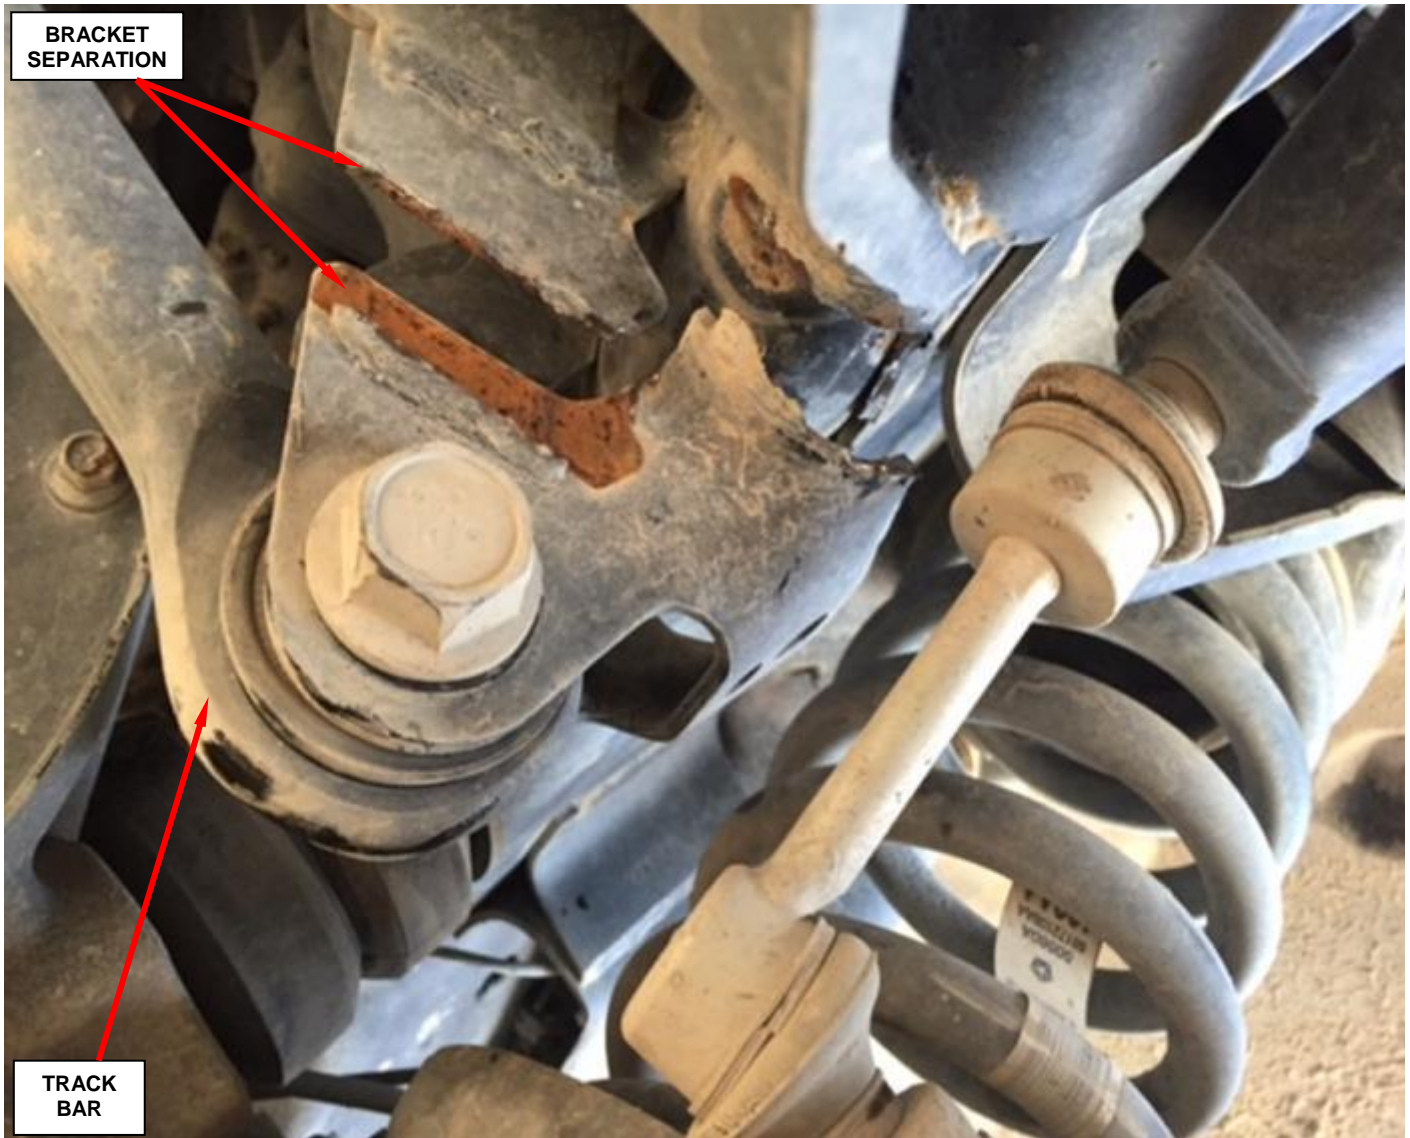
**Figure 4 – Example of Track Bar Bracket Separated from the Left Frame Rail**

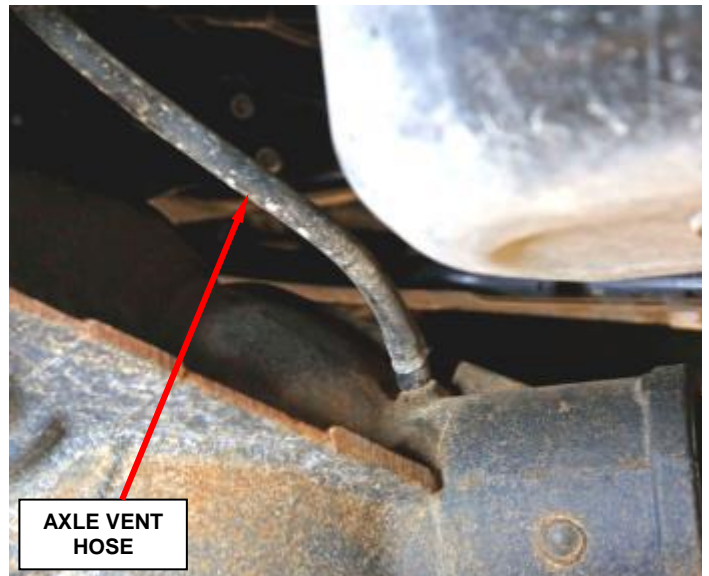
**Figure 5 – Front Axle Vent Hose**

1. Carefully disconnect the vent hose at the front axle (Figure 5).
2. Turn the front wheels to the full “right turn” position to gain additional clearance from the pitman arm (Figure 6).

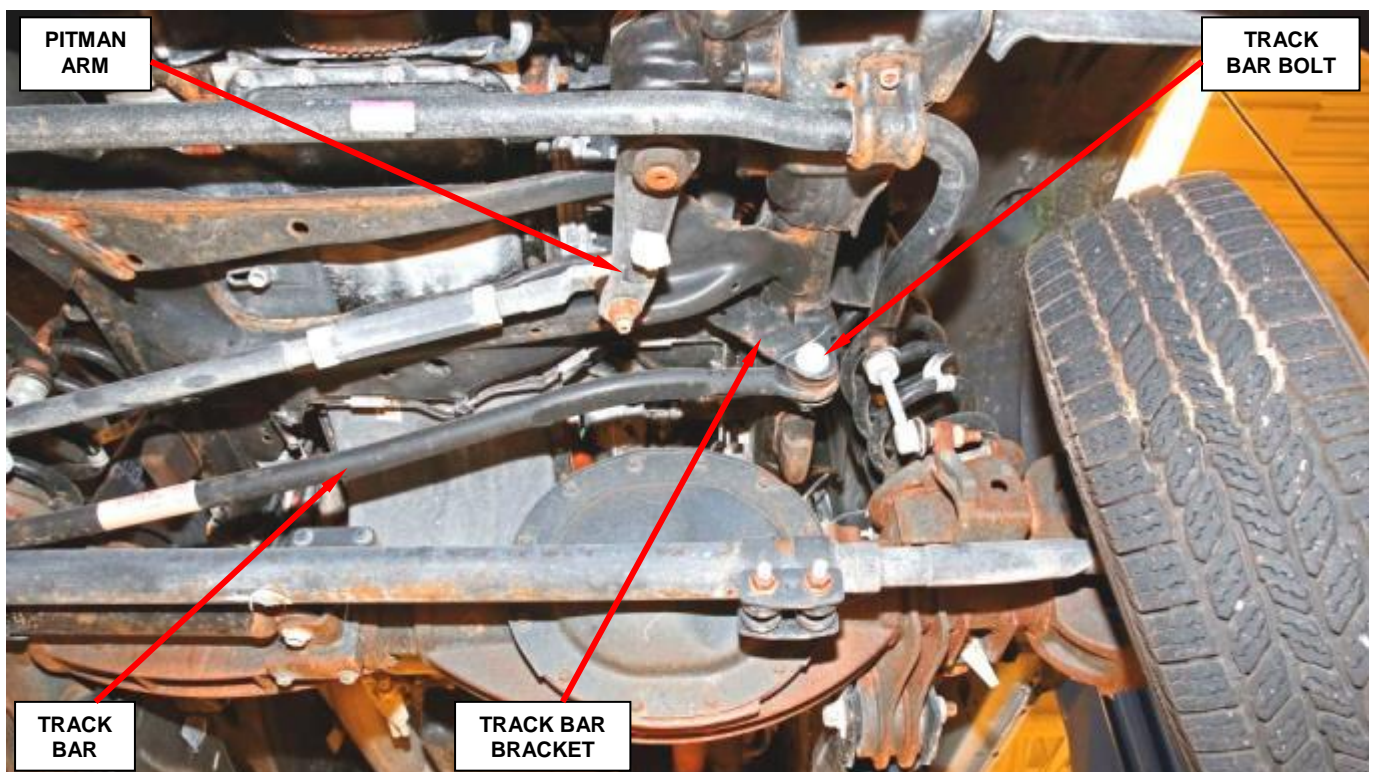
**Figure 6 – Turn Front Wheels full Right and Remove Track Bar Bolt**

3. Remove the track bar bolt and flag nut from the track bar at the frame bracket (Figure 6).

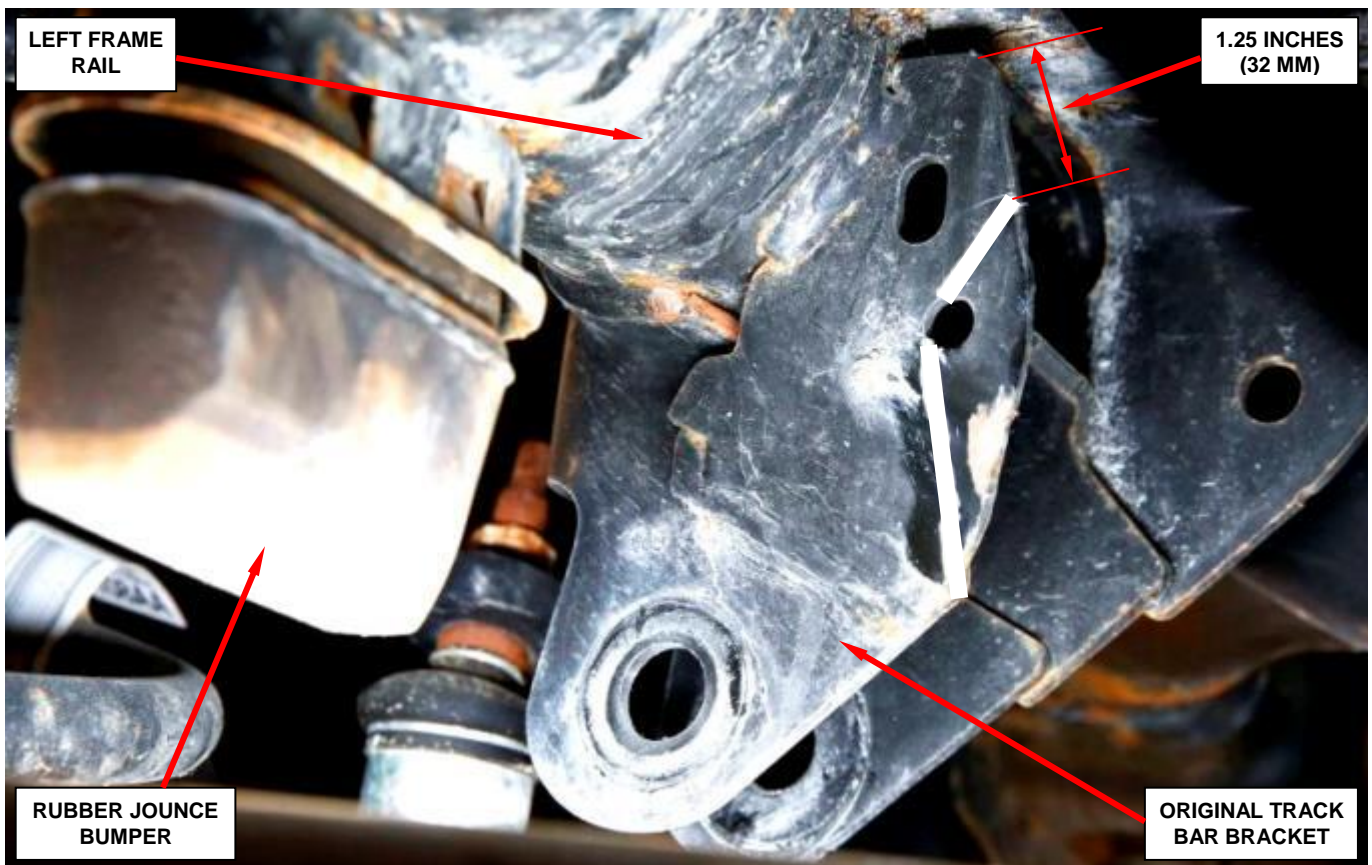
**Figure 7 – Mark Frame and Cut Bracket with a Cut-Off Wheel**

4. Use the following procedure to modify the existing frame bracket:
  - a. Mark the frame bracket shown in Figure 7.
  - b. Carefully disconnect the brake tube from the two original plastic routing clips (Figure 8).
  - c. Relocate the brake tube to gain clearance for the cut-off wheel.

**CAUTION:** Use extreme care not to allow the cut-off wheel to come in contact with the brake tube.

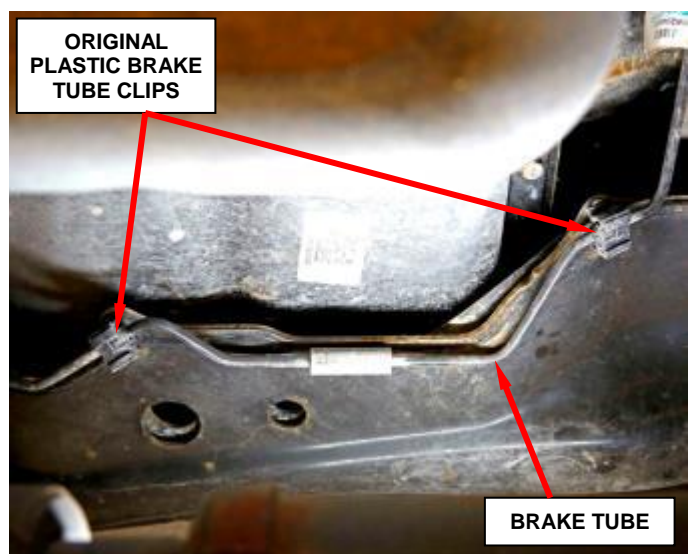
**Figure 8 – Brake Tube Plastic Clips**

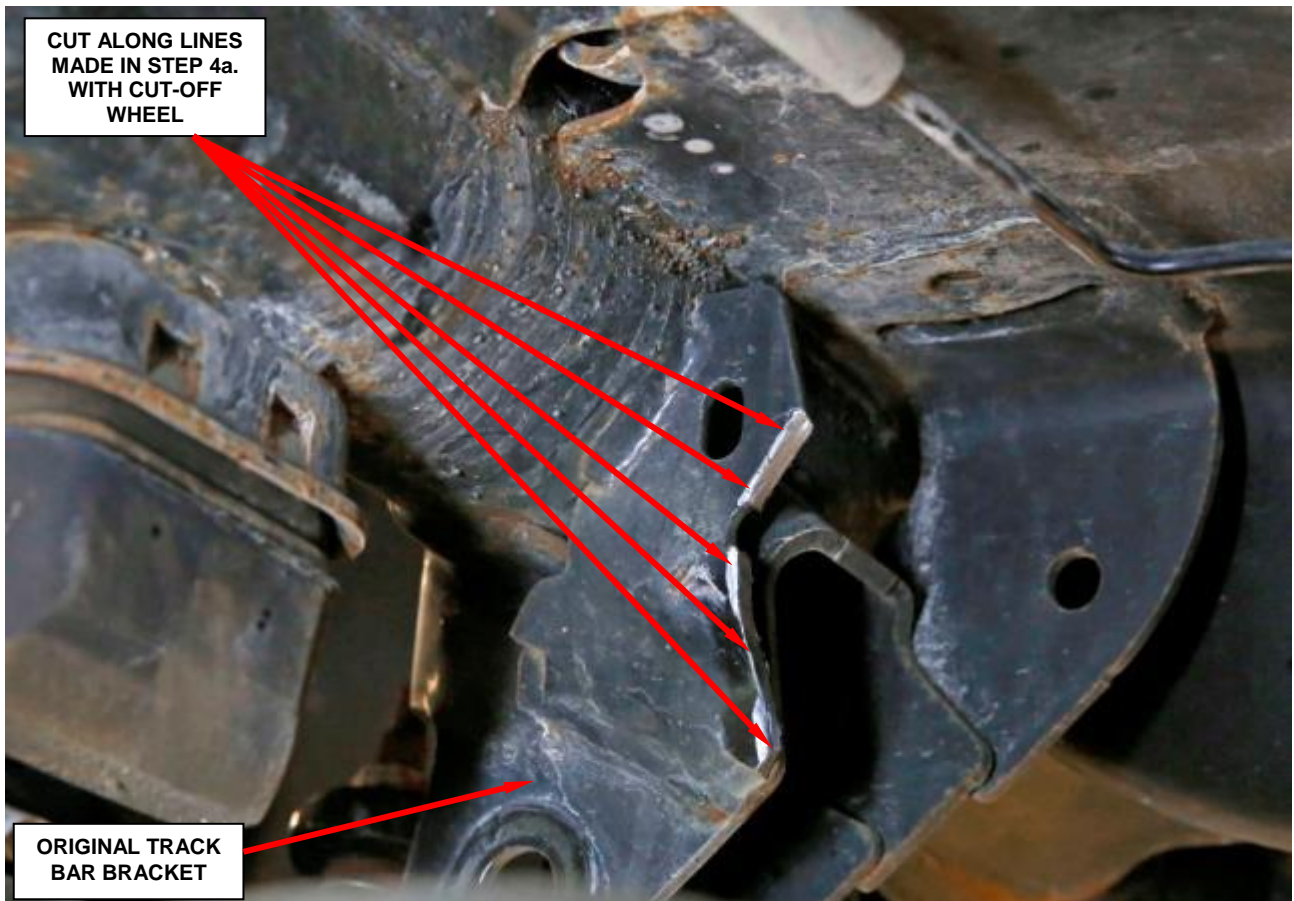
**Figure 9 – Correctly Cut Track Bar Bracket**

d. Using a cut-off wheel, cut the frame bracket along the lines made in Step 4a.

e. Using a small grinder, remove any burrs from the cut edge of the frame bracket.

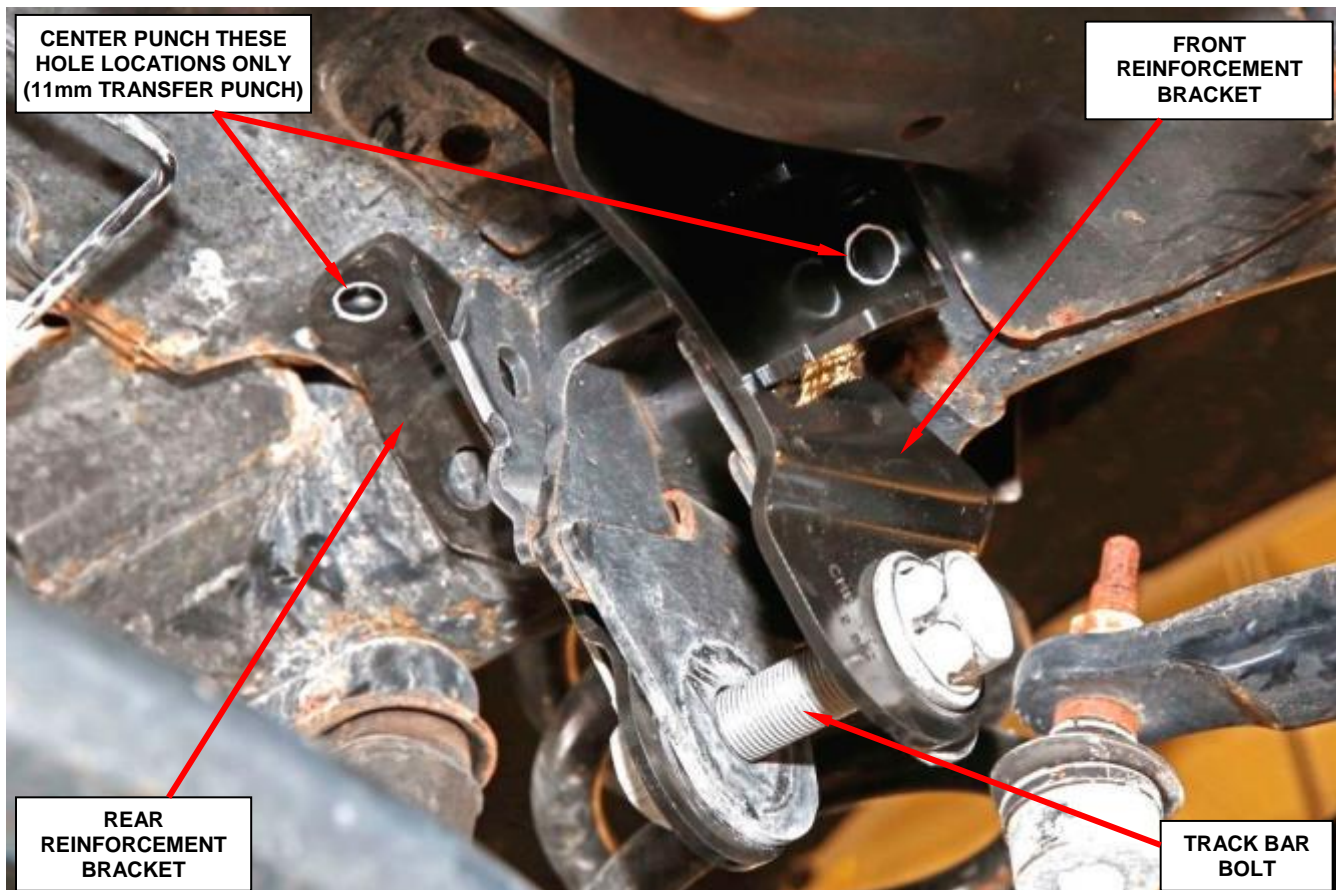
**Figure 10 – Temporarily Install Track Bar Reinforcement Brackets**

- Using the original track bar bolt and flag nut, temporarily place the new reinforcement brackets onto the frame rail bracket (Figure 10). Tighten the original track bar bolt just enough to hold the new reinforcement brackets in place.

**CAUTION:** Be sure to push the reinforcement brackets tight against the frame before snugging the track bar bolt.

- Using the supplied transfer punches, center punch the two hole locations shown in Figure 10, using the new reinforcement brackets as a template.

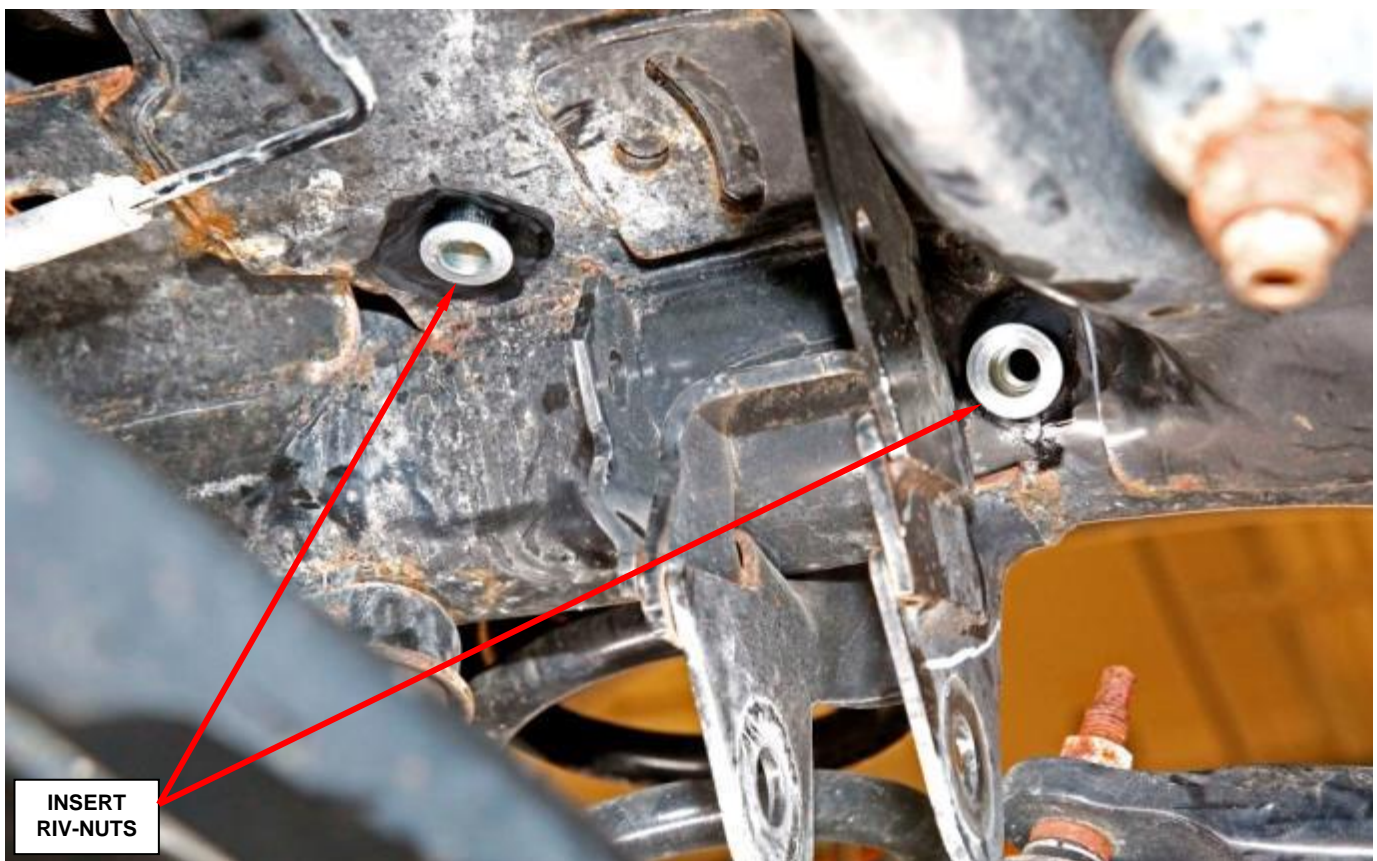
**Figure 11 – Install Two Riv-Nuts**

8. Using the supplied drill bit, drill a 1/8" diameter pilot hole at the two center punch marks made in Step 6 of this procedure.
9. Using the supplied drill bit, enlarge the two pilot holes drilled in Step 8 of this procedure to 3/16" diameter.
10. Using the supplied drill bit, enlarge the two holes drilled in Step 9 of this procedure to 7/16" diameter.
11. Using the supplied drill bit, enlarge the two holes in the frame to 17/32" diameter.
12. Remove all burrs from the two holes drilled in the frame.
13. Apply one coat each of primer and top coat paint to the two hole openings drilled.
14. Using a small hammer, tap a riv-nut into each of the 17/32" diameter holes.

**CAUTION: Make sure the riv-nut shoulder is flush against the frame surface.**

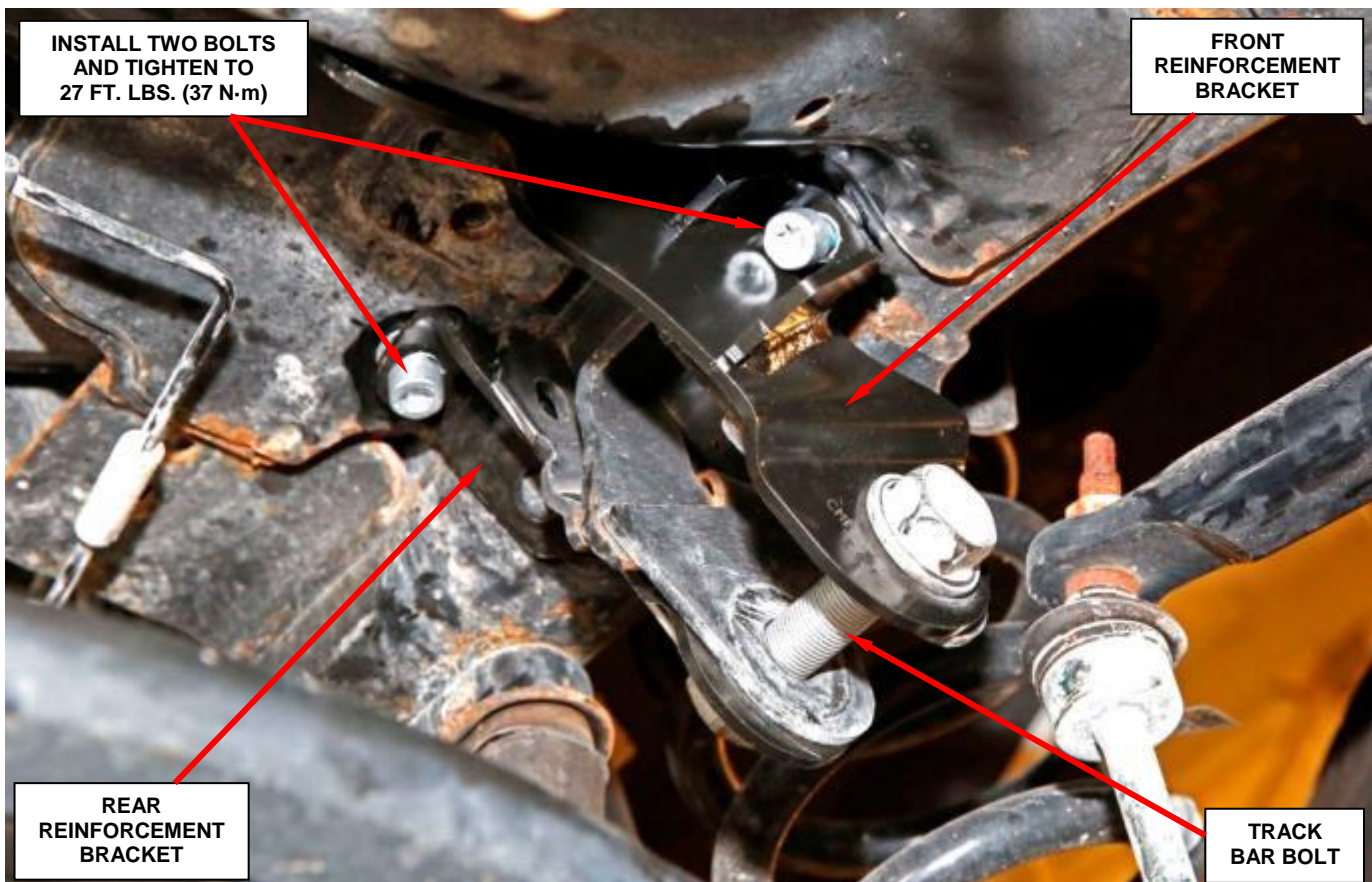
**Figure 12 – Temporarily Install Reinforcement Brackets**

15. Install the reinforcement brackets into the position. Install the original track bar bolt finger tight.
16. Install the two bolts into the riv-nut holes finger tight.
17. Push the reinforcement brackets into place and snug the original track bar bolt.
18. Tighten the two riv-nut bolts to 27 ft. lbs. (37 N·m) to crimp the riv-nuts.

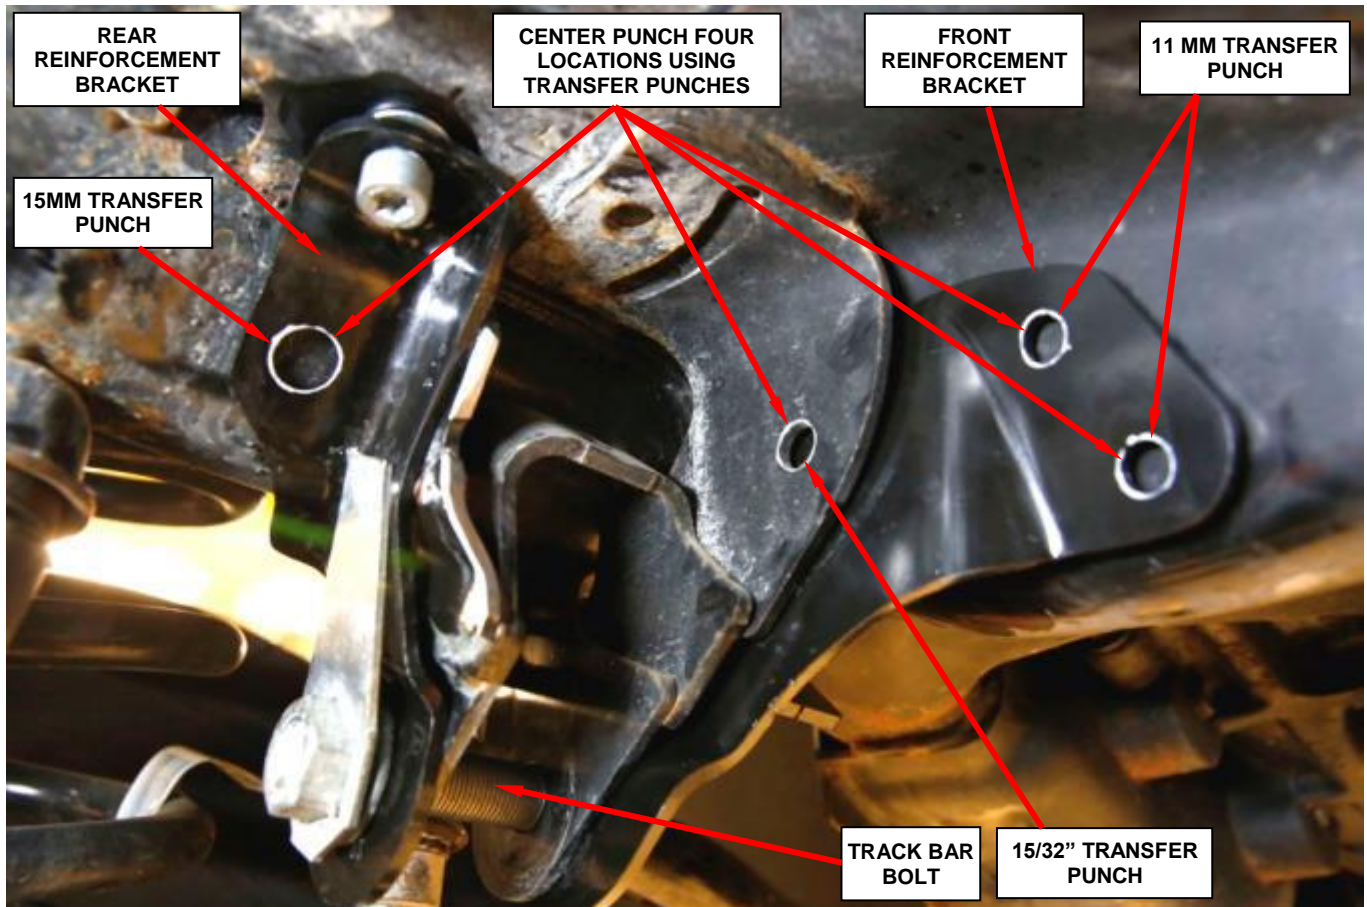
**Figure 13 – Center Punch the Remaining Four Holes with Transfer Punch**

19. Using the proper size transfer punch, center punch the remaining four holes (three on the frame and one on the reinforcement bracket).

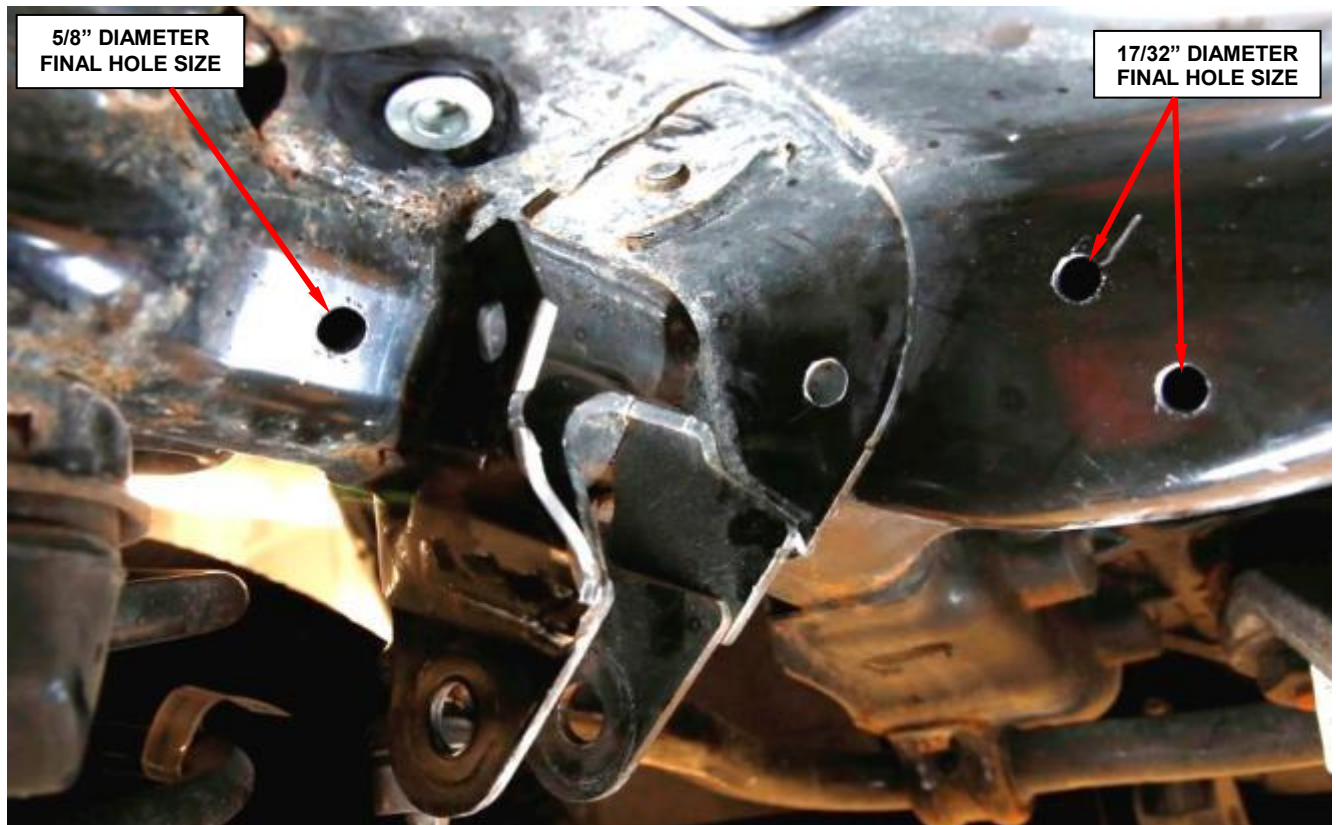
**Figure 14 – Drill Three Holes in Frame at Center Punch Marks**

21. Using the supplied drill bit, drill a 1/8" diameter pilot hole at all center punch marks made in Step 18 of this procedure (three holes on the frame and one on the front reinforcement bracket) (Figure 14 and 15).

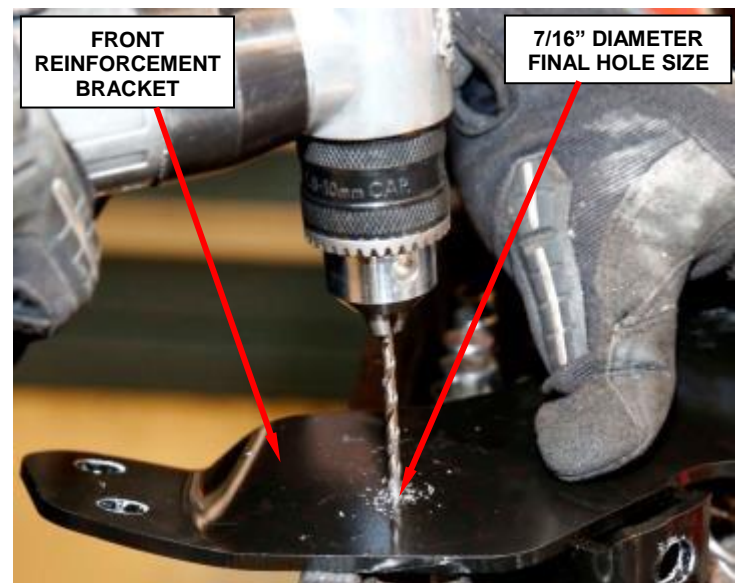
**Figure 15 – Drill One Hole In Front Reinforcement Bracket to 7/16"**

22. Using the supplied drill bit, enlarge all holes drilled in Step 21 of this procedure to 3/16" diameter (three holes on the frame and one on the front reinforcement bracket).

23. Using the supplied drill bit, enlarge all holes drilled in Step 22 of this procedure to 7/16" diameter (three holes on the frame and one on the front reinforcement bracket).

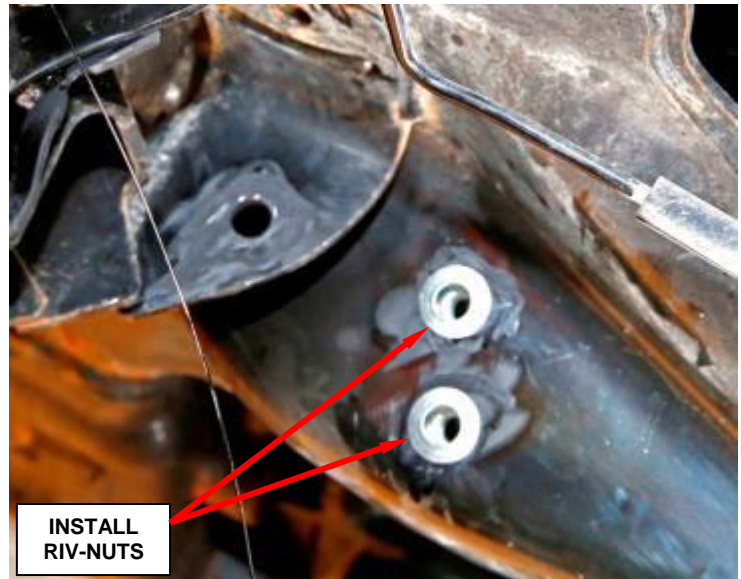
**Figure 16 – Install Riv-Nuts into  $17/32$ " Holes**

27. Apply one coat each of primer and top coat paint to all hole openings drilled and any bare metal edges.
28. Using a small hammer, tap a riv-nut into each of the  $17/32$ " holes (Figure 16).

**CAUTION:** Make sure the riv-nut shoulder is flush against the frame surface.

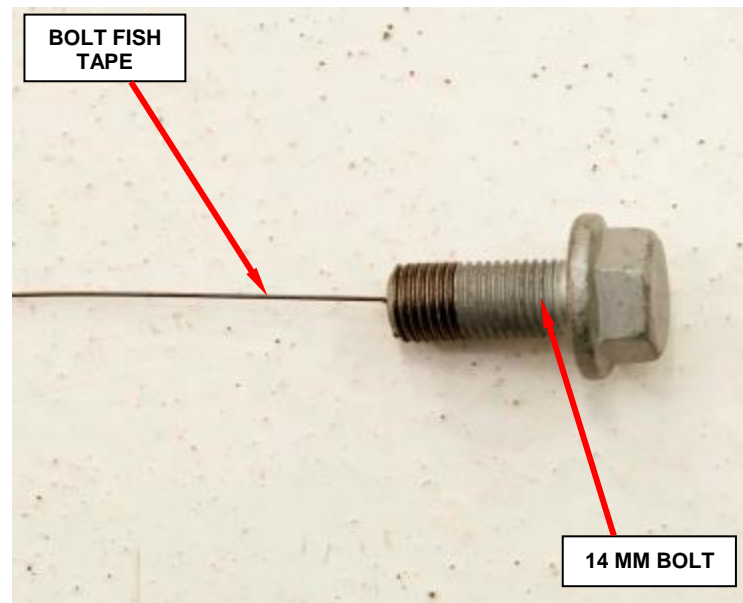
**Figure 17 – "Bolt Fish Tape" Tool**

30. Screw the 14 mm bolt into the "bolt fish tape" tool supplied with the kit (Figure 17).

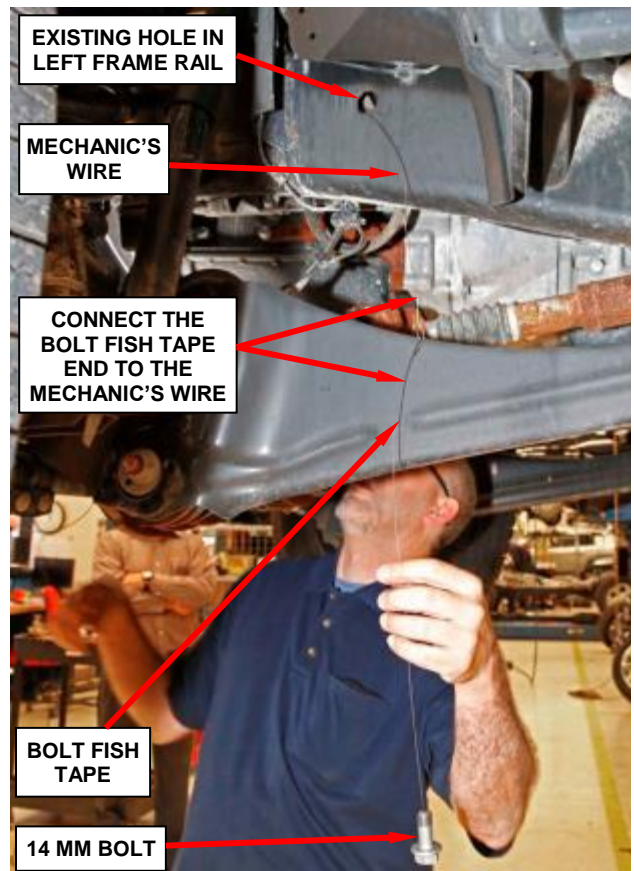
Figure 18 – Install 14 MM Bolt

31. Using a piece of mechanic’s wire and starting at the 5/8” diameter frame hole, insert the mechanic’s wire and feed it through the frame until it comes out the existing hole in the outside face of the left frame rail (Figure 18).

32. Connect the mechanic’s wire end to the “bolt fish tape” end at the outside face of the left frame rail (Figure 18).

33. Carefully pull the mechanic’s wire out of the 5/8” hole until the “bolt fish tape” is pulled through the 5/8” frame hole.

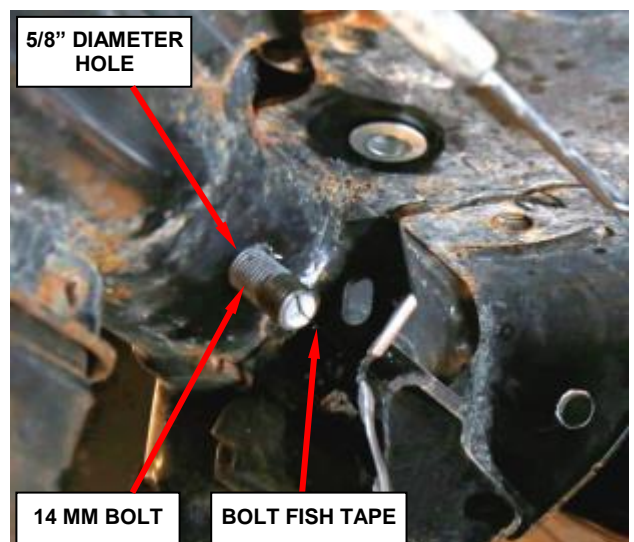
Figure 19 – 14 MM Bolt in 5/8” Diameter Hole Location

35. Carefully pull the “bolt fish tape” until the 14 mm bolt is seated in the 5/8” frame hole (Figure 19).

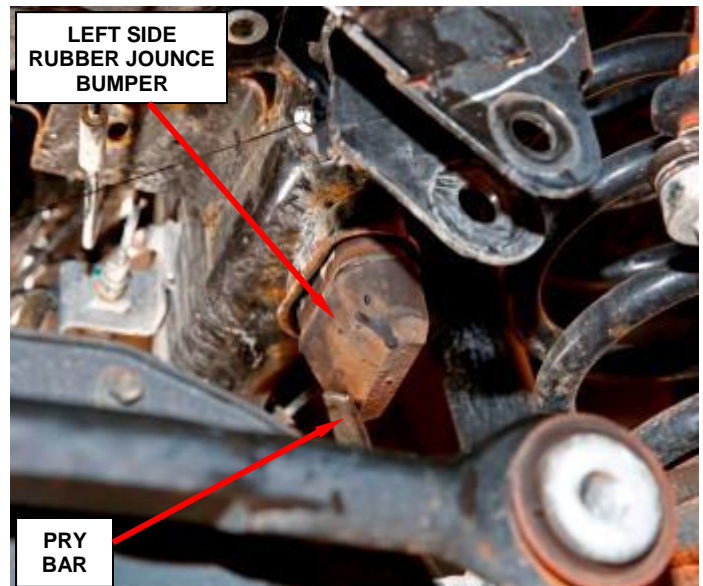
**Figure 20 – Remove Left Rubber Jounce Bumper**

36. Remove and save the left side rubber jounce bumper (Figure 20).
37. Thread the fish tape through the corresponding hole in the rear reinforcement bracket and place the bracket into position.
38. Install the one M10 bolt for the rear reinforcement bracket finger tight (snug) (Figure 21).
39. Apply three drops of threadlocker to the 14 mm nut.
40. Carefully remove the “bolt fish tape” tool from the 14 mm bolt and install the 14 mm nut finger tight (snug). (Figure 21)

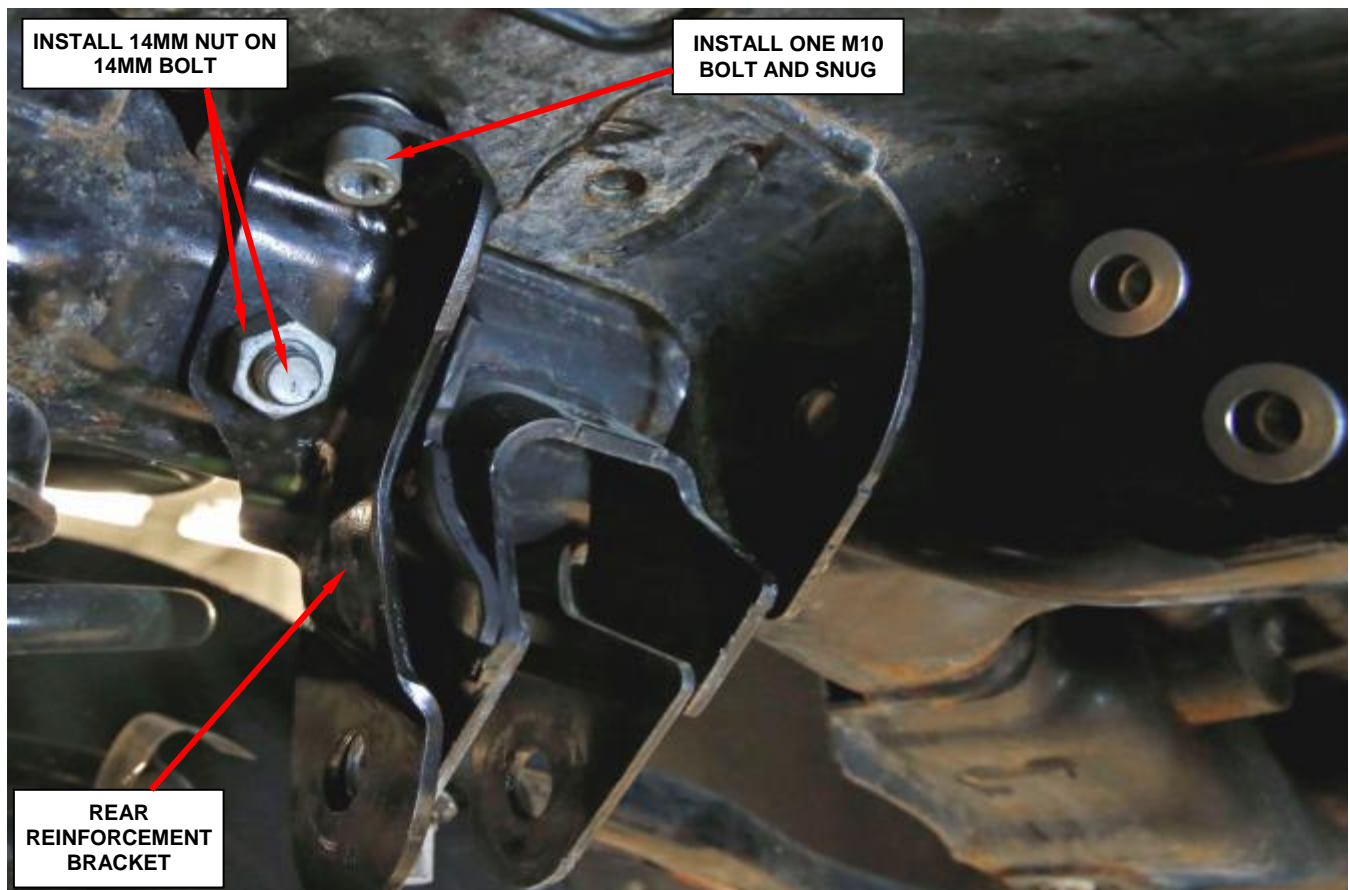
**Figure 21 – Install One M10 Bolt and 14 mm Nut for Rear Reinforcement Bracket**
