Dealer Service Instructions for:

## **Safety Recall R46 / NHTSA 15V-541**

### **Front Suspension Track Bar Frame Bracket**

- 2013 – 2014 (D2) RAM Truck (3500 series)
- 2014 (DD) RAM Cab Chassis (3500 series)
- (DJ) RAM Truck (2500 series)

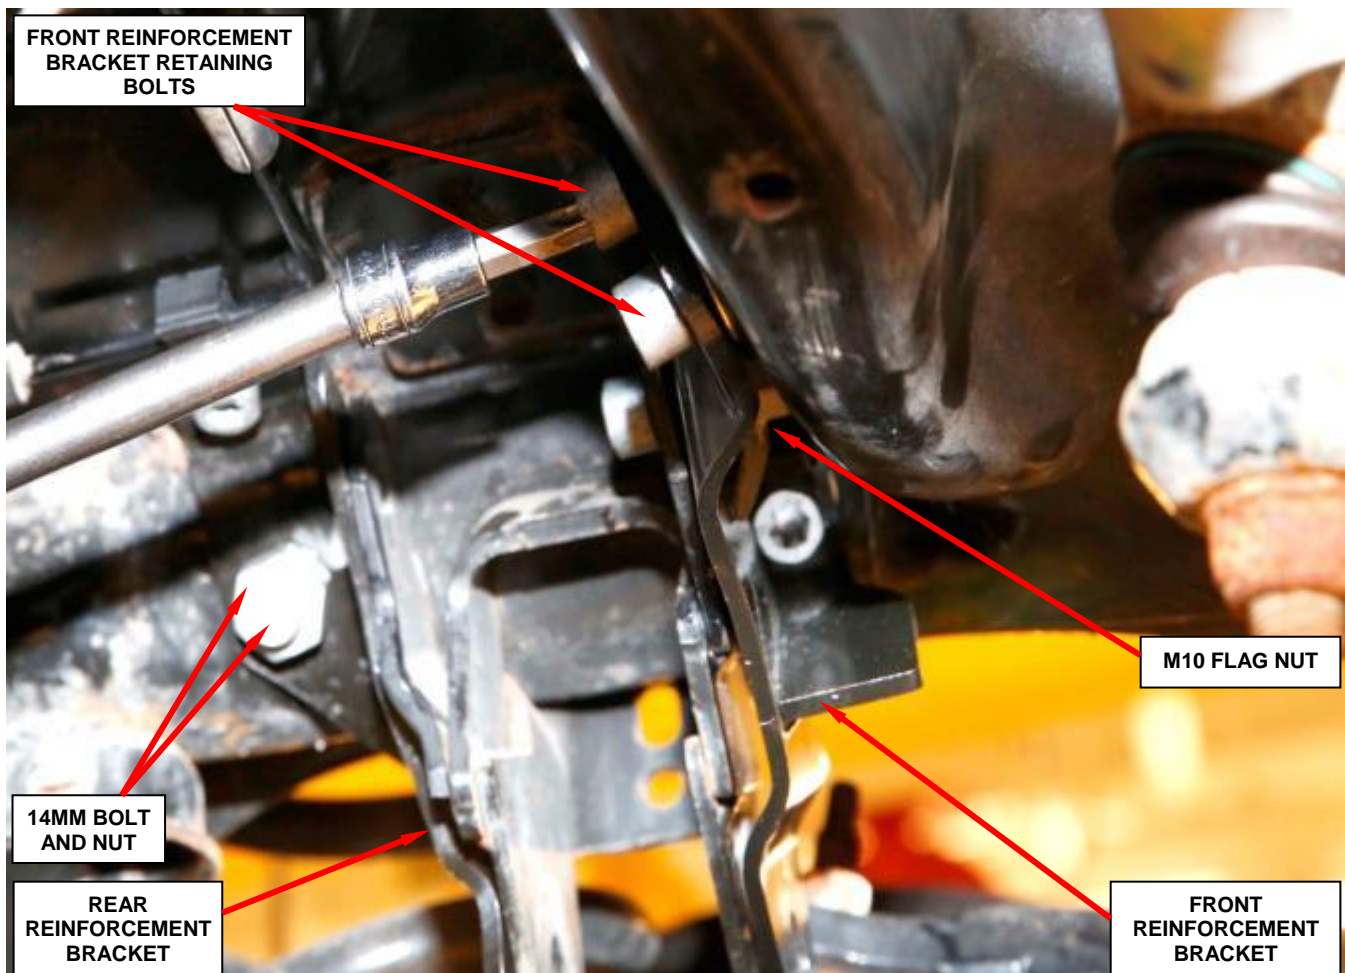
**Figure 22 – Tighten Two Retaining bolts to 27 ft. lbs. (37 N·m) to Crimp Riv-Nuts and then Loosen Both Bolts**

41. Place the front reinforcement bracket into position and install all bolts finger tight (snug) (Figure 22).
42. Crimp the two riv-nuts on the frame by pushing on the bolt while tightening the bolt to 27 ft. lbs. (37 N·m). Loosen the two bolts after the riv-nuts have been crimped (Figure 22).

**NOTE:** If the riv-nut spins in the hole and cannot be crimped, refer to **Section C. Crimping Riv-Nut** for an alternate method to crimp the riv-nut. **Loosen the two bolts after the riv-nuts have been crimped (Figure 22).**

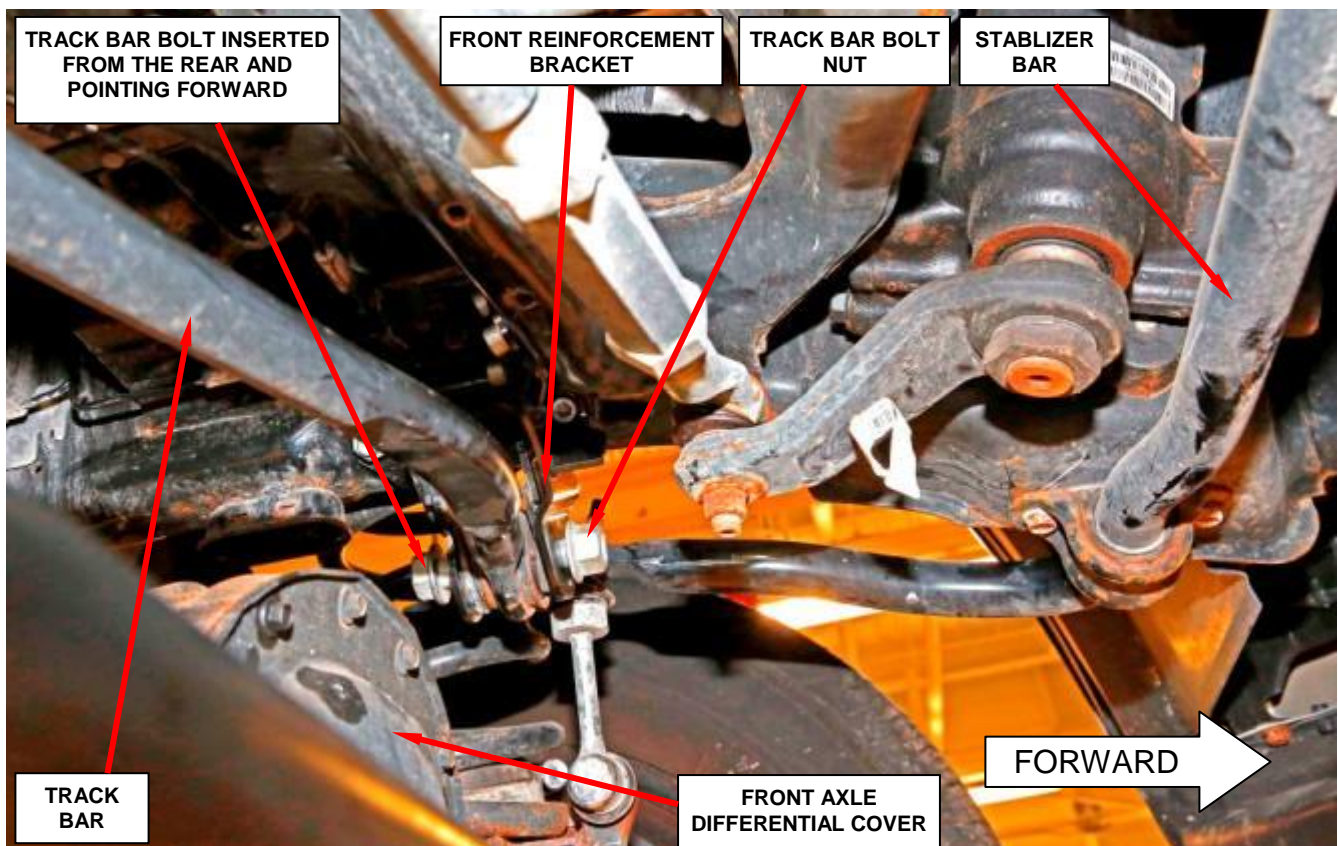
**Figure 23 – Install Track Bar Bolt in Orientation Shown**

43. Place the track bar into position and install the track bar bolt. The bolt must enter from the rear of the vehicle and point forward, with the track bar bolt nut on the front side (Figure 23).

**CAUTION:** If the track bar bolt is installed facing rearward, the suspension will hit the track bar bolt during suspension travel. Install the bolt through the rear reinforcement bracket first, with the nut going against the front reinforcement bracket (Figure 23).

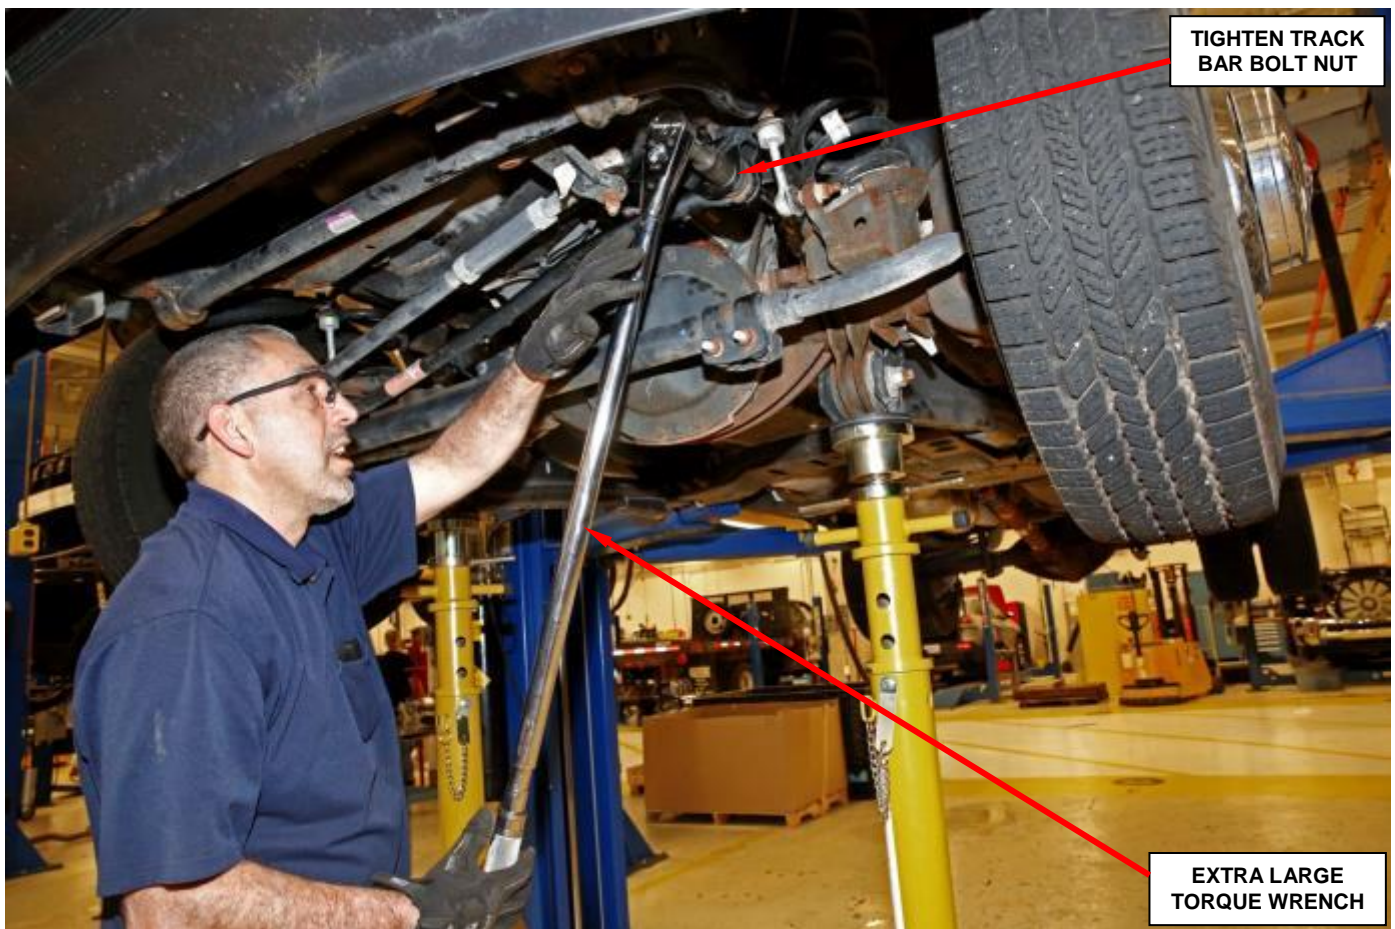
**Figure 24 – Tighten Track Bar Bolt to 285 ft. lbs. (387 N·m)**

44. **With full vehicle weight on the suspension,** tighten the track bar bolt to 285 ft. lbs. (387 N·m).

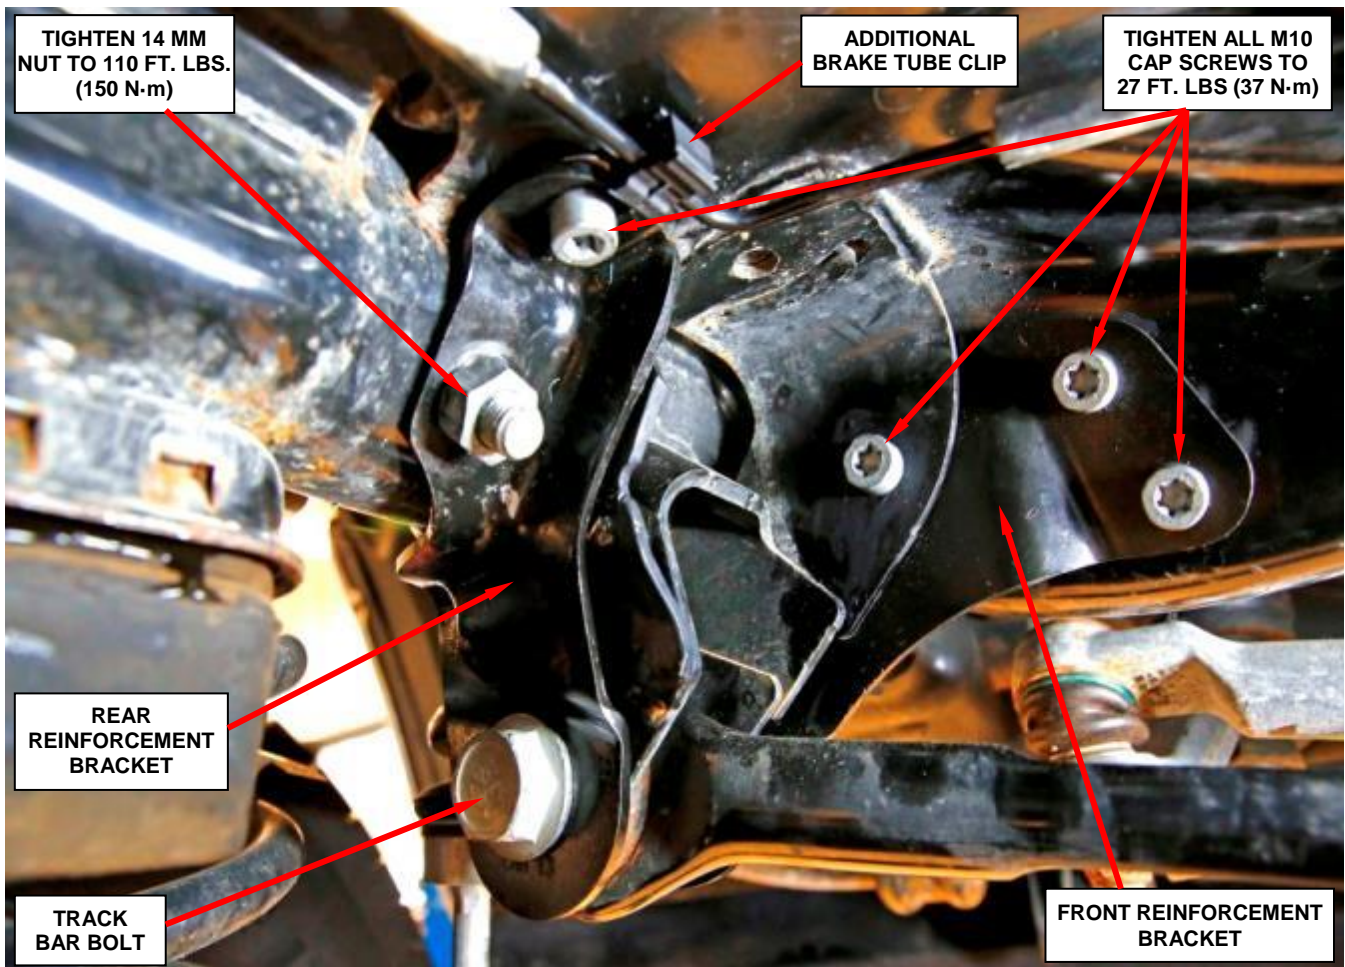
**Figure 25 – Correctly Installed Reinforcement Brackets**

45. Tighten the 14 mm nut on the rear reinforcement bracket to 110 ft. lbs. (150 N·m) (Figure 25).

46. Tighten all of the remaining reinforcement bracket M10 cap screws to 27 ft. lbs. (37 N·m) (Figure 25).

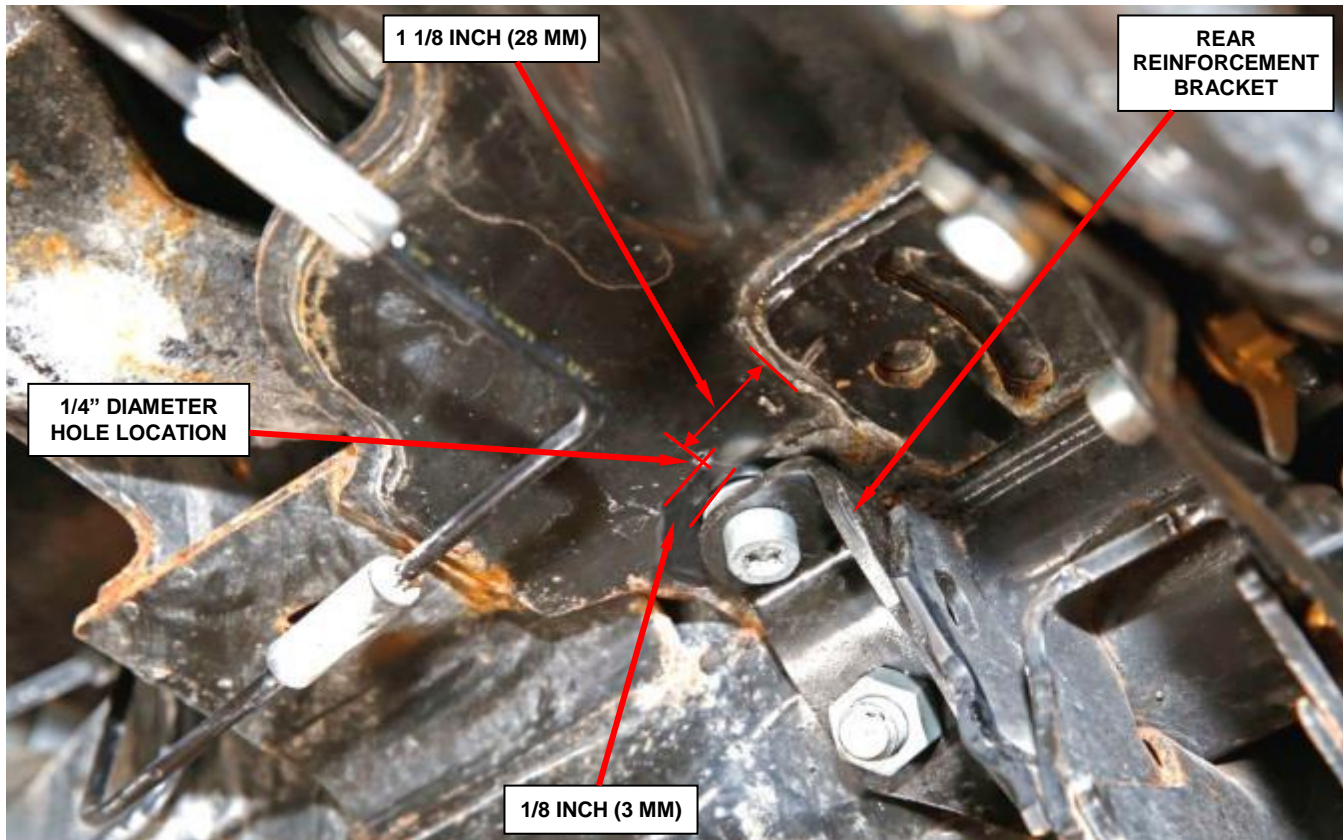
**Figure 26 – 1/4 Inch Diameter Hole Location for Brake Tube Clip**

47. Use the following procedure to install an additional brake tube routing clip:
  - a. Measure and center punch the location shown in Figure 26.
  - b. Drill a 1/8" diameter pilot hole at the center punch mark.
  - c. Enlarge the 1/8" diameter hole to 1/4" diameter.
  - d. Remove any burs from the 1/4" diameter hole.
  - e. Apply one coat each of primer and top coat paint to the edge of the 1/4" diameter hole.
  - f. Insert the brake tube routing clip barbed peg into the 1/4" diameter hole.
  - g. Snap brake tube into the new brake tube routing clip.
  - h. Snap the brake tube into the other two original brake tube routing clips.
  - i. Adjust the brake tube as required to ensure that the brake tube is routed away from other components.

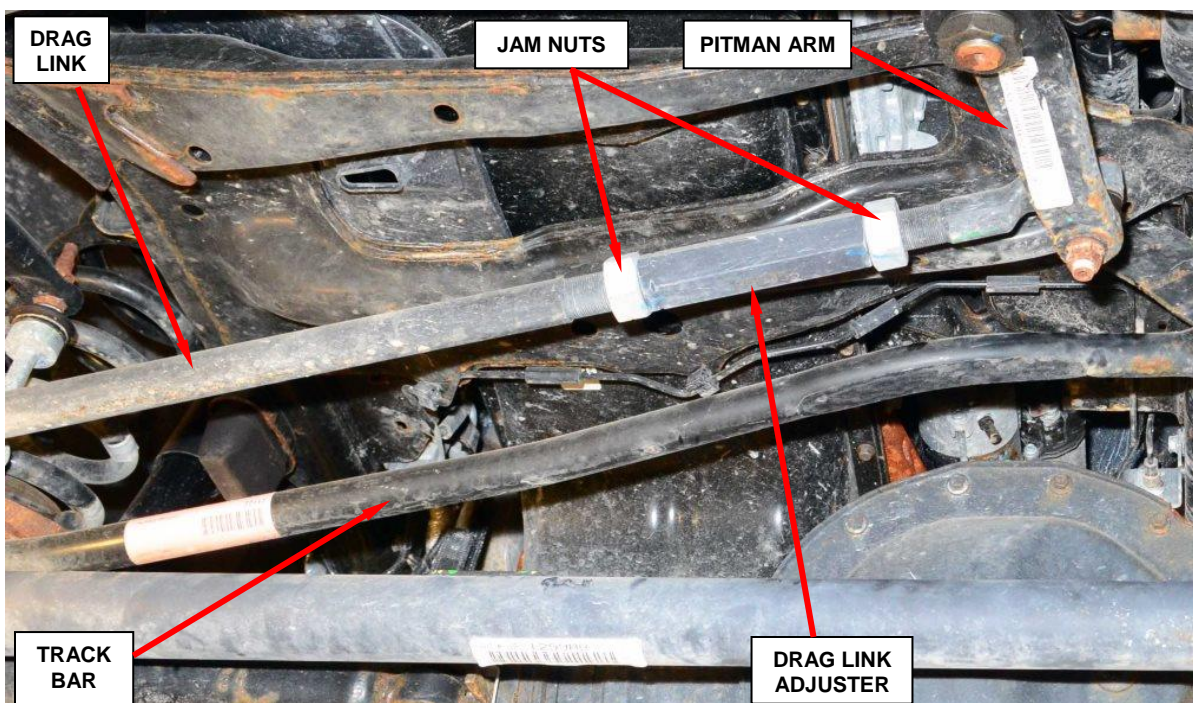
Figure 27 – Drag Link Adjuster and Jam Nuts

48. Coat the jounce bumper frame cup and rubber jounce bumper with Mopar zipper lube or equivalent.
49. Install the left rubber jounce bumper into the receiver cup on the left frame rail.
50. Install the axle vent hose to the axle vent hose fitting.
51. Lower the vehicle from the hoist
52. Road test the vehicle and verify that the steering wheel is centered:
  - If the steering wheel is centered, no further action is required. Return the vehicle to the customer.
  - If the steering wheel is off center, continue with Step 53 of this procedure.
53. Setup the vehicle on an appropriate alignment rack.
54. Loosen the drag link adjuster jam nuts on the drag link and adjust the drag link length as required (Figure 27).
55. Tighten the drag link jam nuts to 109 ft. lbs. (148 N·m).
56. Return the vehicle to the customer.

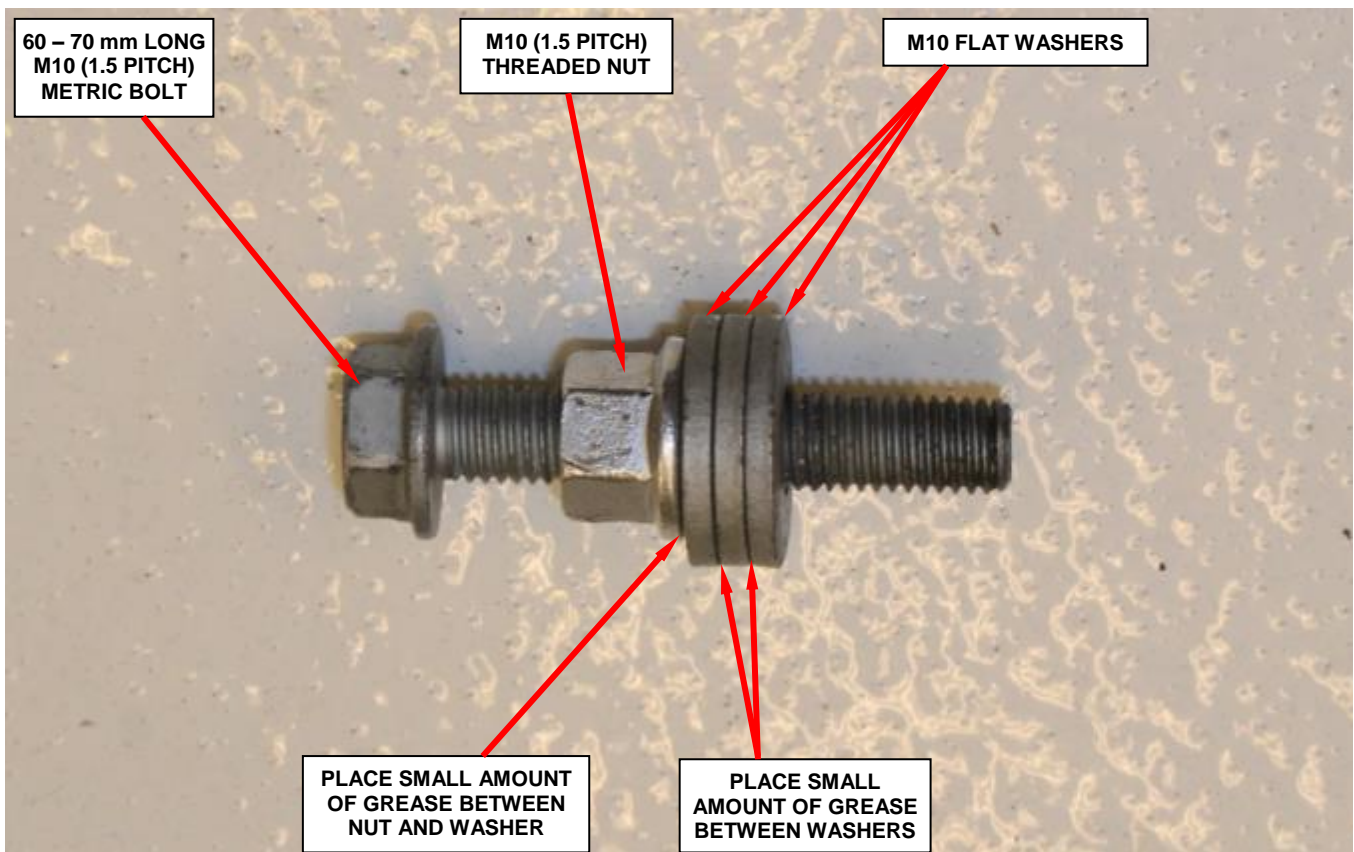
**Figure 28 – Assembly Riv-Nut Crimp Tool**

1. Obtain the following components to create a riv-nut crimping tool (Figure 28):
  - a. One 60 – 70 mm long M10 bolt with 1.5 pitch threads.
  - b. One M10 x 1.5 pitch threaded nut.
  - c. Three M10 flat washers.
2. Assembly the tool as shown in Figure 28.

**NOTE:** Apply a small amount of grease between the flat washers and on the surface of the nut that contacts the flat washer (Figure 28).

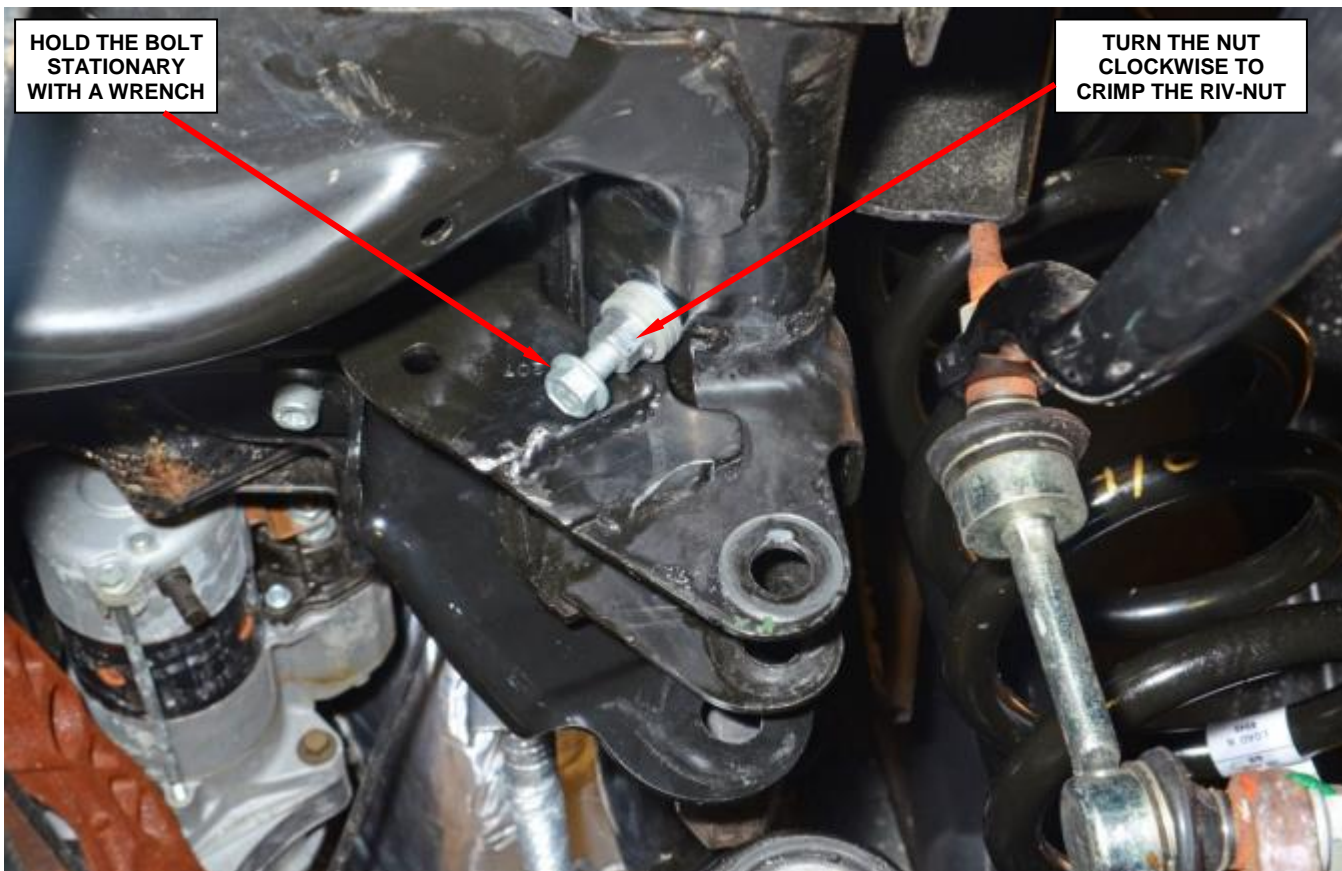
Figure 29 – Riv-Nut Crimp Tool Use (typical)

3. Screw a riv-nut onto the end of the tool so that a minimum of two threads are protruding past the end of the riv-nut.
4. Insert the Riv-nut installed on the tool into the hole (Figure 28).
5. Using two wrenches, hold the bolt stationary with one wrench and tighten the nut with the other wrench until the riv-nut is crimped into position (Figure 29).
6. Loosen the nut and unscrew the bolt to remove the tool.
7. Resume the installation of the reinforcement brackets.

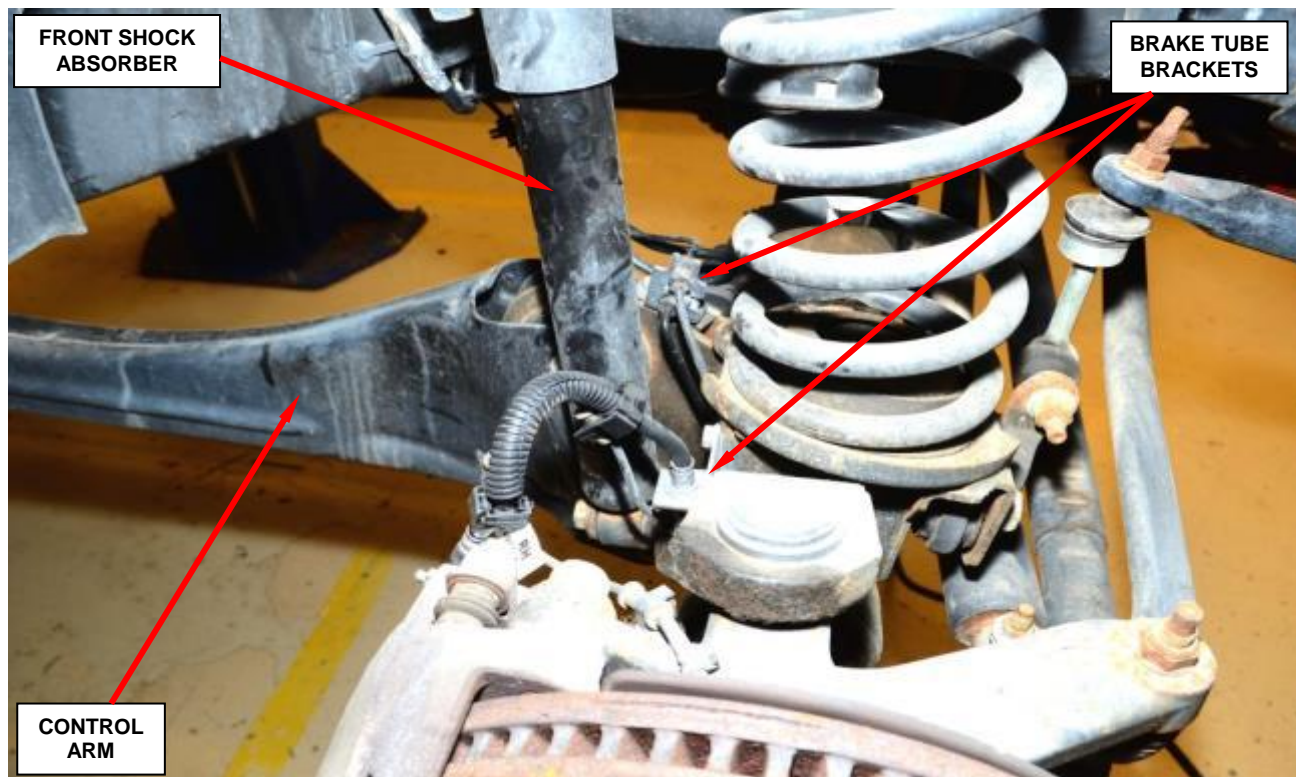
**Figure 30 – Brake Tube Brackets**

1. Position the truck on an appropriate hoist.
2. Place the vehicle in neutral.
3. Disconnect and isolate the negative battery cable(s) from the battery post(s).
4. Remove and save the front wheel/tire assemblies.
5. Remove and save the brake tube bracket bolt from the right and left control arm brackets (Figure 30).
6. Remove and save the brake tube bracket bolt from the right and left coil spring lower bracket (Figure 30).

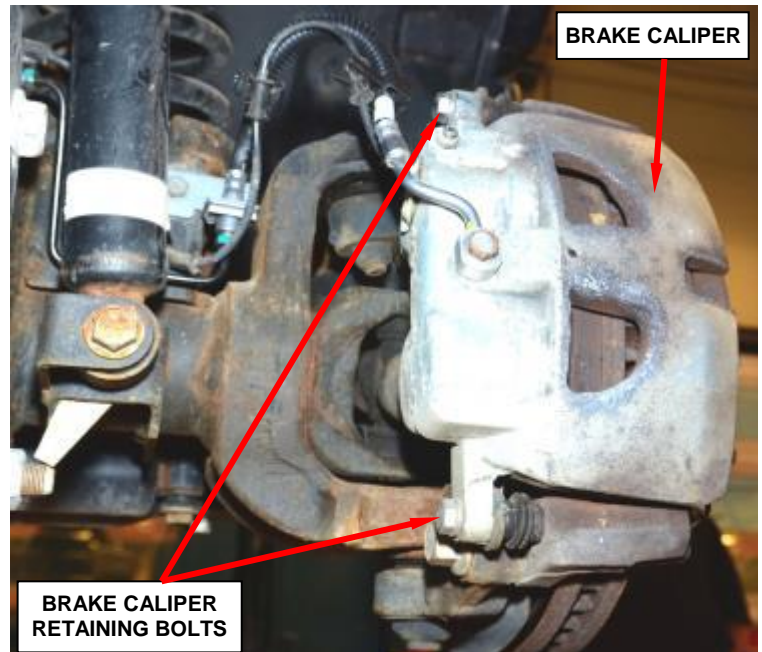
Figure 31 – Brake Caliper Retaining Bolts

7. Remove the front brake caliper retaining bolts and support the calipers using a bungee cords or equivalent (Figure 31).

**CAUTION:** Do not allow the brake caliper to hang from brake caliper flex hoses.

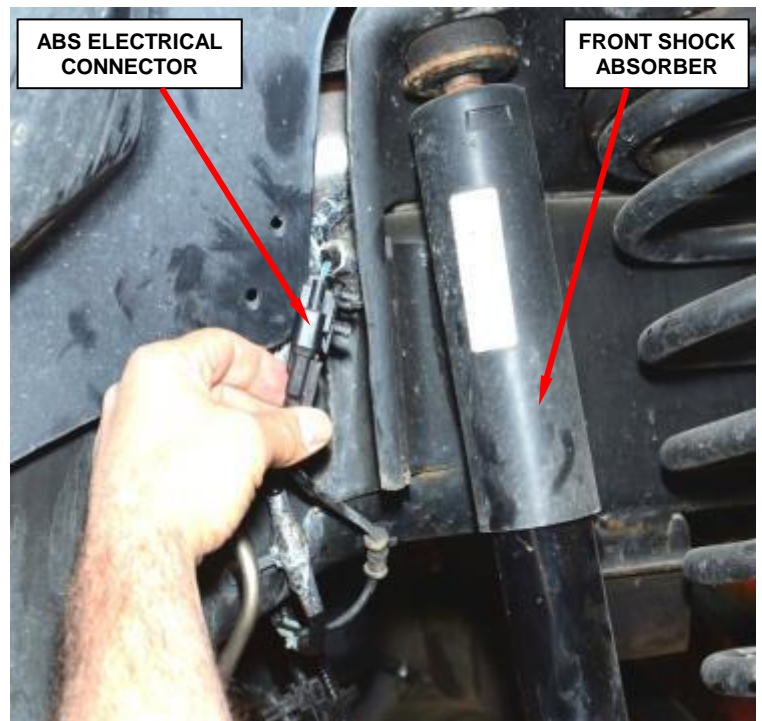
Figure 32 – ABS Wheel Speed Sensor Electrical Connector

8. Disconnect the Anti-Lock Brake System (ABS) wheel speed sensor electrical connector and unclip the ABS wire from brake hose (Figure 32).

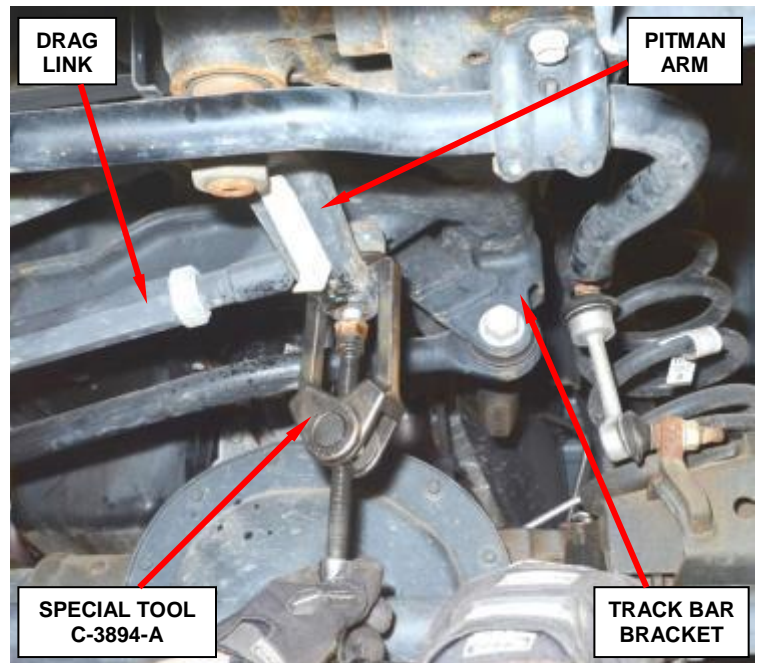
Figure 33 – Disconnect Drag Link from Pitman Arm

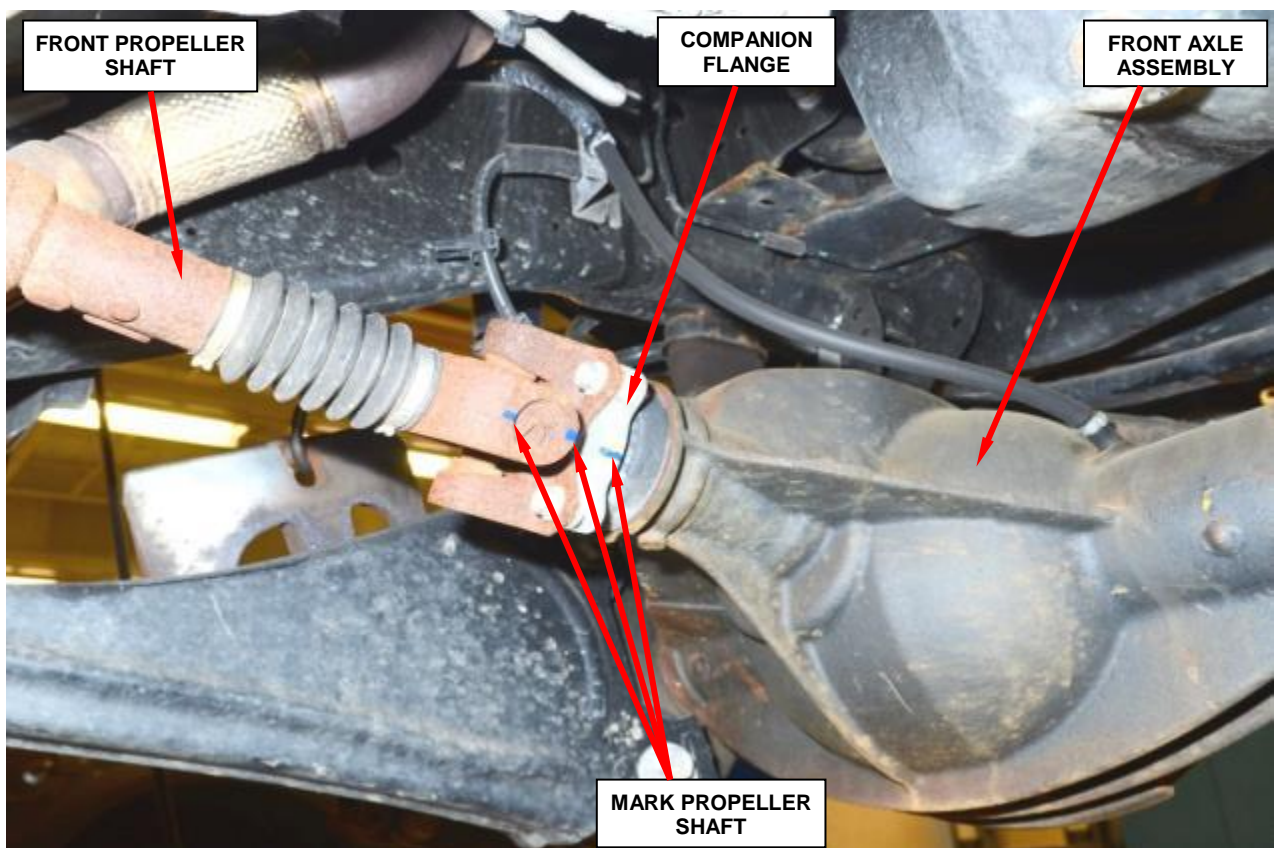
Figure 34 – Mark Front Propeller Shaft

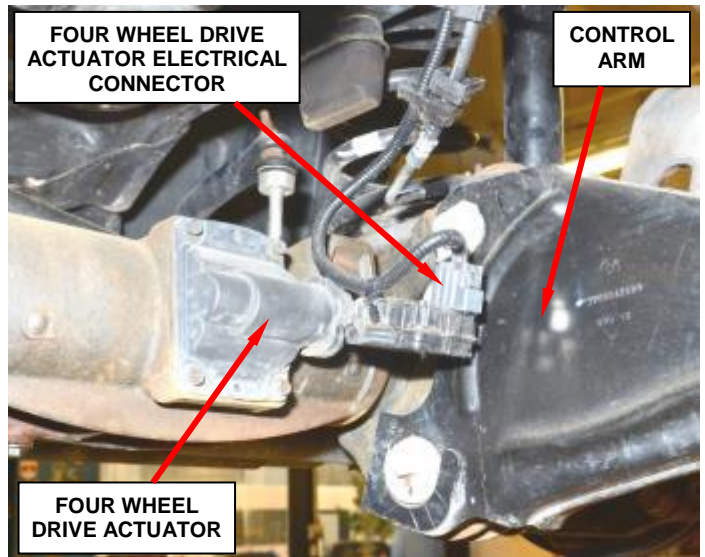
Figure 35 – Actuator Electrical Connector

10. **For vehicles with four wheel drive**, connect the four wheel drive actuator electrical connector (Figure 35).

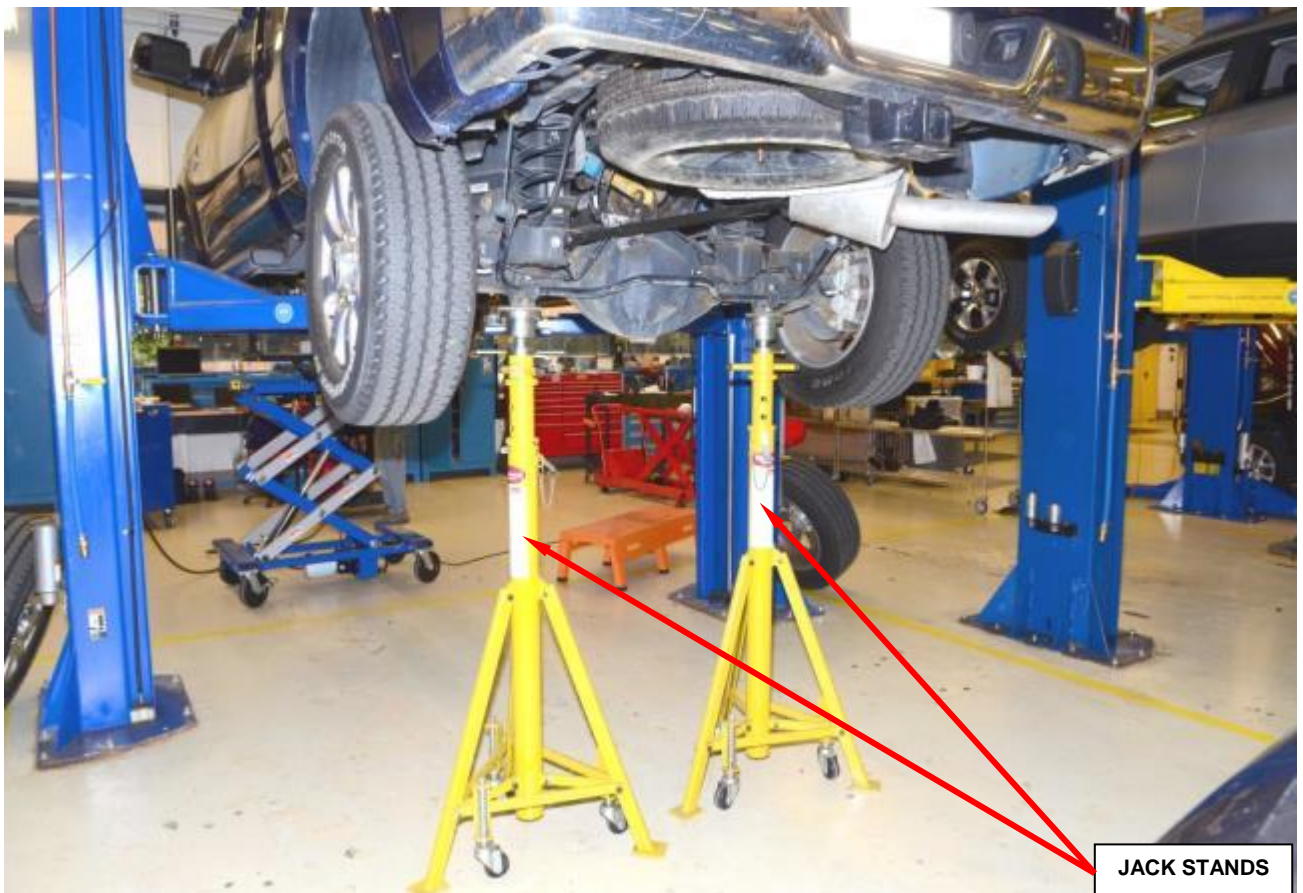
Figure 36 – Secure Vehicle on Hoist with Jack Stands

**WARNING:** Failure to place jack stands at the rear of the vehicle could allow the vehicle to flip off the hoist when the weight of the front axle is removed.

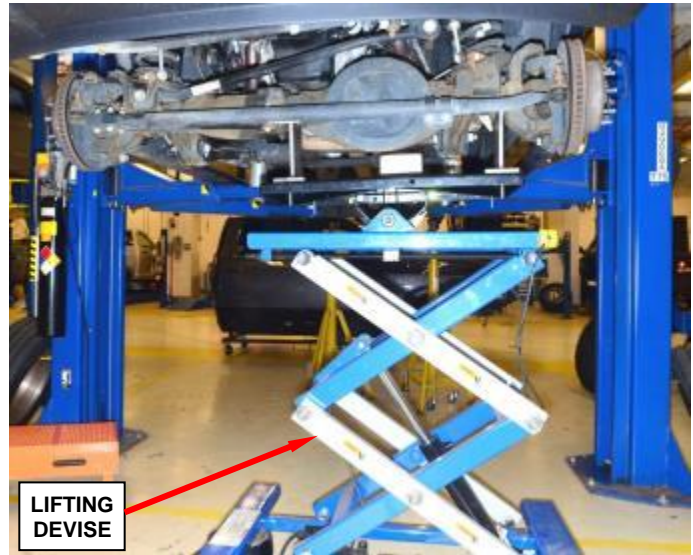
**Figure 37 – Secure Axle to Lifting Device**

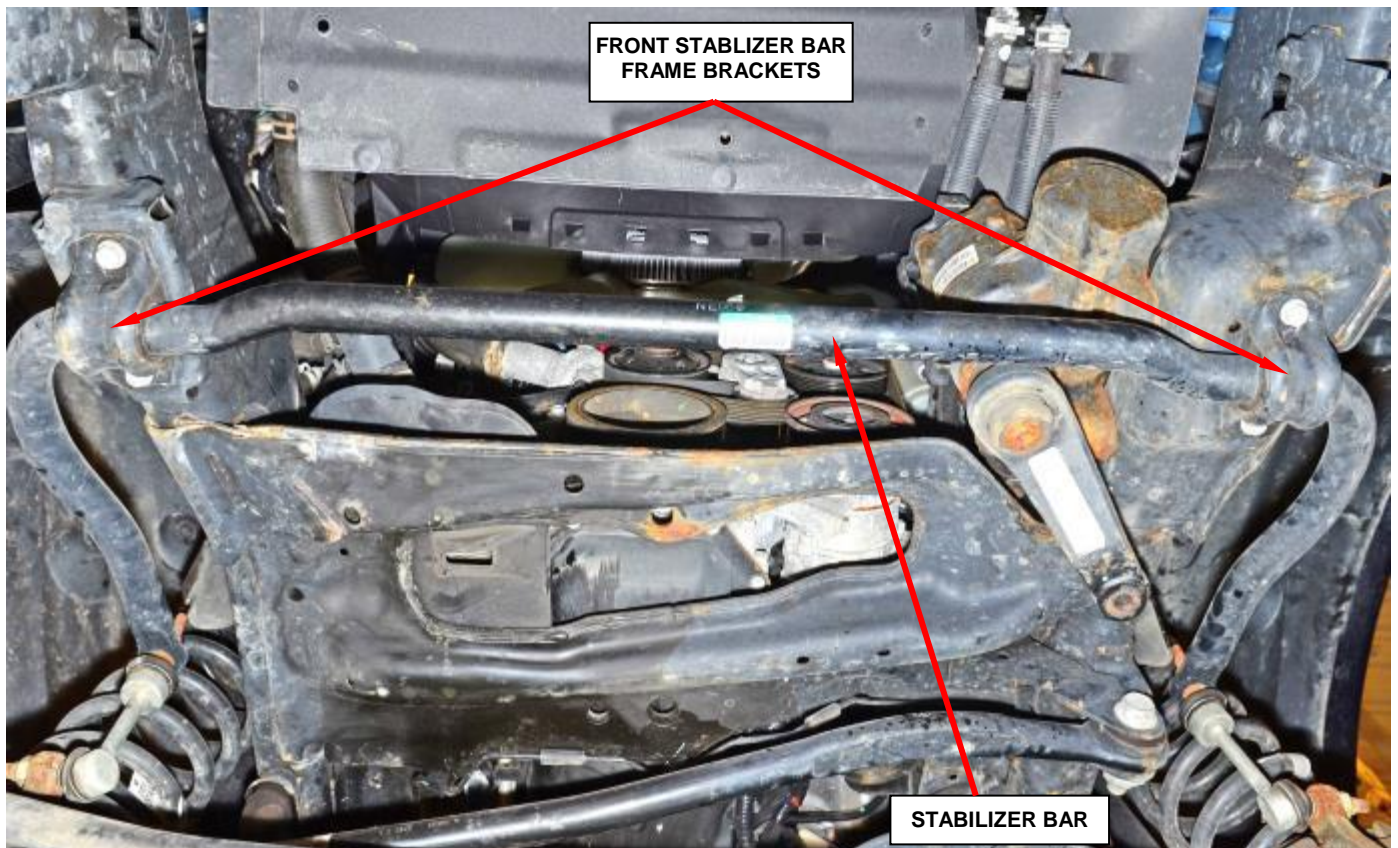
**Figure 38 – Front Stabilizer Bar**

17. Disconnect the front suspension stabilizer bar at the frame brackets (Figure 38).

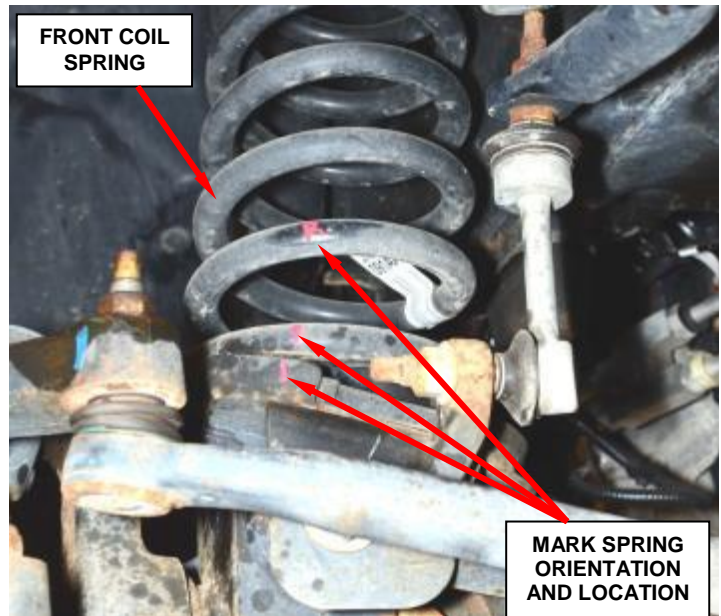
**Figure 39 – Mark Front Coil Spring Orientation and Location**

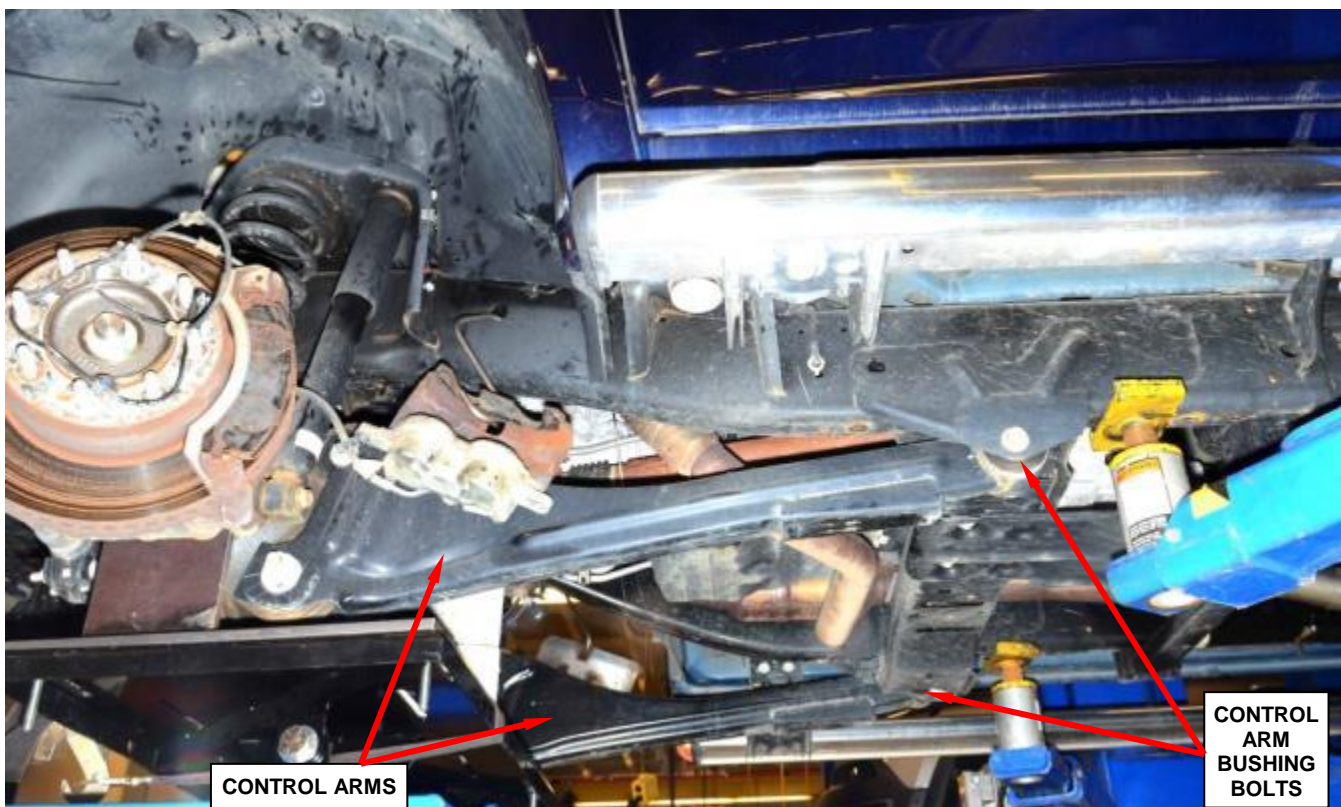
**Figure 40 – Control Arm Bushing Bolts**

20. Remove and save the control arm rear bushing bolts (Figure 40).

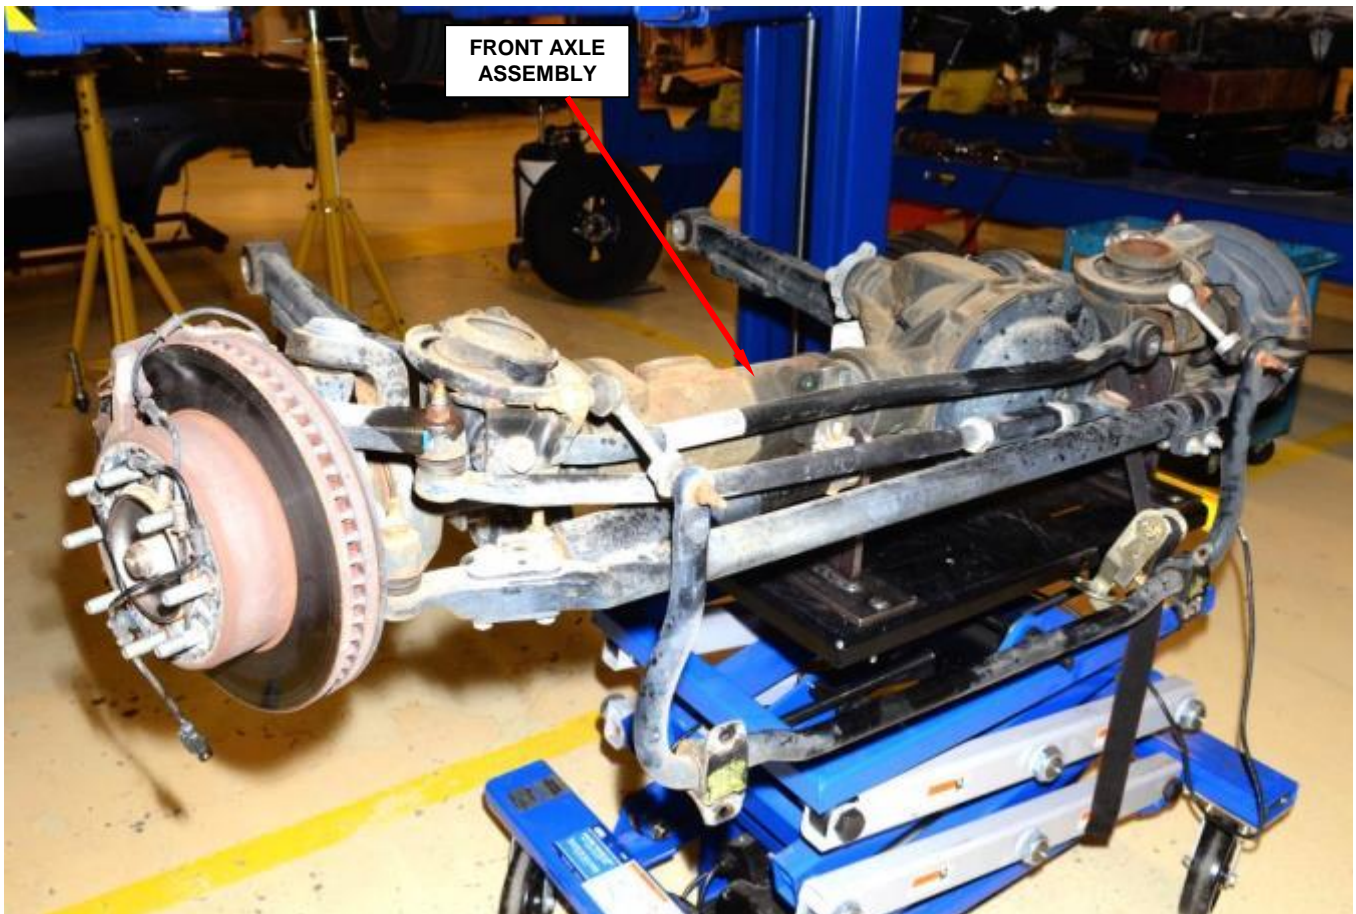
**Figure 41 – Lower Axle Assembly and Store in Safe Location**

21. With the help of an assistant, carefully lower the front axle assembly (Figure 41).
22. Move the front axle assembly to a safe location.
23. Clear the work area of any flammable liquids and/or debris.
24. Install welding curtains around the front of the vehicle.
25. After welding process is complete, continue with **Section E. Install Front Axle.**

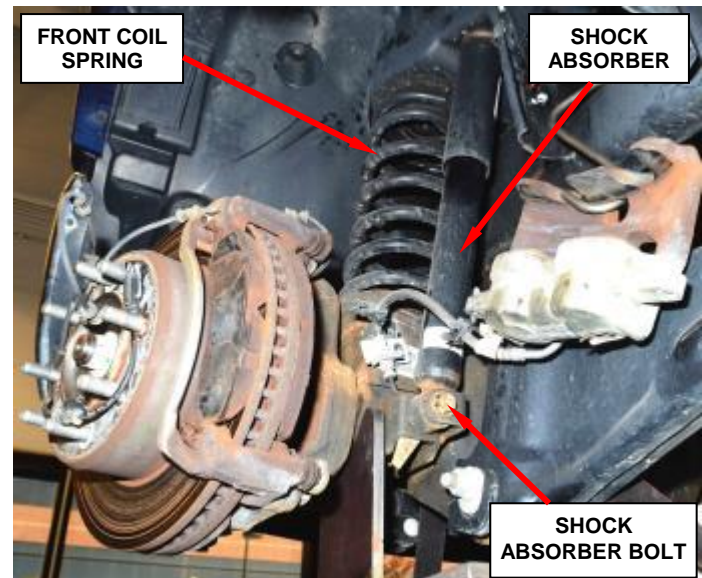
**Figure 42 – Shock Absorber Bolt**

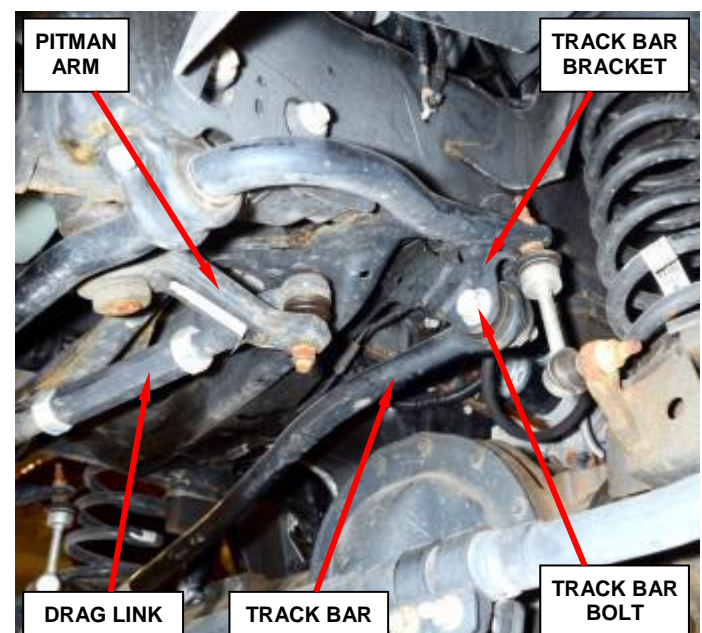
**Figure 43 – Pitman Arm Nut and Track Bar Bolt**
