# HYUNDAI

## Technical Service Bulletin

GROUP <b>RECALL</b>	NUMBER <b>17-01-046-1</b>
DATE <b>SEPTEMBER, 2017</b>	MODEL(S) <b>2011-2012MY SONATA (YF)</b>

**SUBJECT:** SONATA GDI ENGINE INSPECTION /  
REPLACEMENT (RECALL CAMPAIGN 132)

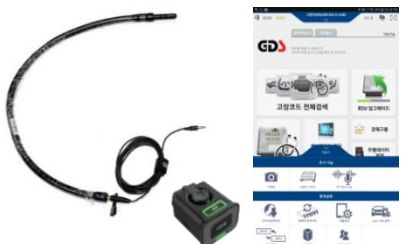
Description	Tool Part #	Image	Comment
Engine Noise Inspection Tool	G1XTD-CP001

For noise inspection
Torque Wrench Socket	09314-3Q100		Only needed if engine replacement required.
Injector Combustion Seal Ring Installer	09353-2B000		Refer to TSB 10-FL-019 for the detailed usage instructions

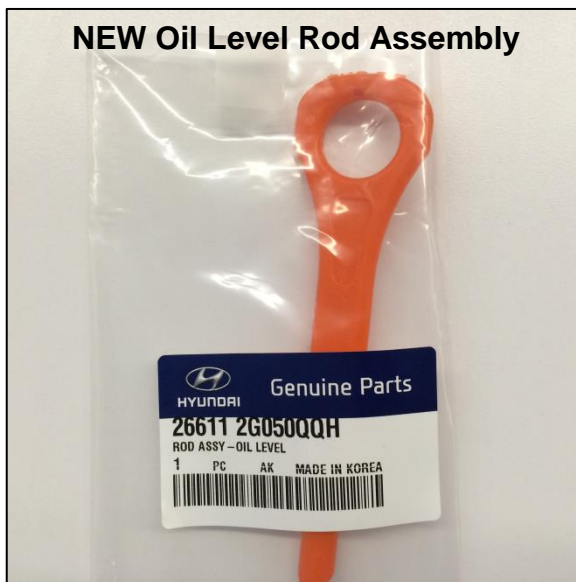
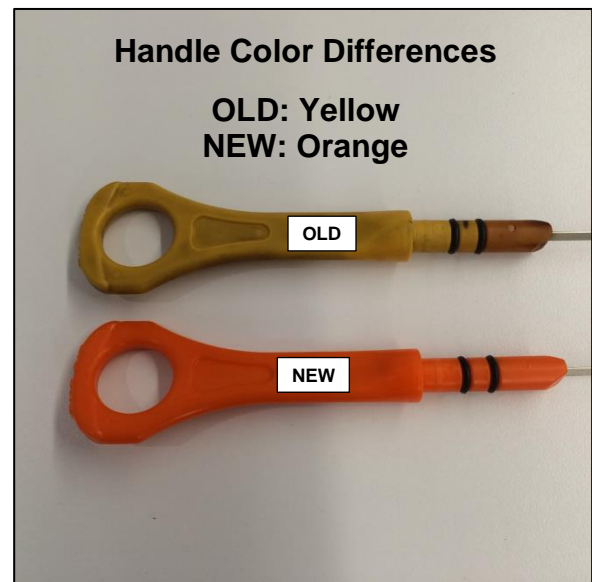
2. Replace the engine oil (4.8 quarts), oil filter, and drain plug gasket.
3. Replace the current Oil Level Rod Assembly with the new campaign part.
  - Remove and discard the existing Oil Level Rod Assembly (engine oil dipstick).
  - Install new ORANGE handle Oil Level Rod Assembly (P/N 26611-2G050QQH)

**Note: Replace the dipstick ONLY if the current dipstick's handle is yellow. Do not replace if it's red.**

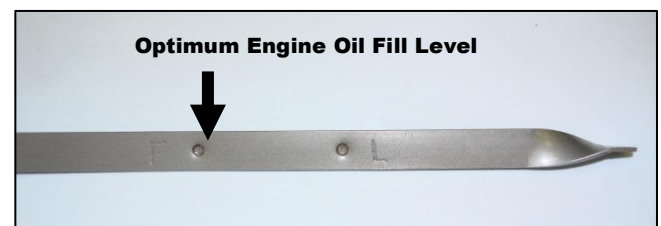
4. Start the engine and allow it to run for 10 seconds. Then adjust the engine oil level to near the "F" mark as shown in the picture.
  - Use Quaker State 5W-30 viscosity engine oil or other brand if not available (conventional type allowed with API SM / ILSAC GF-4 or higher service grade).
  - Do not overfill.

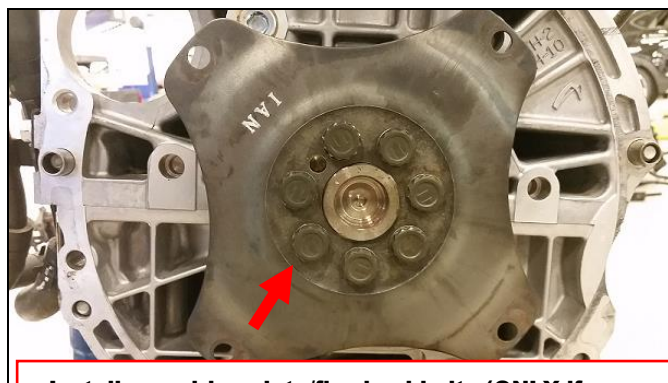
6. **For replacement engines packaged with new drive plate/flywheel bolts only**

If the QQH replacement engine was packaged with new bolts, install the drive plate/flywheel on the QQH replacement engine using the new bolts (QTY 7).

**Tightening torque : 111.7 ~ 127.5 Nm (86.8 ~ 94.1 lb-ft)**

If the QQH replacement engine was not packaged with new bolts, reuse the old bolts when installing the drive plate/flywheel. Do not order new bolts.

**Install new drive plate/flywheel bolts (ONLY if new bolts are included with the replacement engine)**

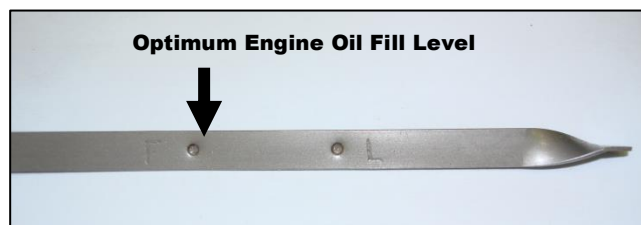
13. Start the engine to warm it up and begin the cooling system air bleeding process.
- During this time, check for any leaks.
  - After the engine has warmed up to normal operating temperature, turn the engine off, wait a few minutes, and then adjust the engine oil level to near the "F" mark as shown in the picture.
