Dealer Service Instructions for:

Safety Recall R54 / NHTSA 15V-590 Passenger Airbag Module

2015 (BF) FIAT 500L

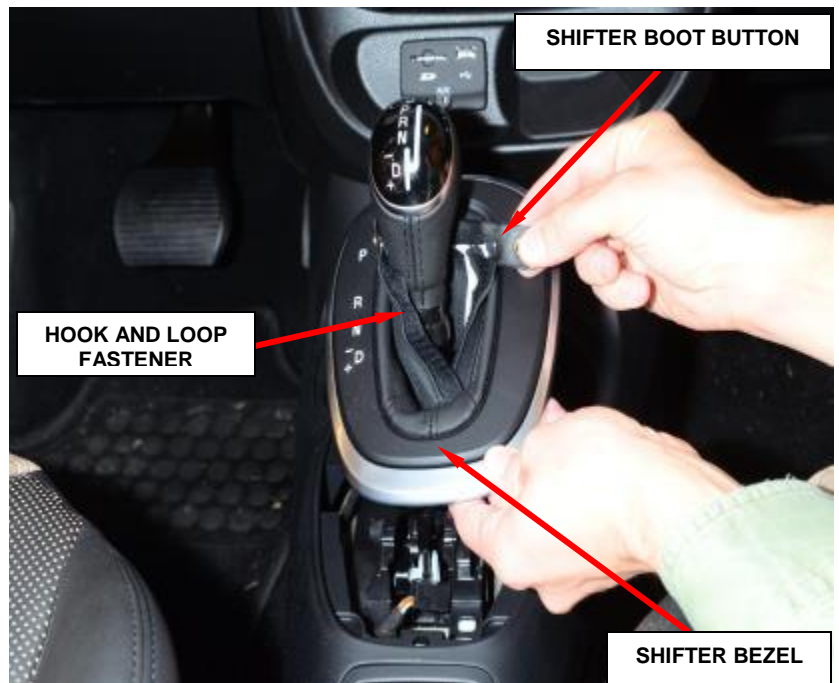
Figure 1 - Shifter Boot

2. Use the following steps to remove the floor console.
 - a. Unfasten the shifter boot button and release the hook and loop fastener (Figure 1).
 - b. Using a trim stick or equivalent, release the retainers securing the shifter bezel to the floor console (Figure 1).
 - c. **If equipped**, disconnect the shifter bezel electrical connector.
 - d. Remove and save the shifter bezel.
 - e. Position the parking brake handle in the full up position.
 - f. Grasp the park brake handle bezel in the center area and pull upward to release the retaining tabs (Figure 2).

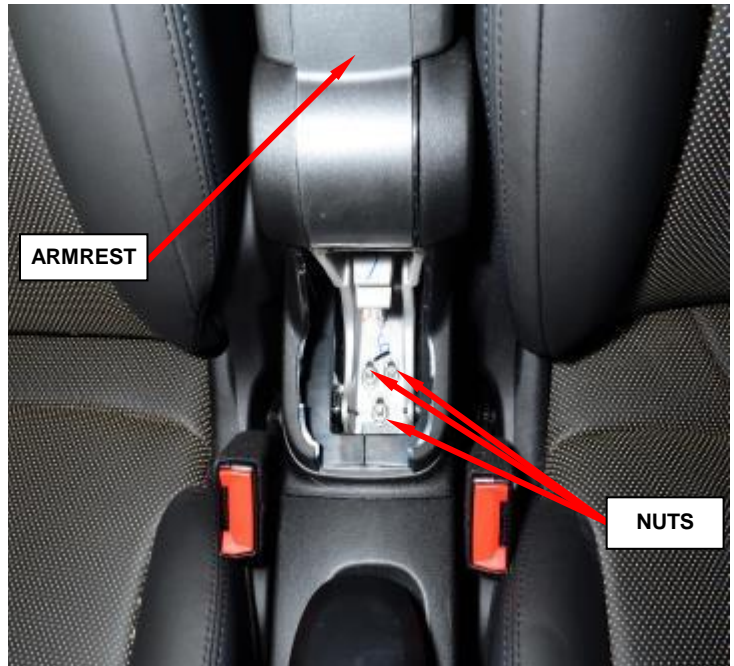
Figure 5 – Arm Rest

- l. Using a trim stick or equivalent, placed between the armrest hinge and arm rest bezel, release the armrest bezel retainers.

- m. Remove and save the three armrest nuts and remove and save the arm rest (Figure 5).

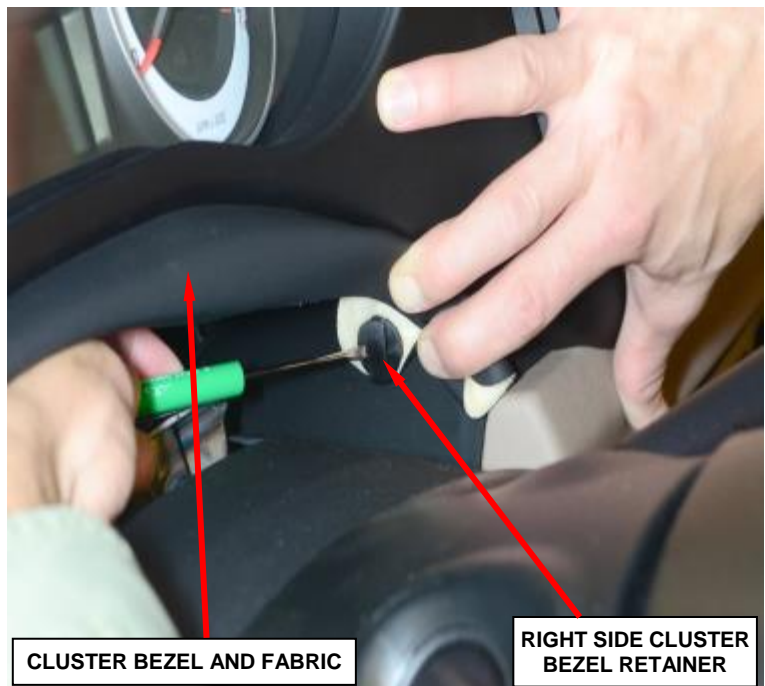
Figure 10 – Cluster Bezel

9. Using a small flat bladed tool or equivalent, remove the center insert from the cluster bezel retainer located above the right side of the steering column (Figure 10).

10. Using a trim stick or equivalent, remove the retainer securing the cluster bezel and fabric to the instrument panel (Figure 10).

118. Install the left retainer securing the cluster bezel and fabric to the instrument panel, located above the steering column (Figure 10).
119. Insert the center into the left retainer fully (Figure 10).

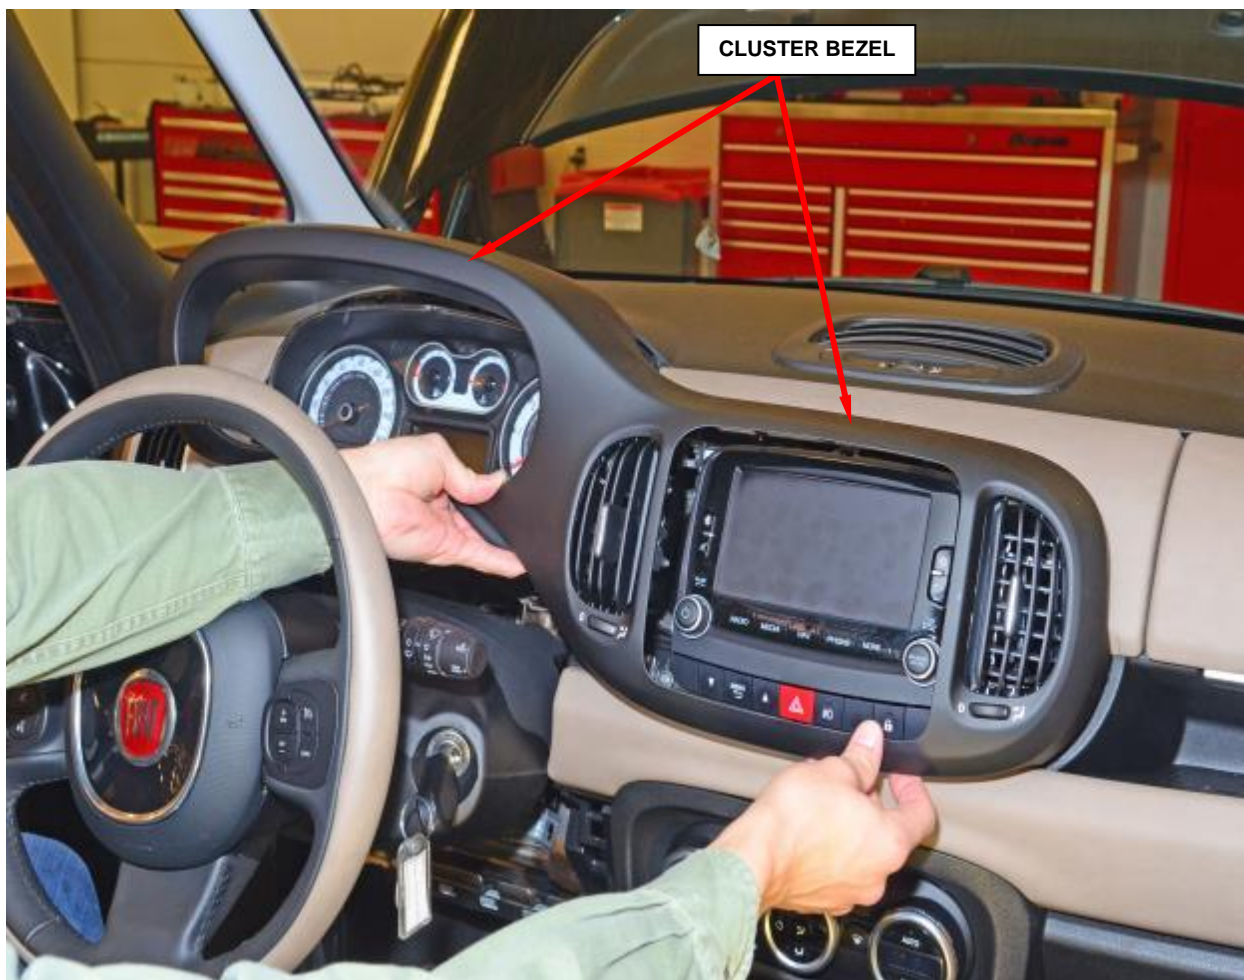
Figure 11 – Cluster Bezel

12. Using trim stick or equivalent, release the cluster bezel retaining clips and remove the cluster bezel (Figure 11).

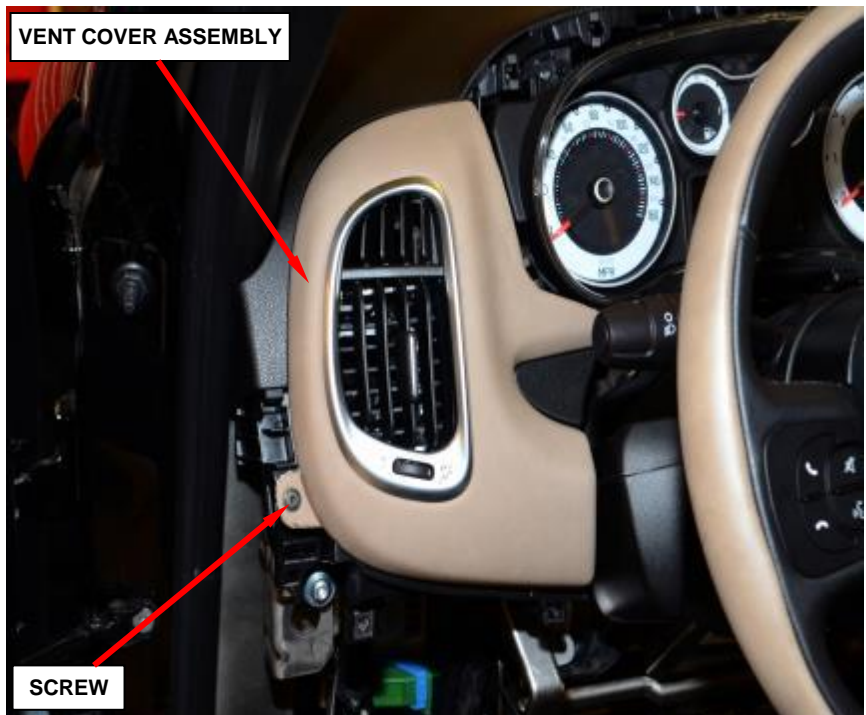
Figure 13 –Vent Cover Assembly

- 15. Remove and save the screw from the driver side vent cover assembly (Figure 13).

- 16. Using a trim stick or equivalent, release the driver side vent cover assembly retaining clips.

103. Position the driver side vent cove assembly to the instrument panel cover (Figure 13).
104. Insert the driver side vent cover assembly retaining clips fully.

105. Install the screw into the driver side vent cover assembly and tighten securely (Figure 13).
106. Connect the antenna connectors to the radio.
107. Connect the radio electrical connectors to the radio.

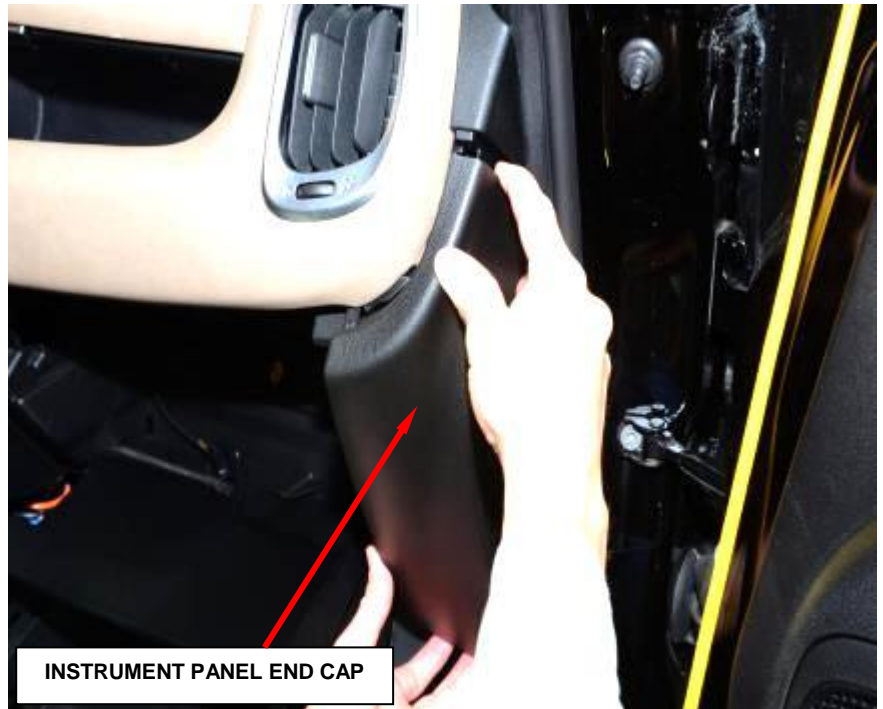
Figure 26 – Instrument Panel End Cap

31. Using a trim stick or equivalent, release right instrument panel end cap retaining clips (Figure 26).

32. Remove the end cap.

91. Position the instrument panel end cap to the instrument panel and engage the instrument panel end cap fully (Figure 26).
92. Position the center instrument panel bezel to the instrument panel cover (Figure 30).

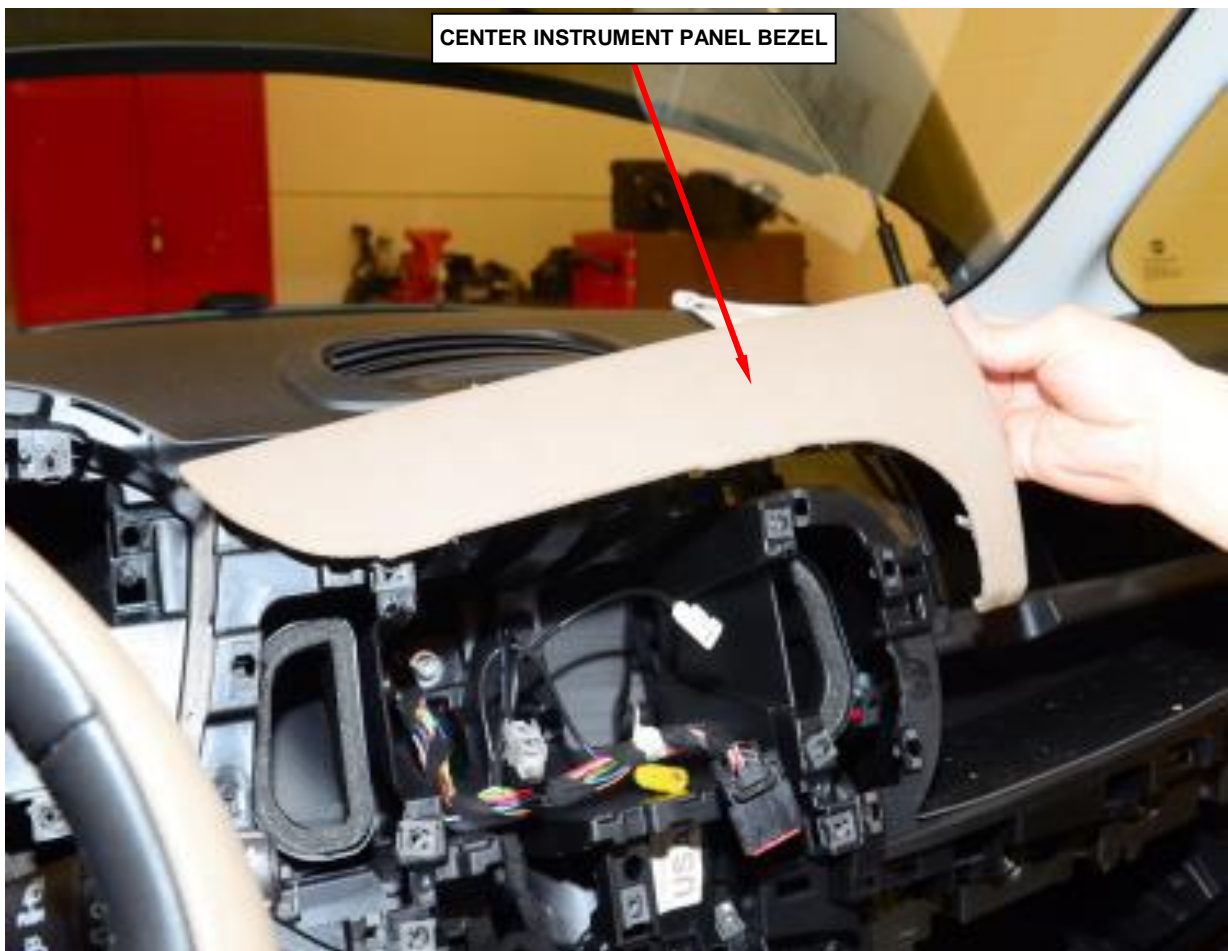
Figure 30 – Center Instrument Panel Bezel

40. Using a trim stick or equivalent, release the center instrument panel bezel retaining clips.

41. Remove the center instrument panel bezel from the vehicle (Figure 30).

93. Engage the center instrument panel bezel retaining clips fully (Figure 30).
94. Open the glove box door.
95. Use the following steps to install the glove box limiter the instrument panel.
