# SAFETY RECALL

Date	Number	Release	Page
12.2015	RVXX1507	01	1 (2)

## Fontaine Ultra LT Fifth Wheel, Replacement

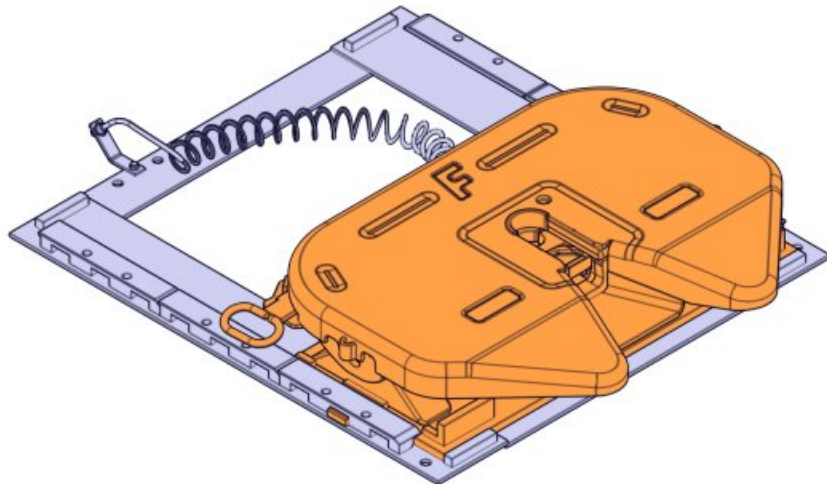
Fontaine/ Ultra LT SLTPL400

Fontaine Fifth Wheel Company (Fontaine) is recalling certain Ultra LT Fifth Wheel connectors, part number SLTPL4000, manufactured July 29, 2009 to May 27, 2013. Over time, improper coupling techniques may result in cumulative damage to the fifth wheel and its locking mechanism, which in turn may result in failure of and/or improper engagement of the locking mechanism (Reference Fontaine Recall 15E-066).

The defect involves susceptibility of the fifth wheel and its locking mechanism to cumulative damage that may cause the fifth wheel lock to function improperly or a failure of the locking mechanism to properly engage. This cumulative damage is the result of the failure of operators to use proper coupling and maintenance procedures over a period of time. These practices include, but are not limited to, high coupling, a failure to conduct a proper visual inspection, a failure to ensure that the fifth wheel is in the fully open and ready to couple position prior to coupling, and failure to follow recommended maintenance practices.

In the interim, owners/operators should inspect each of the Ultra LT fifth wheels in their fleets to look for signs of any damage, including bent operating handles, wedge guides, locking wedges and locking jaws. Special care should be taken to inspect fifth wheels after known or suspected improper coupling attempts and instances in which preventative maintenance has not been performed per Fontaine's instructions. When the severe damage to the fifth wheel was caused by improper coupling procedures, drivers may notice during their required visual inspection the locking mechanism of the fifth wheel does not extend across the entire throat of the fifth wheel. In some instances if the fifth wheel locking mechanism has been damaged, the driver may notice excessive slack in the fifth wheel connection as he/she operates the vehicle.

Where any damage is noted to the fifth wheel during an inspection it should be immediately taken out of service.
