Recall Campaign

NHTSA#: 15V-877
 TC#: 2016-017

Date of Publication: February 2016

| Action Required | Inspect current entrance step to determine if a LCI COACHSTEP. If a COACHSTEP is confirmed, the recall repair is required. Repair per LCI's recall Instructions provided. | | | |

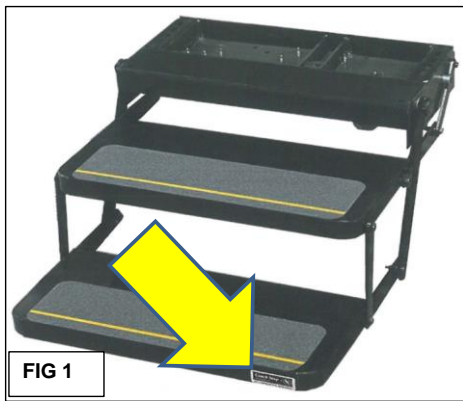
- Fig 1:** Open the complete step assembly and look at the bottom step, right corner for the label identifying the step as a **COACHSTEP**.
Fig 2: If the label is missing, look at the motor parts under the step.
 The **COACHSTEP** will have the motor, gear plate assembly and step module located as shown in this diagram.
- Complete the enclosed Reply Form and return to Jayco Engineering / Regulatory Compliance
