**DATE: SEPTEMBER 14, 2015**  
**TO: BLUE BIRD OWNERS**  
**SUBJECT: RECALL R15YA**  
**DRIVER'S HEATER SWITCH PANEL INVERTER FAILURE**

**NHTSA Recall Number: 15V181 School Bus**

## Driver's Heater Switch Panel Inverter Failure

Models Affected: Certain 2015-2016 Vision

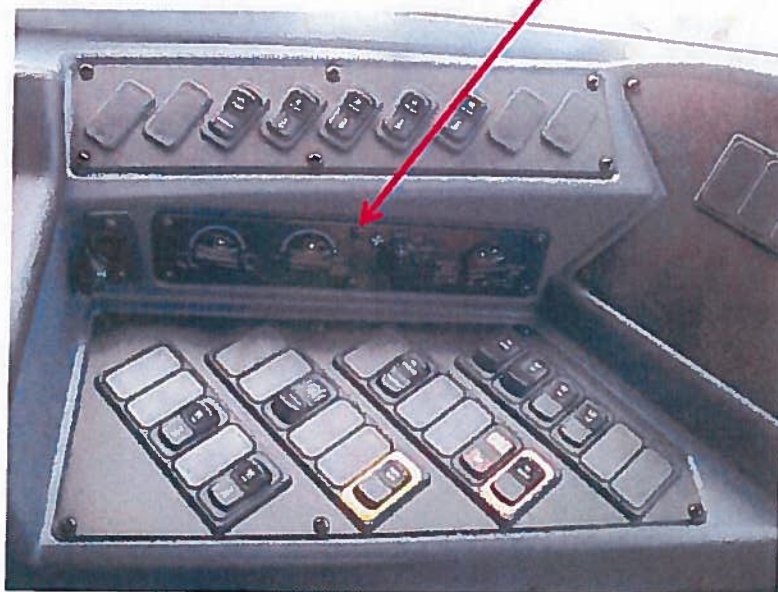
1. Park bus, apply parking brake, and remove ignition key.
2. Disconnect battery ground cable(s).
3. Driver's heater control panel is located on the driver's console.
4. Locate and remove six (6) screws that attach panel-to-console.

Remove six (6) screws from Driver's Heater Control Panel

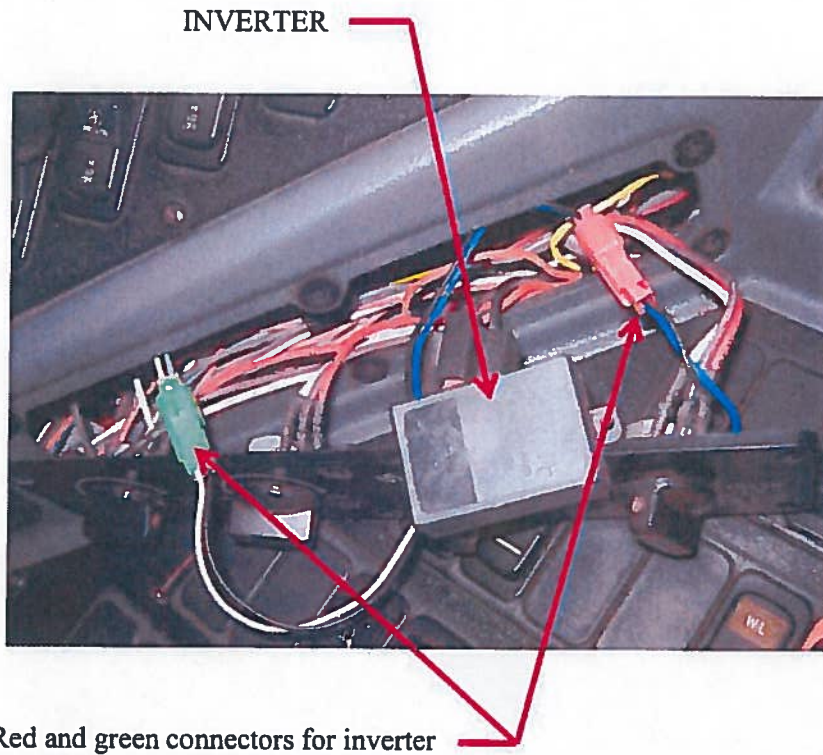
5. Pull the panel assembly toward the center of the bus to access inverter.
6. Unplug red and green connectors, and then remove inverter.
7. Connect new inverter to the appropriate red and green connectors. Place inverter and wiring back into the driver console and install the six screws that were removed in Step 4.
8. Reconnect battery ground cable(s).
9. Place bus back in service.
