**DATE: MARCH 11, 2016**  
**TO: BLUE BIRD OWNERS**  
**SUBJECT: RECALL R15YD**  
**C E WHITE CUSHION FOAM NON-COMPLIANCE FMVSS 302**

**NHTSA Recall Number: 15V277 School Bus**

**Subject: Recall R15YD, C E White – Cushion Foam Non-Compliance FMVSS 302  
Flammability of Interior Materials**

## C E White Quasi-Static Seat Cushion Replacement

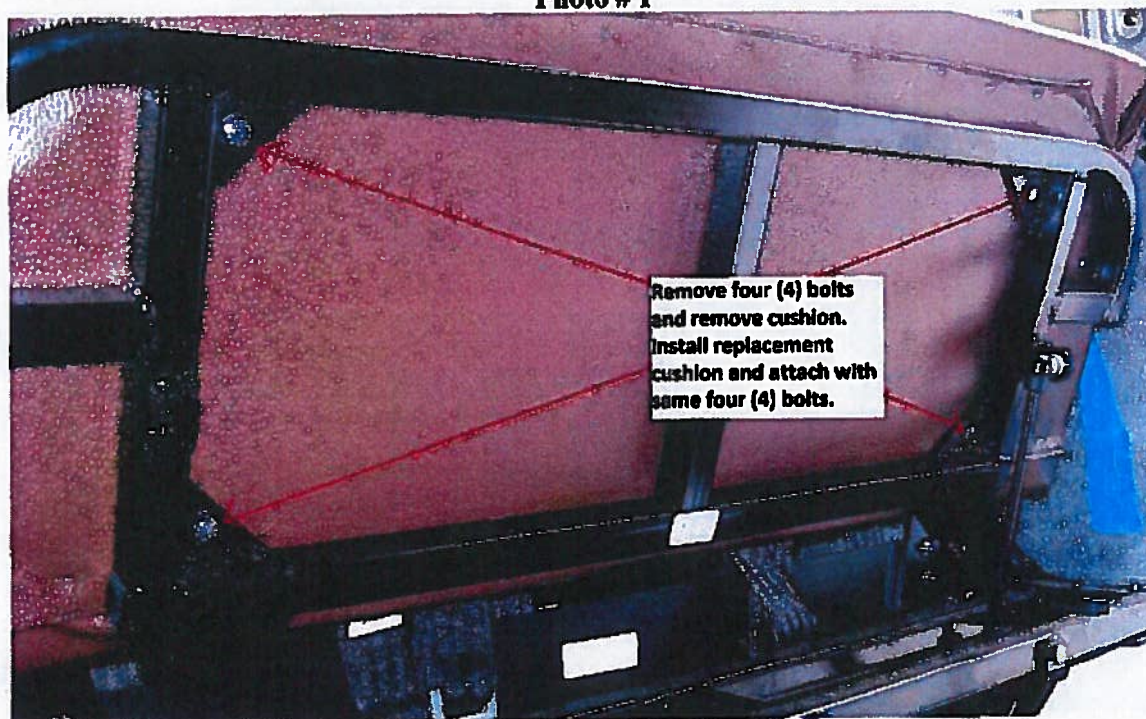
#### Right-Hand and Left-Hand Flip Seat Cushion:

1. From bottom side of cushion, per Photo # 1 remove the four (4) bolts attaching cushion to flip seat frame.
2. Remove existing cushion and install replacement cushion with same four (4) bolts removed from original cushion.

ISSUE	CORRECTIVE ACTION
C E White Quasi-Static Davenport and Flip Seat Cushion Assemblies may have been manufactured with foam that does not meet the requirements of FMVSS 302 – Flammability of Interior Materials.	C E White Quasi-Static Davenport and Flip Seat Cushion Assemblies must be removed and replaced with new FMVSS 302 compliant Seat Cushion Assemblies.

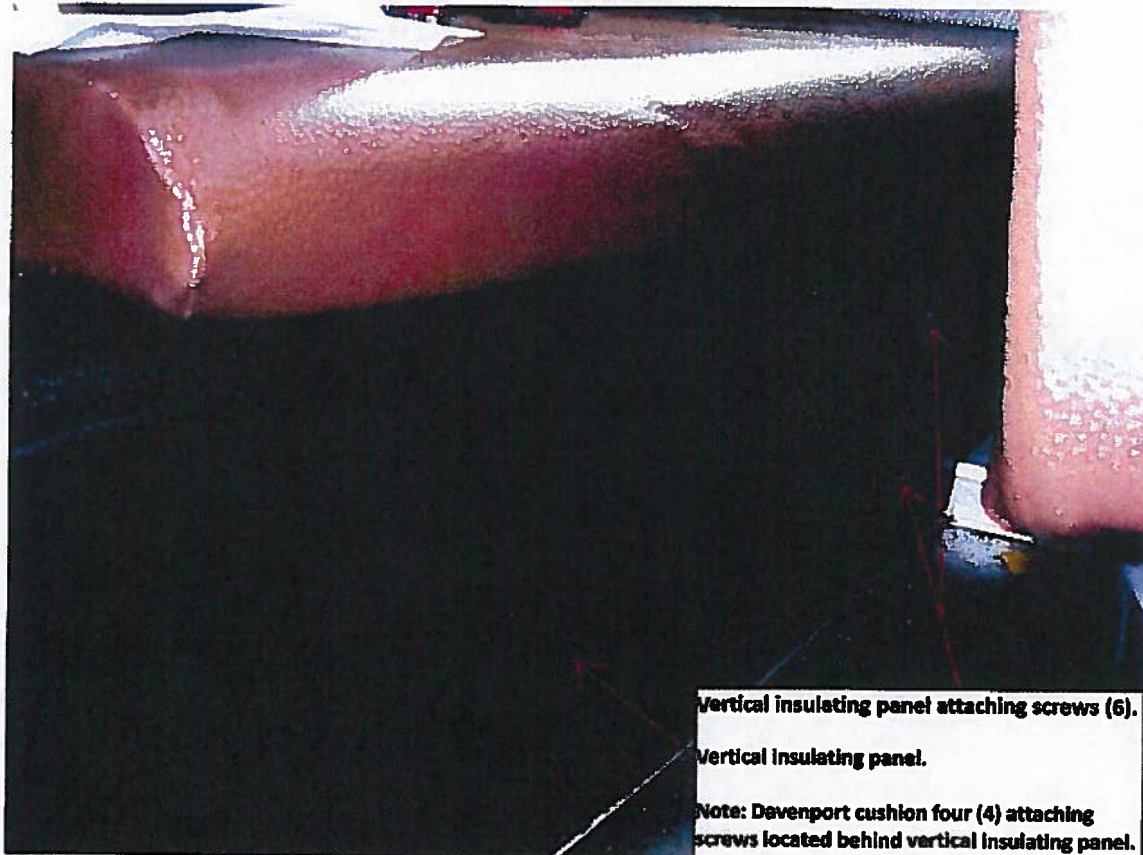
Photo # 2

### Right-Hand and Left-Hand Davenport Seat Cushion For Rear Engine Units:

1. Remove trim caps to access six (6) screws attaching Davenport vertical insulating panel. Remove six (6) screws, pull insulating panel away from Davenport to access the four (4) screws per Davenport seat cushion (see Photo # 2).
2. Remove the four (4) Davenport seat cushion attaching screws, lift up and remove cushion assembly.
3. With cushion removed, using original cushions as location pattern, transfer the four (4) cushion attaching brackets from original cushion to replacement cushion (see Photo # 3).
4. Reinstall both right and left Davenport cushions and vertical insulating panel.
5. Repair complete.
