# SAFETY RECALL NOTICE

## IMPORTANT SAFETY RECALL RVXX1509 NHTSA RECALL # 15V-651 – 2<sup>nd</sup> notice

# Inspection and Replacement Criteria for Drag Links

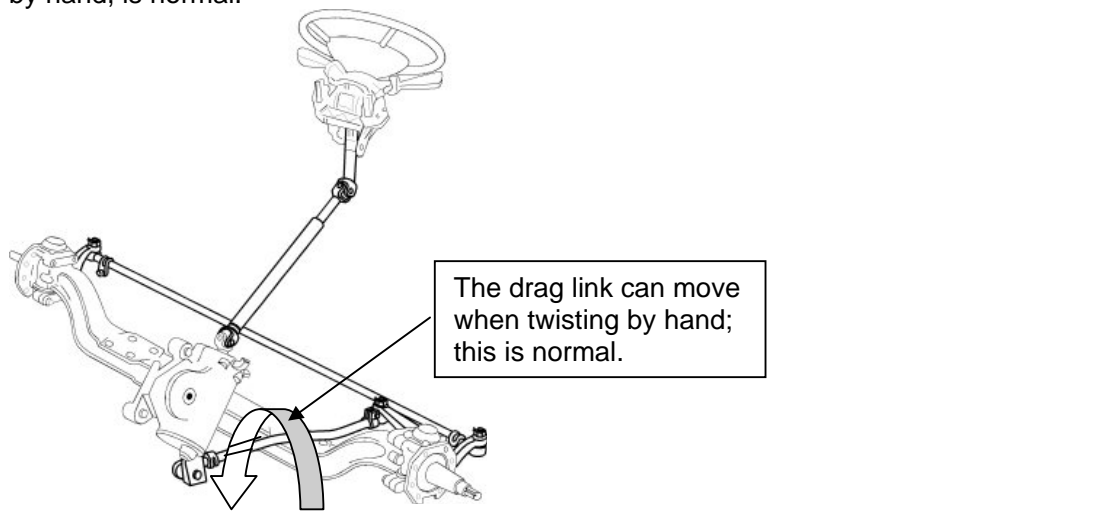
**Important Note:** Rotational Movement, movement when twisting or rotating the drag link by hand, is normal.
