Technical BULLETIN

SAFETY RECALL

ALL 2015 YZF-R1 AND YZF-R1M MODELS FACTORY MODIFICATION CAMPAIGN – Transmission Gears

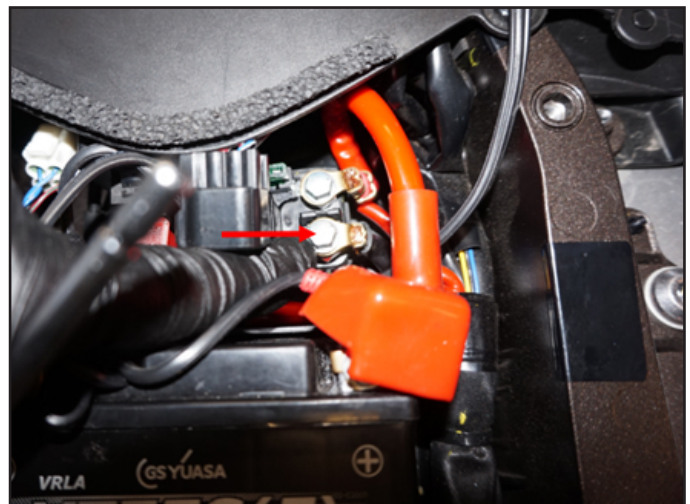
2. Disconnect the negative battery cable.
3. At the starter relay (solenoid), located near the battery, disconnect the primary lead that goes from the relay to the starter motor.

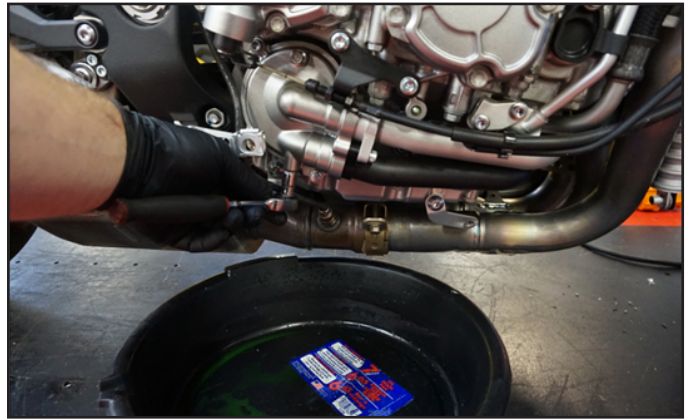
4. With the engine at room temperature, remove the radiator cap then remove the coolant drain bolt located at the water pump.

5. Remove the engine oil drain bolt and drain the oil. Remove the oil filter.

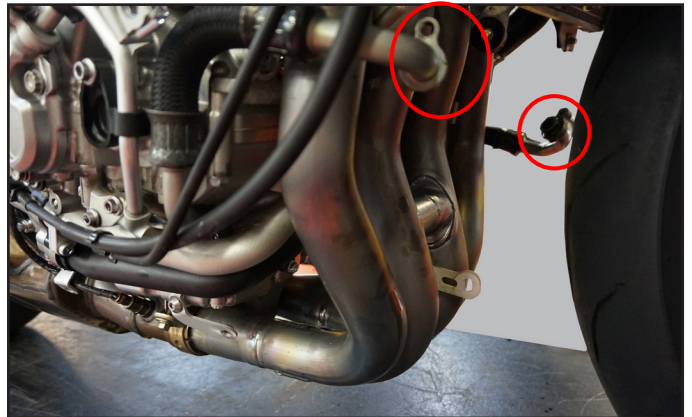
6. Disconnect the oil lines from the oil cooler and remove the oil cooler assembly.

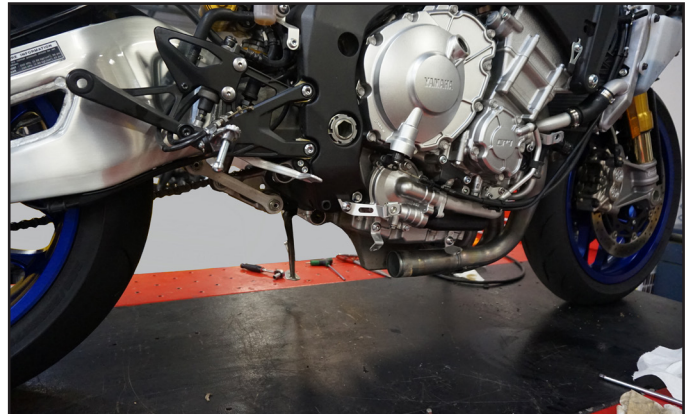
7. Disconnect the EXUP cables from the exhaust. Note that the black colored cable end is on the top and the silver cable end is the bottom for re-assembly. Next, remove the exhaust system from the headers back.

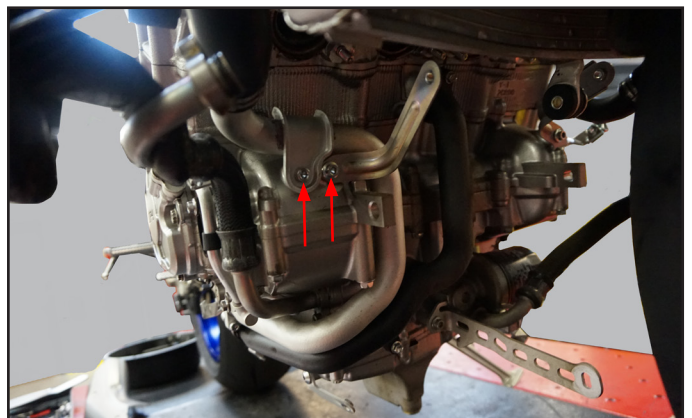
8. Remove the oil cooler bracket and water pipe mounting bolt from the crankcase.

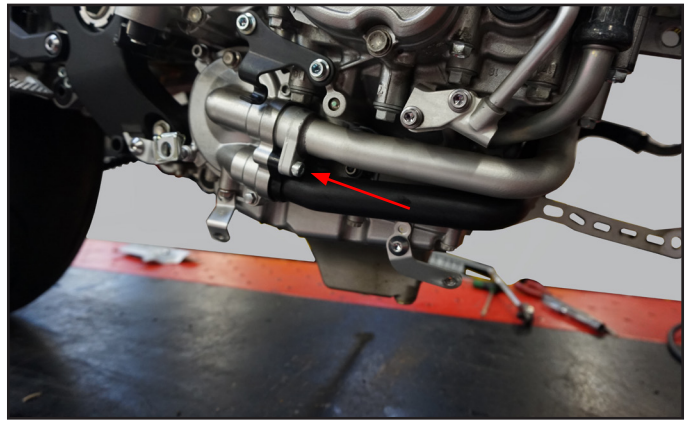
9. Disconnect the cooling pipe from the water pump by removing the retaining bolt. Remove the small diameter hose from the top right of the radiator **taking care to not bend the radiator fitting**. Disconnect the clutch cable at the cable-retaining bracket and detach the cable from the engine.
10. Disconnect the hose from the radiator on the left side of the unit by removing the clamp from the hose. Discard this clamp, it will not be reused.

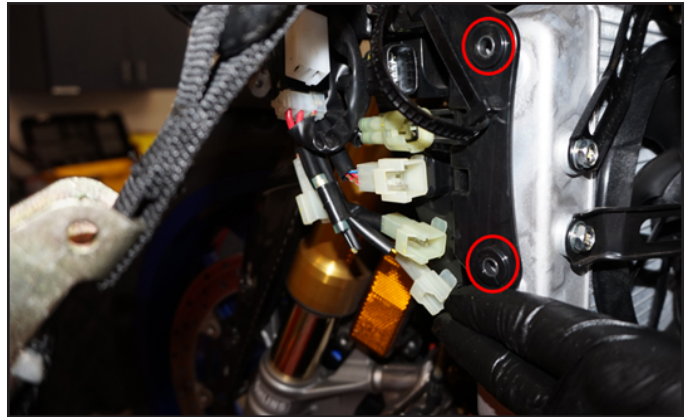
11. Unplug all of the electrical connectors on the upper left side of the radiator located on the plastic rectifier bracket, then remove the 2 bolts retaining the rectifier bracket to the radiator.
12. Remove the radiator from the unit, being careful to not scratch the front fender.

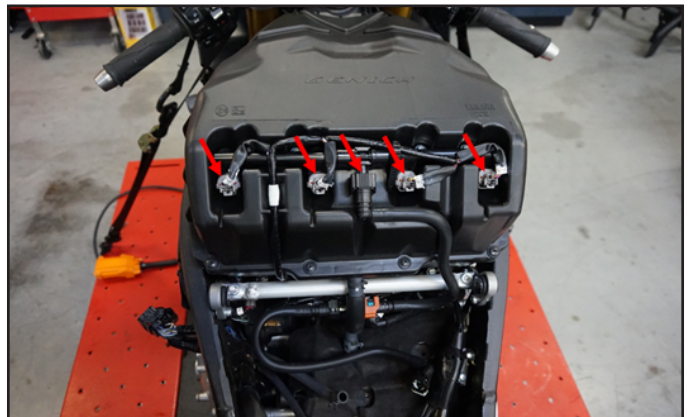
13. Disconnect the secondary injector wiring couplers and fuel line from the air box and remove the air box lid and air filter.

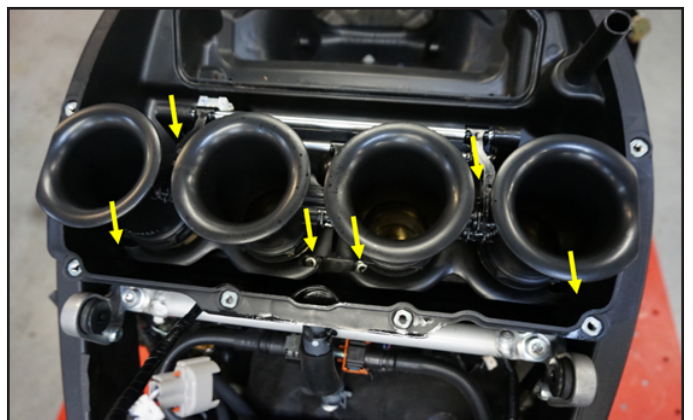
14. Depress the YCC-I (intake) funnels and remove the 6 allen head bolts that attach the air box to the throttle bodies. Unplug the YCC-I servo coupler, crankcase breather hose, and AIS hose. Remove the air box.
15. Disconnect the electrical connectors and the vacuum hose from the throttle bodies. Using an allen socket with extension, loosen the 4 clamps that secure the throttle bodies to the intake manifolds by inserting the tool from below the frame on either side.

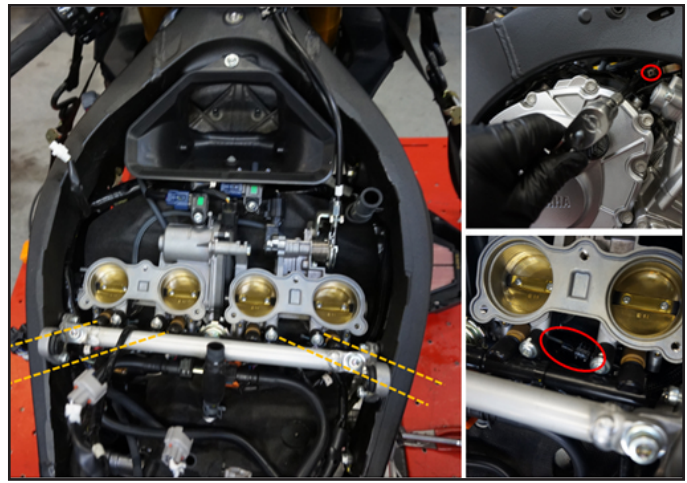
16. Remove the ignition coils and AIS assembly from the valve cover.
17. Disconnect all electrical connections below the fuel tank area/top of the engine. Pay close attention to verify all of the connectors were disconnected to prevent damage to sensors when removing the engine. The coolant temperature sensor (back of the cylinder head) and the gear position sensor (top of crankcase above countershaft sprocket area) are particularly easy to overlook. Remove the starter motor cable that was disconnected in step 3 from the tail area and set the excess wire on top of the engine.

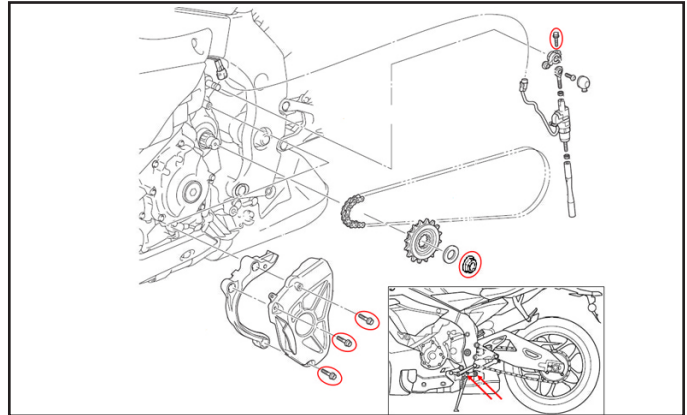
18. On the left side of the unit, unplug the electrical connections for the stator, oil pressure sensor, and QSS shift switch located inside of the black rubber boot. Remove the shifter from the end of the shift shaft splines, and remove the side stand assembly. Next remove the countershaft sprocket cover and countershaft sprocket. If needed, loosen the rear axle and adjust the drive chain to gain additional chain slack to aid in removing the countershaft sprocket from the engine.

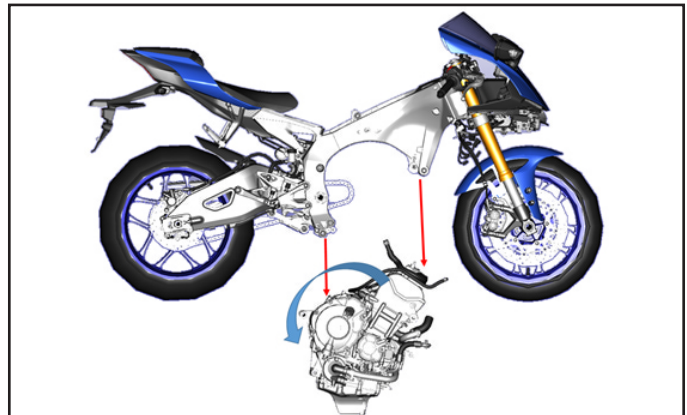
19. Place a suitable jack or stand under the engine. When lowering the engine from the frame, it is best to use 2 people. Remove the 2 upper engine mounting bolts, then remove the nuts from the 2 rear engine mounts. Retract the 2 rear bolts that secure the engine to the frame and loosen the 2 collars inside the frame using the special tool (KM-01485, available from K&L Supply). Lower the engine from the chassis carefully while checking for wiring connections or hoses that may have been overlooked in earlier steps. It may be necessary to rotate the engine slightly so the drive chain is free of the transmission counter shaft. When the engine is removed, place the engine upside down on the prepared work surface.

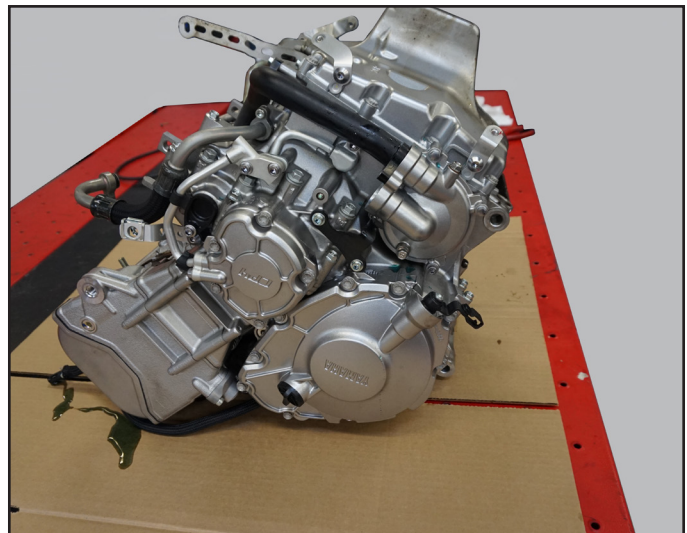
NOTE: The adjacent photo shows the engine correctly positioned after removal. The remainder of this procedure can be performed with the engine in this position.

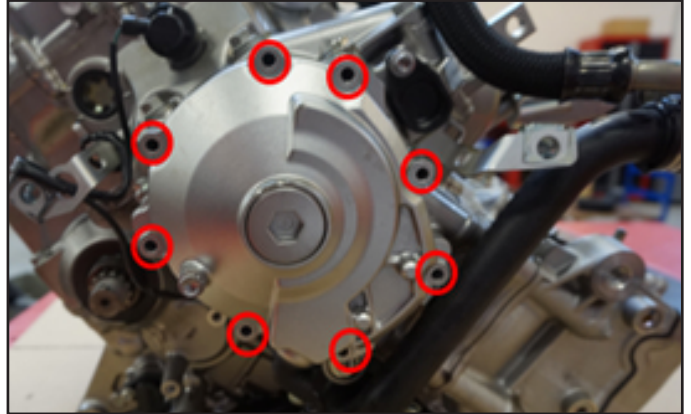
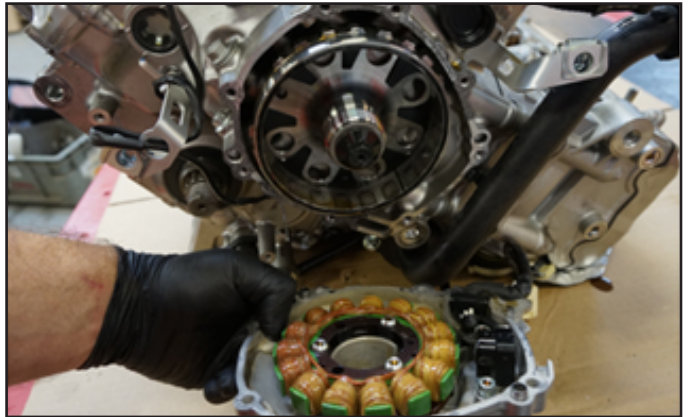
20. Remove the generator cover from the left side of the engine and discard the bolts. It is NOT necessary to remove the flywheel.

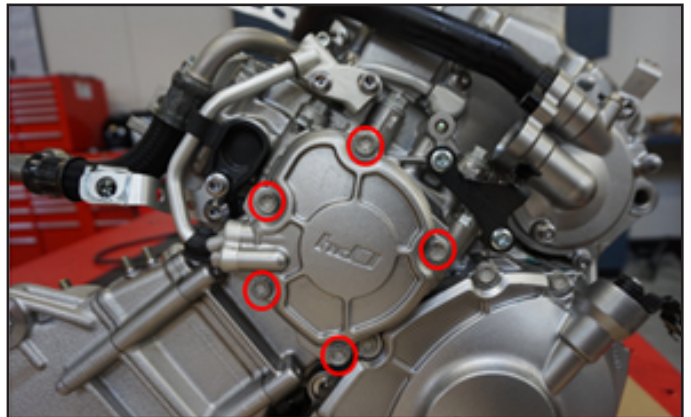
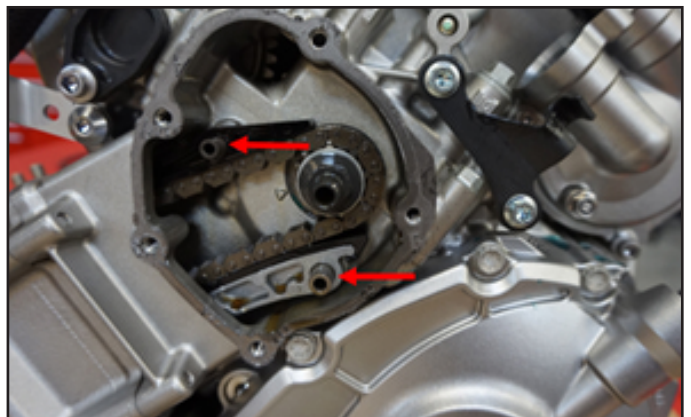
21. Remove the timing cover from the right side of the engine and discard the bolts. Make sure to reinstall the cam chain tensioner guide pivots if they come off with the engine cover.

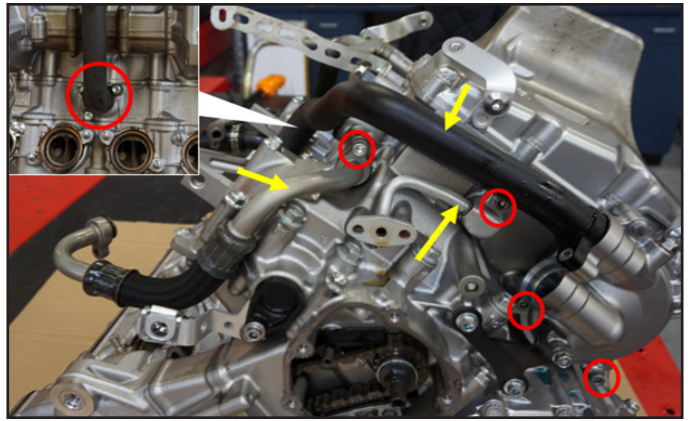
22. Remove the oil pipes, water pump, and coolant pipe.

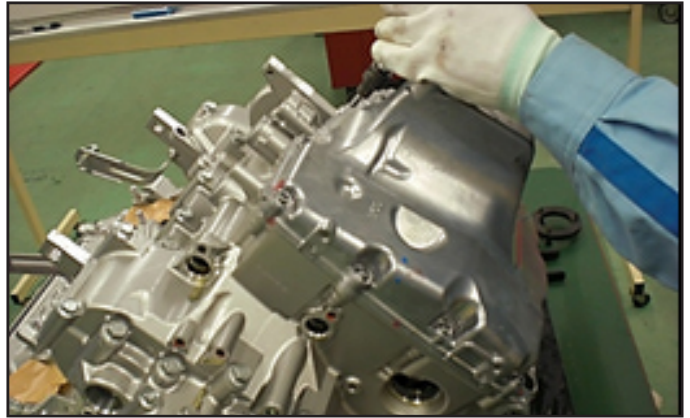
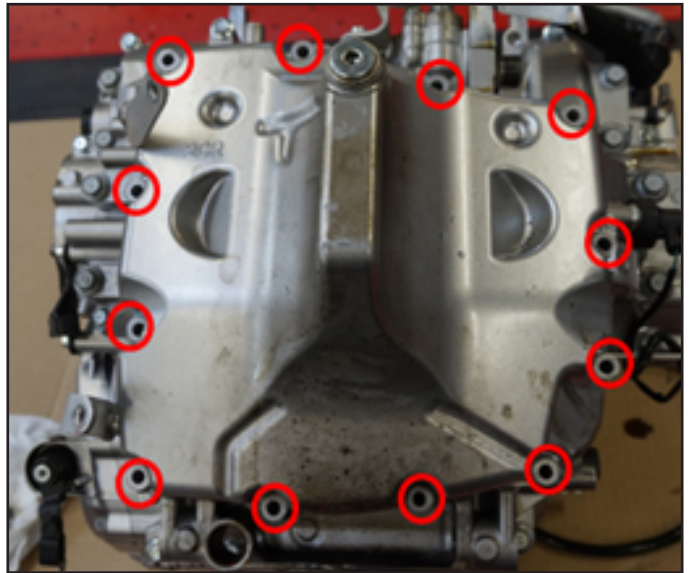
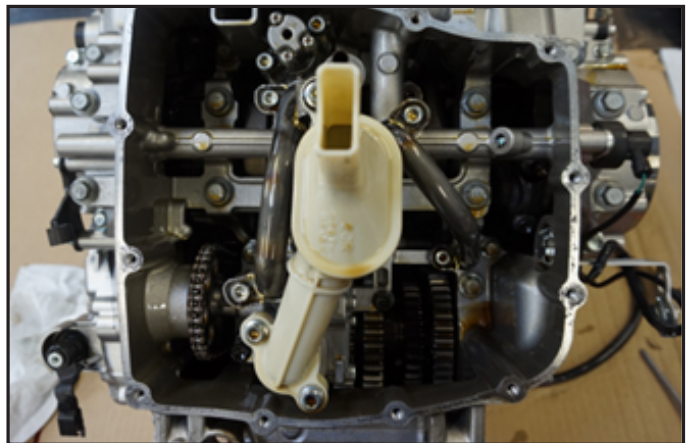
23. Remove the oil strainer cover (oil pan) and discard the mounting hardware.

Loosen each bolt 1/4 of a turn at a time, in stages, and in a crisscross pattern. After all the bolts are fully loosened, remove them.

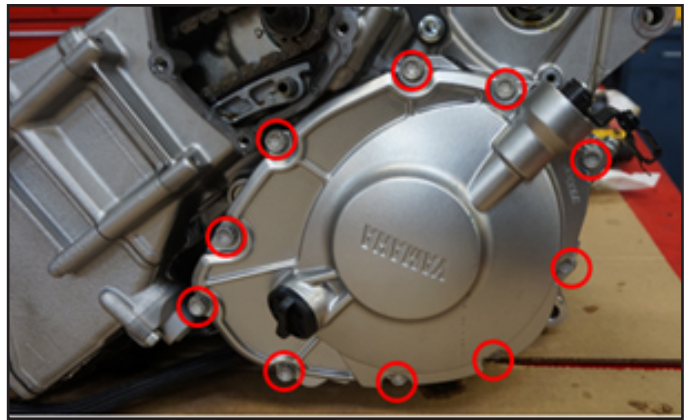
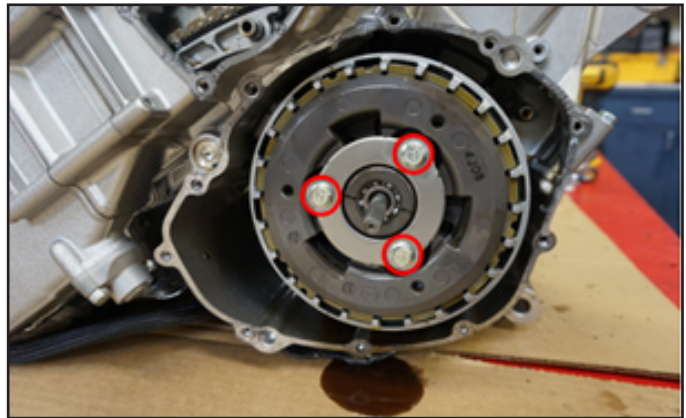
24. On the right side of the engine, remove the clutch cover and discard the mounting hardware. Next, remove the 3 bolts that secure the clutch springs and remove the clutch plates.

Make note of the order of the plates. The outer 3 plates (2 fiber and 1 steel) and innermost fiber plate are different.

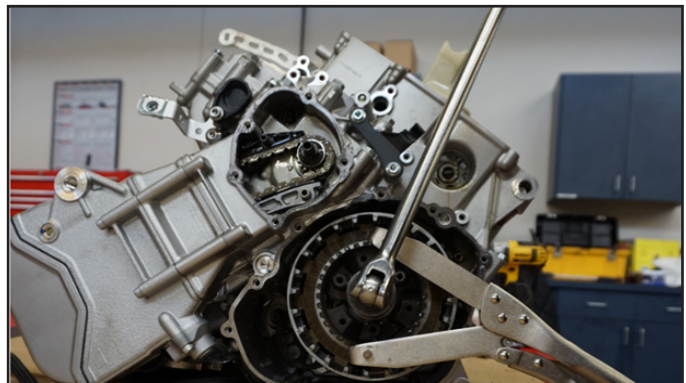
25. Using a clutch holder and appropriate hand tools (breaker bar), loosen then remove the clutch hub nut.

Remove the remainder of the clutch assembly. A universal clutch holder (shown in the adjacent photo) is available through K&L Supply (P/N: YM-91042).

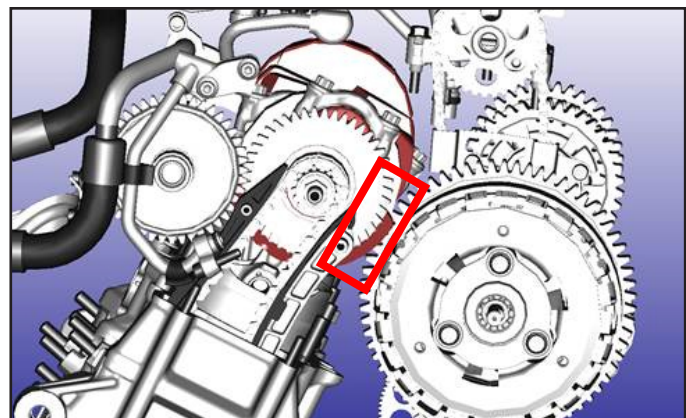
Depending on the position of the crankshaft, the webbing of the crank or connecting rod #4 may overlap the primary drive gear, making it difficult, if not impossible, to remove the clutch basket/primary drive gear. If so, rotate the engine to eliminate the overlap.

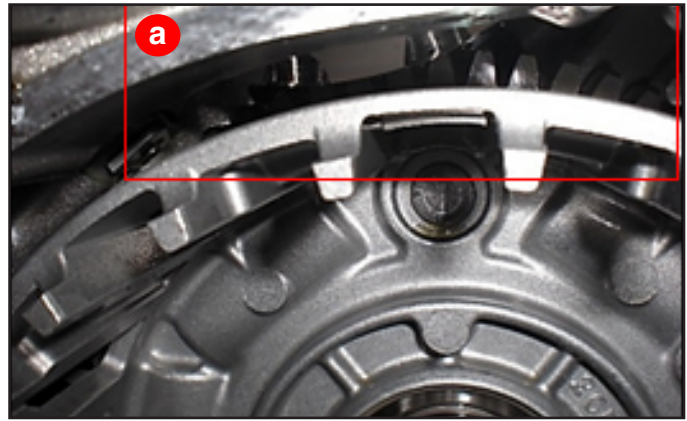
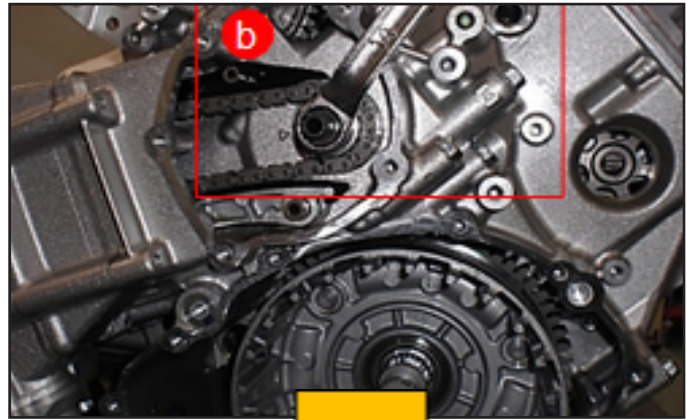
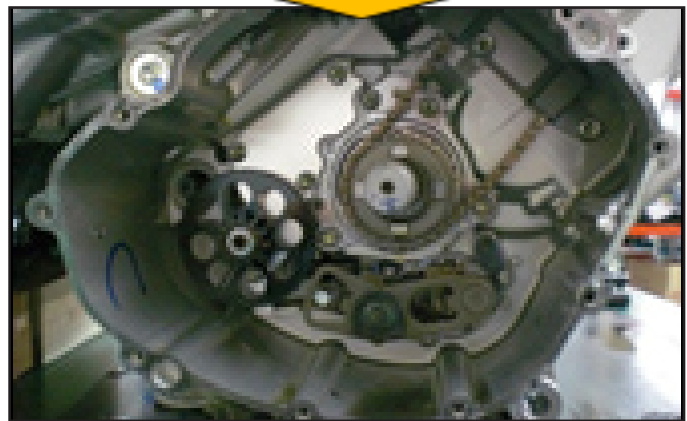
- a. Check to see if the crankshaft web or connecting rod is in front of the primary driven gear.
- b. If it is, rotate the crankshaft to move the crank web or connecting rod out of the way before continuing.

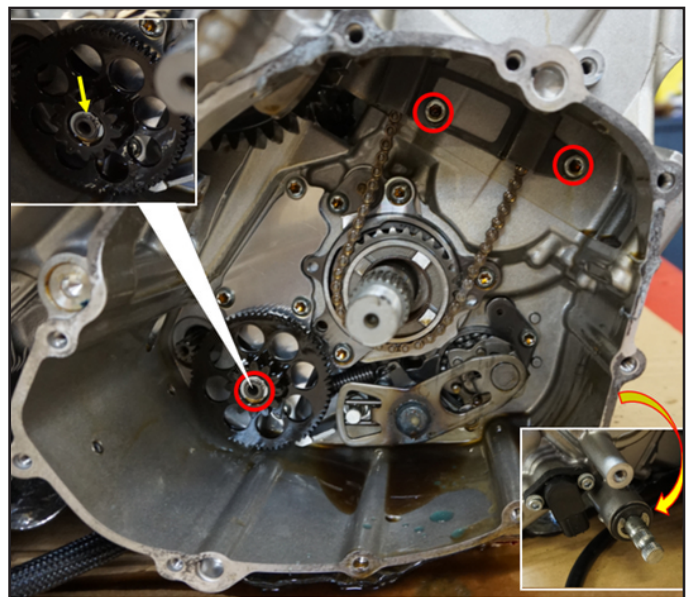
26. Remove the oil pump chain guide, starter idler gear, and shift shaft. Note that the shift shaft has an e-clip located on the opposite side of the engine. Take care to watch for the washer from the shift shaft, it may stick to the crankcase. Keep this washer for reuse upon assembly.

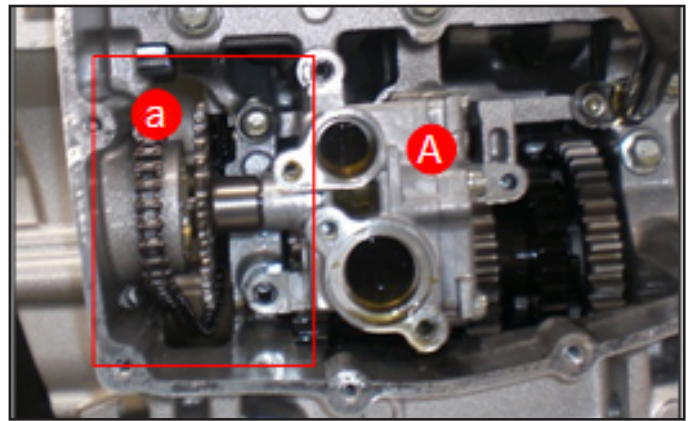
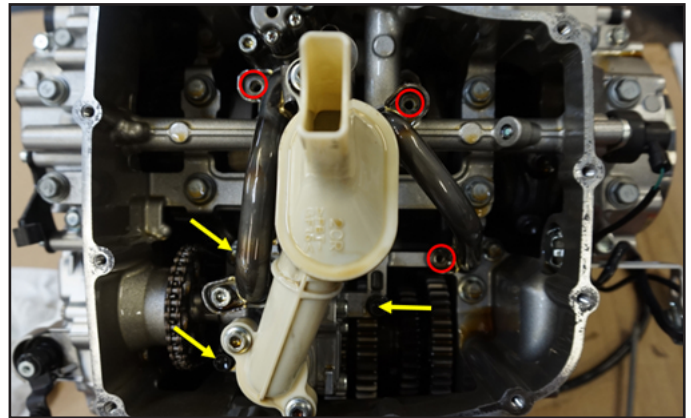
27. Remove the oil pump drive chain from the oil pump gear. Remove the 3 bolts from the oil pump assembly and the 3 bolts from the oil pipes shown, then remove the oil pump with the pipes attached as an assembly. Take care to not lose the oil pump dowel pins and watch for O-rings around the oil delivery pipes that may stick in the crankcase when removing them.

Remove the oil pump chain “a” from oil pump sprocket before oil pump “A” removal.

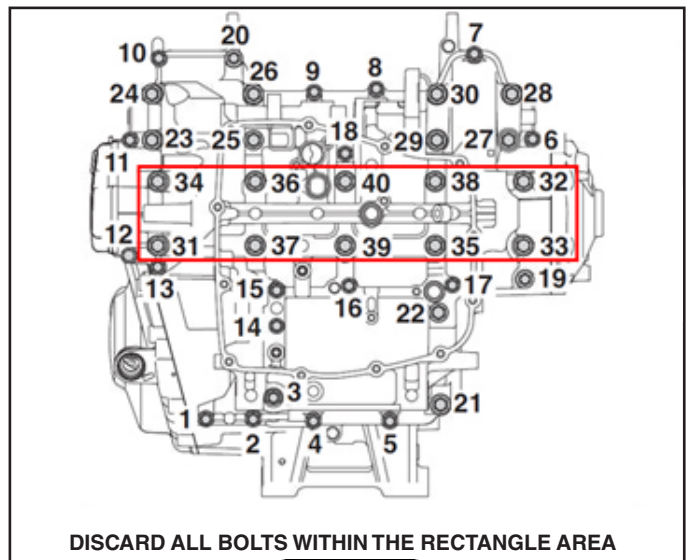
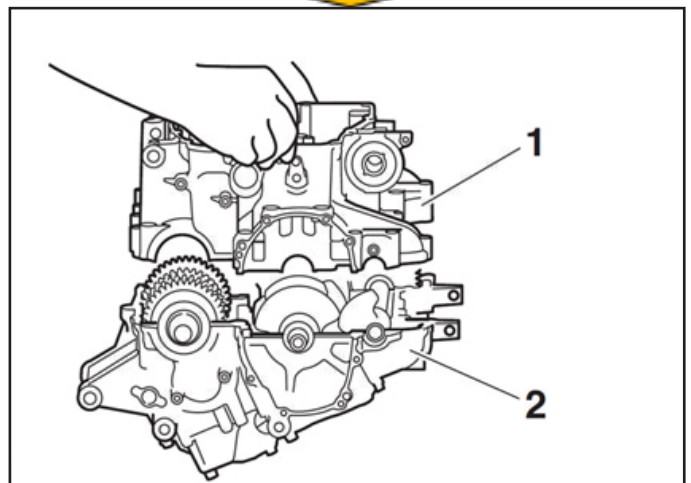
28. Separate the case halves by loosening, then removing the 40 fasteners in the order shown. Gently use a soft-faced mallet on the reinforced areas of the crankcase to release the 2 halves evenly. Do not use excessive force. Lift the lower portion of the crankcase off taking care to not dislodge any of the crank journal or counter balancer bearings out of place. If any of the bearings come out, be careful to reinstall them into the correct positions on the case half.

- Loosen each bolt ¼ of a turn at a time, in stages and in a crisscross pattern. After all of the bolts are fully loosened, remove them.
- Loosen the bolts in the proper sequence as shown.
- The numbers embossed on the crankcase indicate the crankcase tightening sequence.

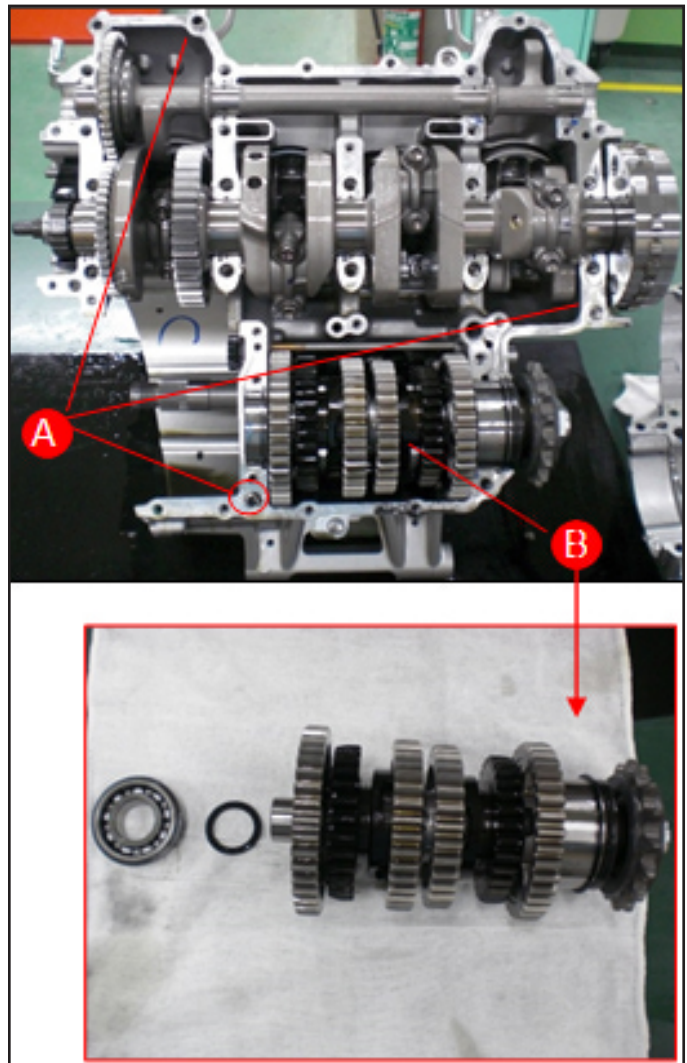
29. Remove the countershaft and crankcase dowel pins, "A." Remove the drive axle assembly "B."

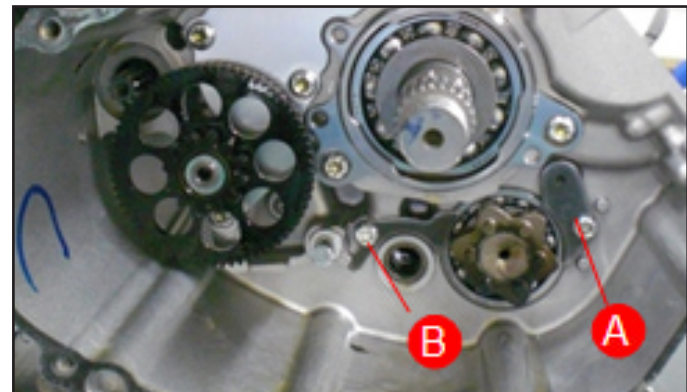
30. Remove the retainers that cover the shift drum and shift fork shafts and remove the shift drum, shift forks shafts, and shift forks. Take note of the orientation and position of the forks for reassembly. There is a spring located inside of the shift fork shaft on both ends; do not lose these. Next, remove the 3 bolts retaining the transmission main shaft.

31. Remove shift drum retainer "A" and "B."

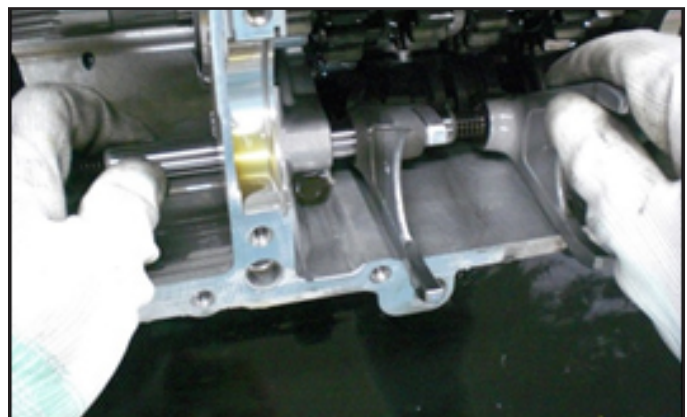
32. Remove:

- Shift fork guide bars
- Shift fork-L
- Shift fork-R
- Shift drum assembly
- Shift fork-C

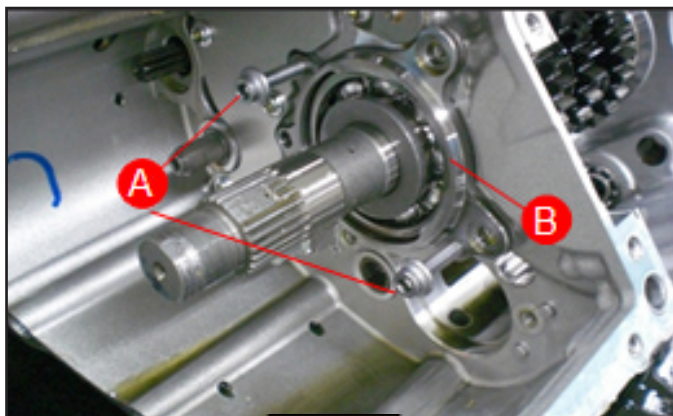
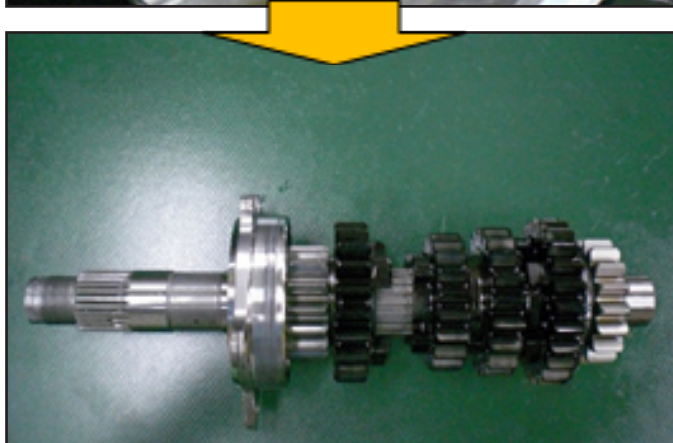
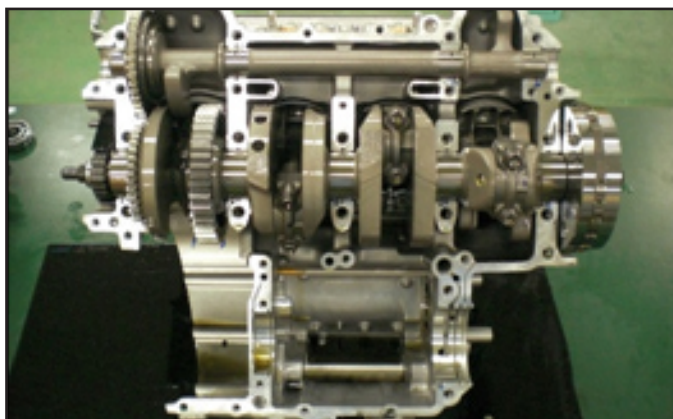
33. Remove the main axle assembly.

- Insert two bolts (M6) "A" into the main axle assembly bearing housing "B."
- Tighten the bolts until they contact the crankcase surface.
- Continue tightening the bolts until the main axle assembly comes free from the upper crankcase.
- Do **NOT** use power tools to tighten.

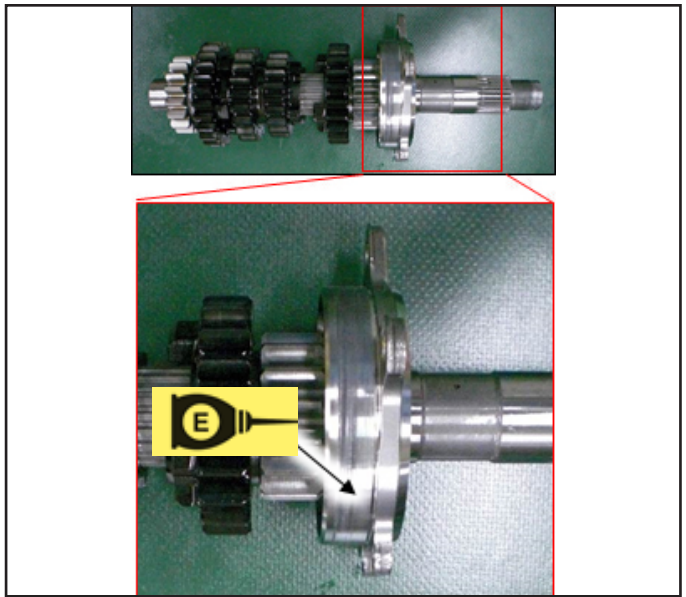
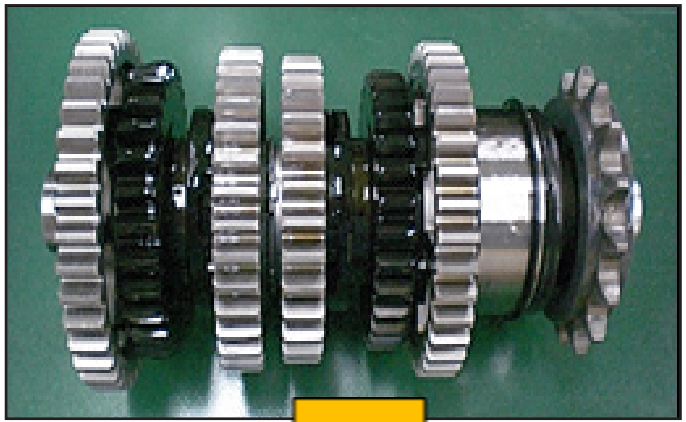
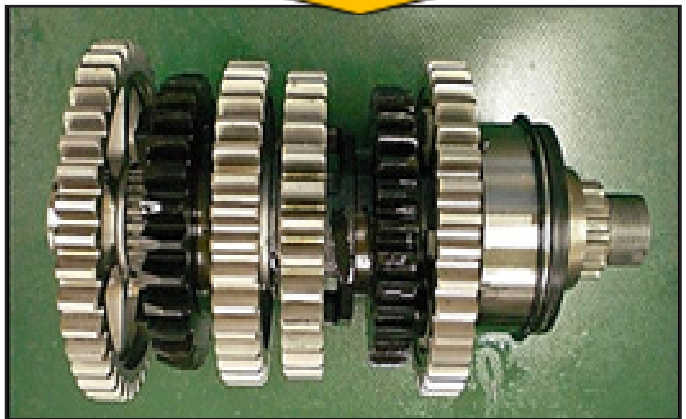
35. Apply engine oil on the outer surfaces of the main axle bearing. Then, insert the main axle into the crankcase axle assembly bearing housing.

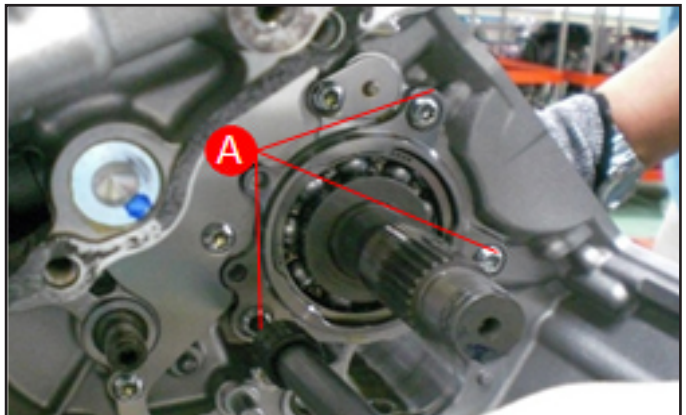
- Insert three bolts (M6 20mm) "A" into the main axle assembly bearing housing.
- Tighten each bolt 1/2 of a turn at a time until the bearing housing contacts to crankcase surface. During this procedure, check if the shaft can be turned smoothly.
- Remove the three bolts and tighten the three new bolts with LOCTITE 12 Nm (1.2m-kgf, 8.7 ft-lbf).

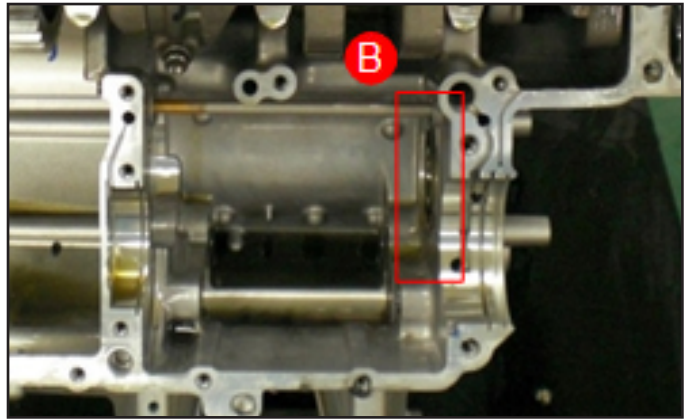
- After tighten three bolts, check if the shaft can be turned smoothly.
If it is not smooth, remove the shaft and tap the bearing "B" to insert it into the crankcase properly. Repeat the procedure.
- Reinstall the shift forks after installing the main axle but before installing the drive (counter-shaft) axle.

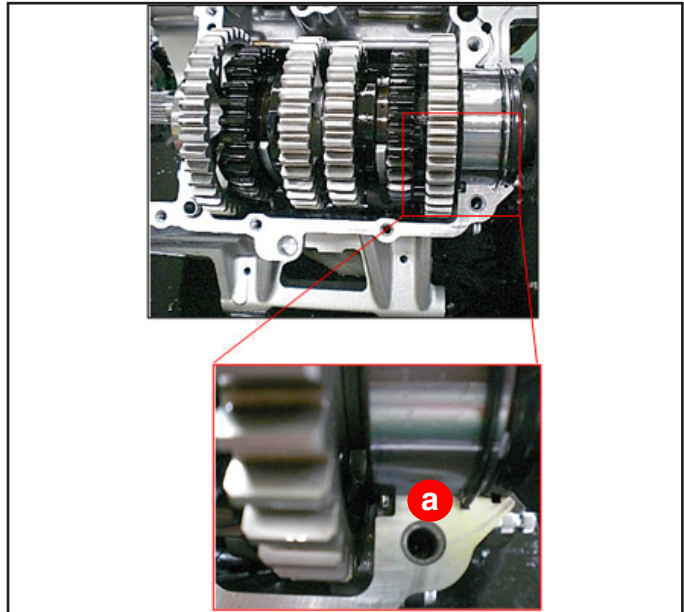
37. Make sure the projection "a" on the drive assembly is inserted into the slot in the crankcase.

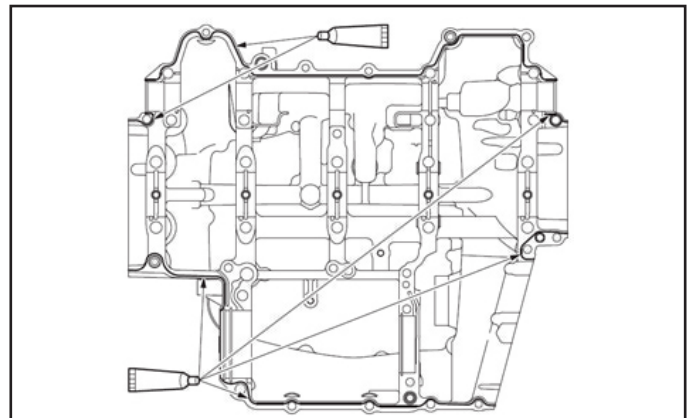
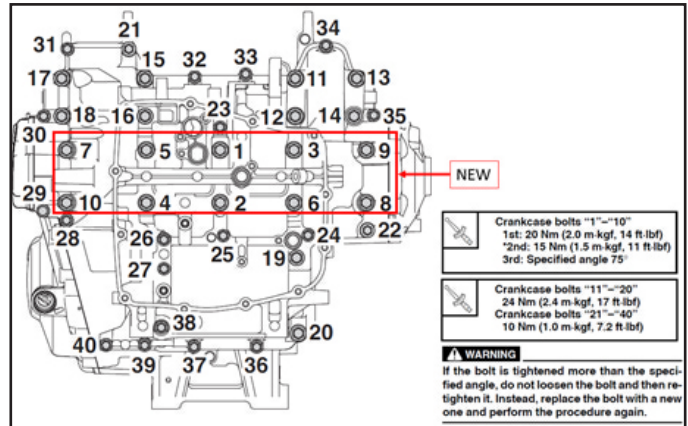
- When installing the shift drum into the crankcases, be cautious inserting the indexed end of the shaft into the gear position sensor. Do not force the shift drum into position.
- Double check that all main journal and counter balancer bearings are in their correct locations and add a light coating of oil to the bearing surfaces before assembling the crankcase halves.
- Apply sealant only in the areas designated in the above right diagram.

- When installing the crankcase bolts, install and torque the bolts in the correct order and to the correct torque specification.

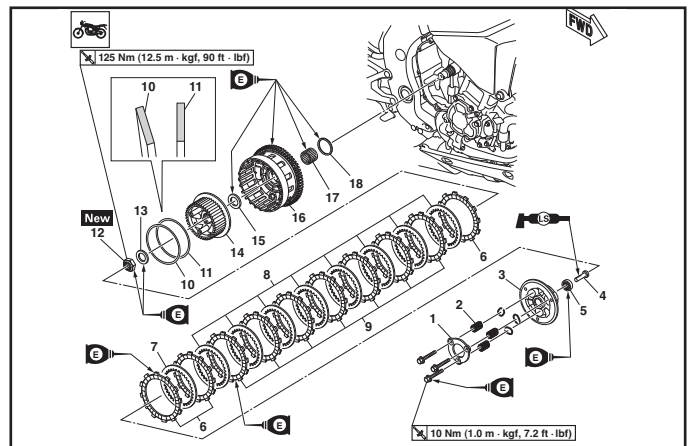
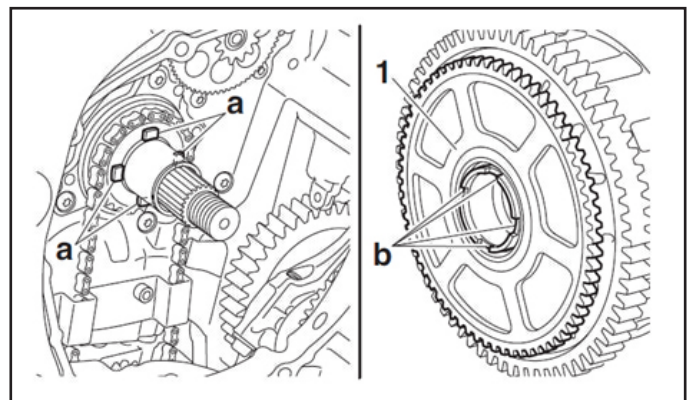
- When assembling the clutch, be aware that the outermost 3 plates (2 fiber and one steel) and innermost 1 fiber plate are different than the others.
- Verify the oil pump gear is properly aligned to the primary gear. Make sure the projections "a" of the oil pump drive sprocket fit into the indentations "b" on the clutch housing "1."

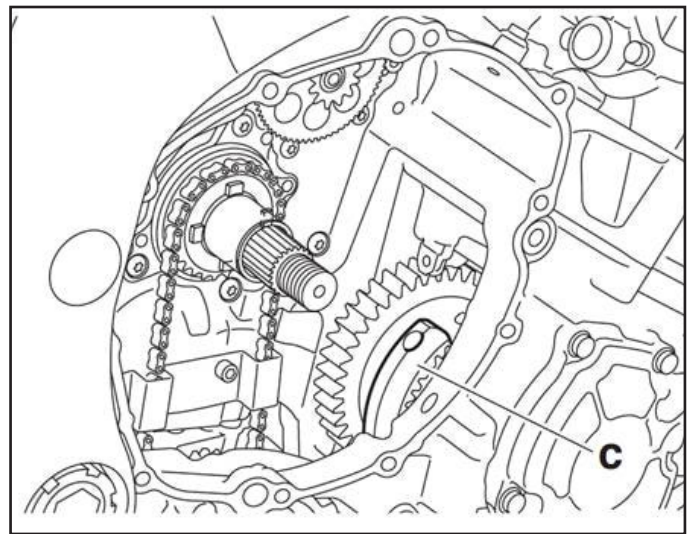
- When installing the clutch housing assembly, turn the crankshaft so the crankshaft web “c” is not visible if it was moved after step 25.
- Verify that the the oil pump chain is correctly installed before tightening the clutch hub nut. Do this BEFORE installing the oil pan so the oil pump chain can be visually inspected and verified.
- Do not reuse the clutch hub nut. Torque all fasteners to specification.

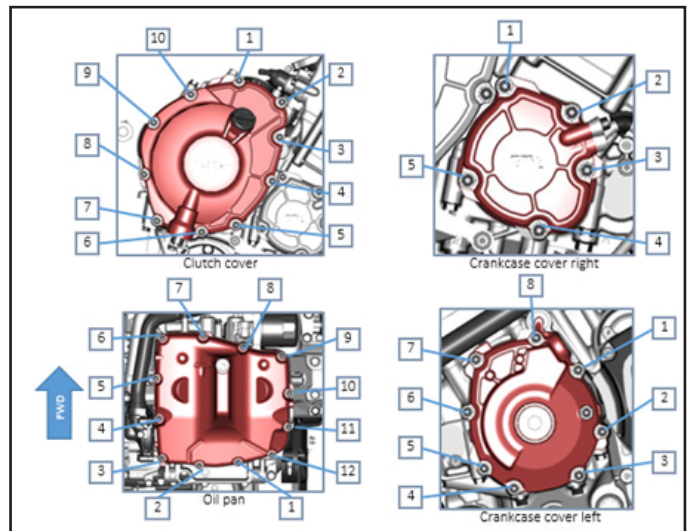
- Do not reuse ANY of the aluminum crankcase cover bolts. Torque these fasteners to the specified torque using the following steps:
 1. Tighten each bolt to 6 Nm (0.6 mkg, 4.3 ft lb) - tighten in order starting at bolt #1.
 2. Loosen bolt #1 and then retighten to 3 Nm (0.3 m kg, 2.2 ft lb).
 3. Angle-torque the bolt to 90 degrees.
 4. Perform step 2 and 3 on the remaining bolts in the specified order.
