SAFETY RECALL NOTICE

IMPORTANT SAFETY RECALL RVXX1508 NHTSA RECALL # 15V-651

Inspection and Replacement Criteria for Drag Links

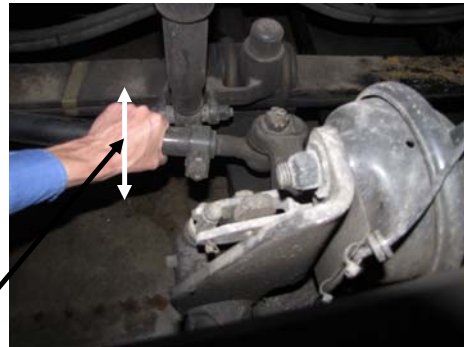
At the steering arm end (i.e., the adjustable end), **push down and pull up** on the drag link in a direction toward the ground by reaching over the driver's side front tire. **Any movement requires placing the vehicle out of service for immediate replacement of the ball socket.**

The adjustable end is the rearmost end and is to be checked by pushing down and pulling up on the drag link.

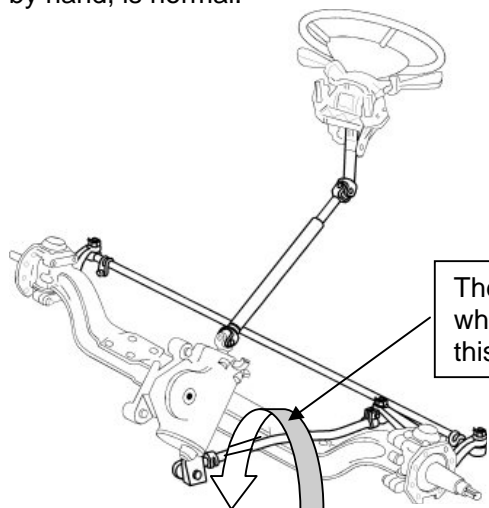
Important Note: Rotational Movement, movement when twisting or rotating the drag link by hand, is normal.
