SUZUKI MOTOR OF AMERICA, INC.

## IMPORTANT SAFETY RECALL

In July 2015 Suzuki notified owners of 2006 - 2015 Suzuki VZR1800 (Boulevard M109R) motorcycles of a safety recall certain Suzuki Genuine Accessory backrest mounting hardware kits (Part Number 990A0-75148 or Part Number 990A0-75148-BLK). These mounting hardware kits may have been used to install accessory backrests on 2006 - 2015 VZR1800 (Boulevard M109R) motorcycles.

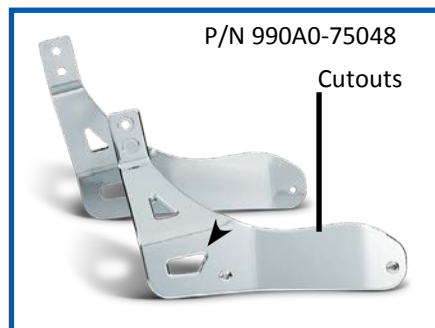
Early Model Brackets

If the motorcycle is equipped with early model backrest mounting brackets with cutouts as shown below, no action is needed.

**NO REPAIR NEEDED**

Because it is equipped with two 75mm and two 95mm mounting bolts.

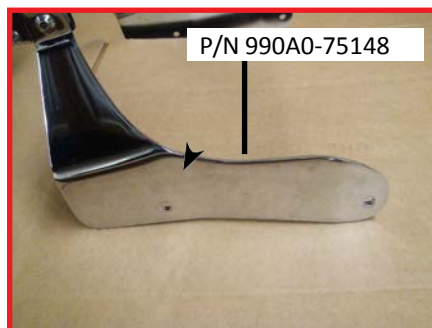
Late Model Bracket

If the motorcycle is equipped with late model backrest mounting brackets without cutouts and it does NOT have saddlebag supports, the mounting bolts must be replaced.

**without** saddlebag supports

**NEEDS REPAIR**

Because it is equipped with incorrect four 110mm mounting bolts — these bolts must be replaced with correct 75mm (two) and 95mm (two) mounting bolts.

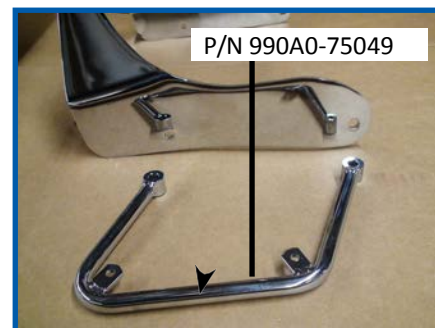
Late Model Bracket

If the motorcycle is equipped with late model backrest mounting brackets without cutouts and it is equipped with Suzuki Genuine saddlebag supports (P/N 990A0-75049), no action is needed.

**with** saddlebag supports

**NO REPAIR NEEDED**

Because it is equipped with longer four 110mm mounting bolts required for the saddlebag supports. Shorter 75mm (two) and 95mm (two) bolts are not required.

**If the Suzuki Genuine saddlebag supports (P/N 990A0-75049) are removed and the saddlebag support bolts are used to install only the backrest, these bolts are an incorrect length and may come into contact with the rear tire. This may cause the rider to lose control, increasing the risk of a crash.**

**If the saddlebag supports are removed, the mounting bolts must be replaced using Suzuki bolt kit P/N 990A0-75048-002 or P/N 990A0-75048-003 (black). Please contact an authorized Suzuki dealer before removing the saddlebag supports. Your Suzuki dealer will remove the saddlebag supports and replace the mounting bolts.**
