GLOBAL SAFETY FIELD INVESTIGATIONS  
DCS4166  
URGENT - DISTRIBUTE IMMEDIATELY

Subject: 15822B - Safety Recall  
Seatbelt Lap Anchor Tensioner Cable – Driver's Side  
Important Information - Performing Service Procedure  
Revised to Add Corrected Photos

Models: 2014-2015 Chevrolet Silverado 1500 Series  
2014-2015 GMC Sierra 1500 Series

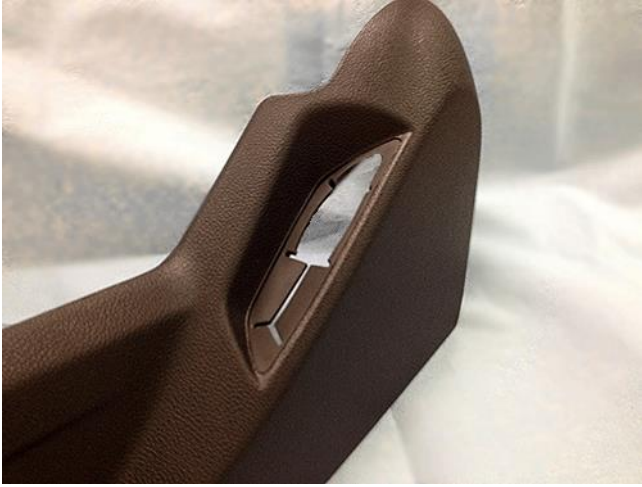
Example of properly executed repair before the seatbelt panel has been reinstalled on the vehicle.

The proper execution of this repair requires using the template and following the detailed instructions provided in the recall bulletin without exception. Doing so will ensure that a consistent and uniform repair is performed on each involved vehicle. The images below show a properly executed repair before the seatbelt panel has been reinstalled on the vehicle, a properly executed on-vehicle repair, and poorly executed on-vehicle repair.

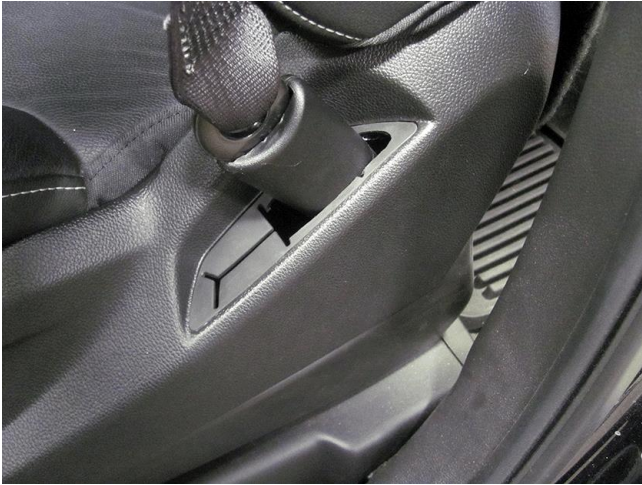
Example of properly executed on-vehicle repair.

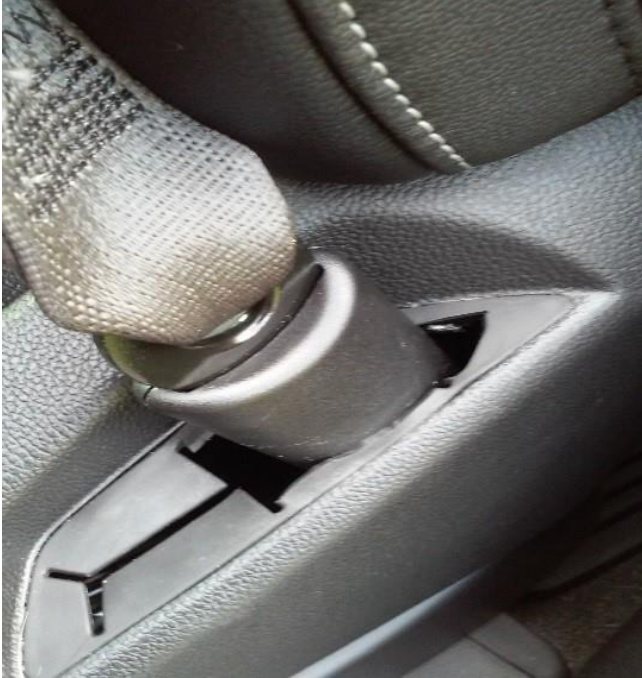
General Motors has received comments from customers regarding the quality of the repair for safety recall 15822B. Specifically, some customers have stated that after the repair was performed, a larger than specified seatbelt trim opening with uneven and jagged edges was visible.

Example of poorly executed on-vehicle repair.
