NISSAN

Rear Liftgate Stay  
Voluntary Safety Recall Campaign

Reference: PC458

Date: June 15, 2016

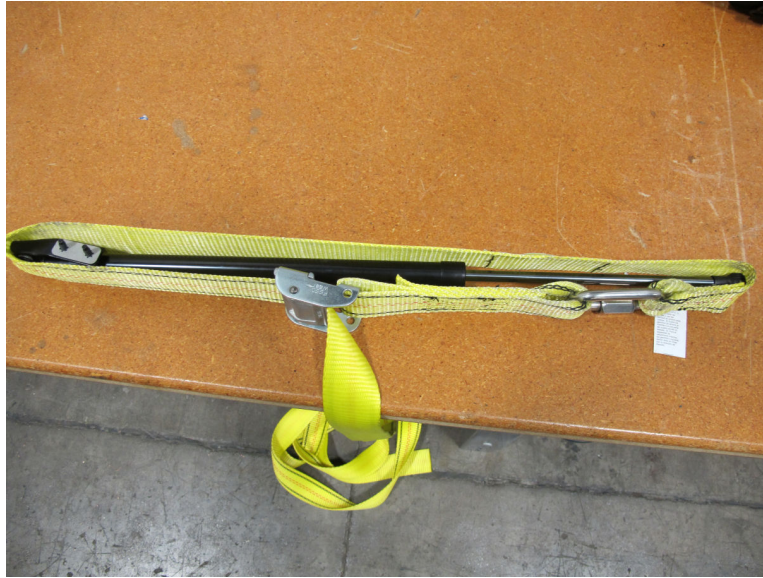
(Figure 1)

1. Install tie down strap over the lift gate stay assembly (Figure 1).

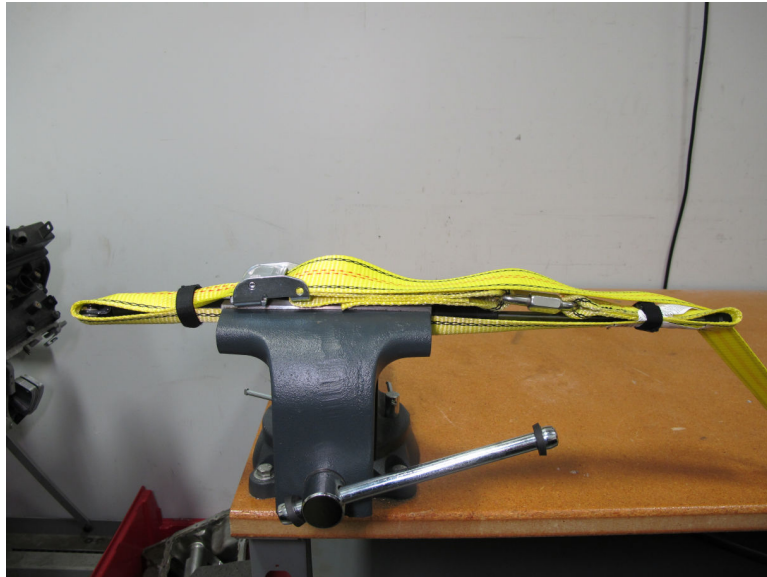
(Figure 3)

3. Secure lift gate stay in vice (Figure 3).

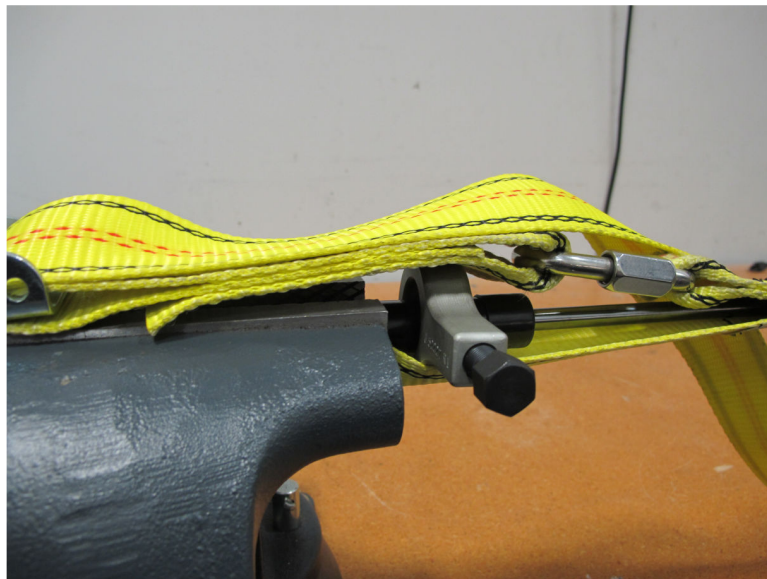
4. Position the gas-venting tool (tool J-52227) just below the top collar of the lift gate stay (Figure 4) and hold in place by finger tightening.

5. Tighten the gas-venting tool (to puncture lift gate stay) until it starts to vent.
  - Allow all gas pressure to completely vent before proceeding.
  - Remove venting tool and remove lift gate stay from vice.
  - Remove safety strap and dispose of lift gate stay through normal parts disposal process.
