Rear Liftgate Stay  
Voluntary Safety Recall Campaign

Reference: PC458  
Date: June 15, 2016

# PC459 - Rogue Lift Gate Stay Venting Procedure

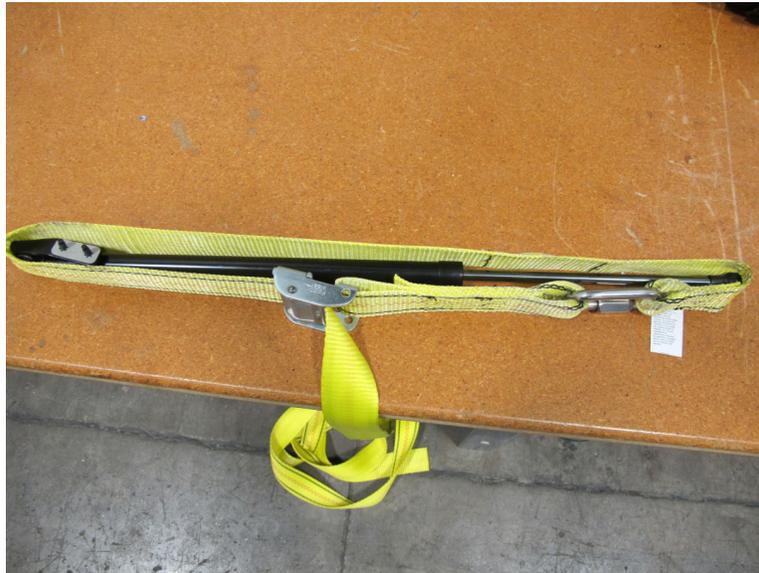
(Figure 1)

1. Install tie down strap over the lift gate stay assembly (Figure 1).

**WARNING: Use a tie down strap rated at 2200 lbs. (1000 kg) or greater to safely and securely hold the lift gate stay assembly.**

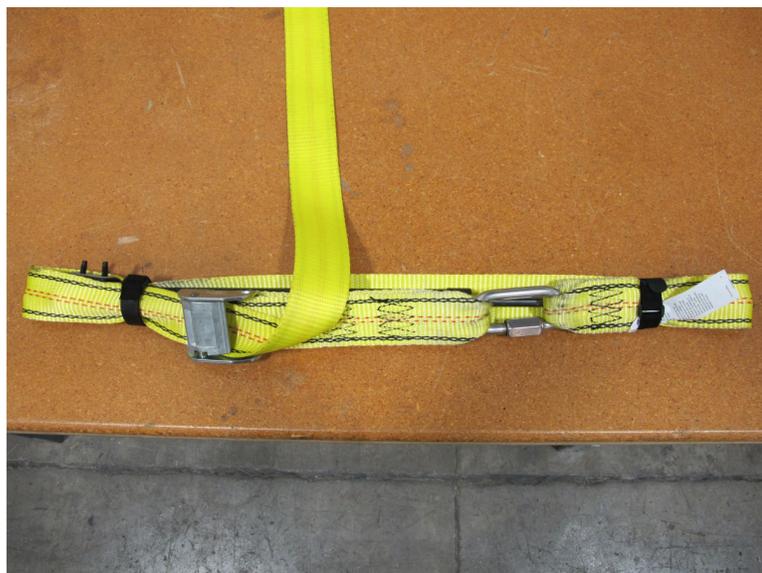
(Figure 2)

2. Secure tie down strap to lift gate assembly using two secure straps (tool # J-52233) (Figure 2).

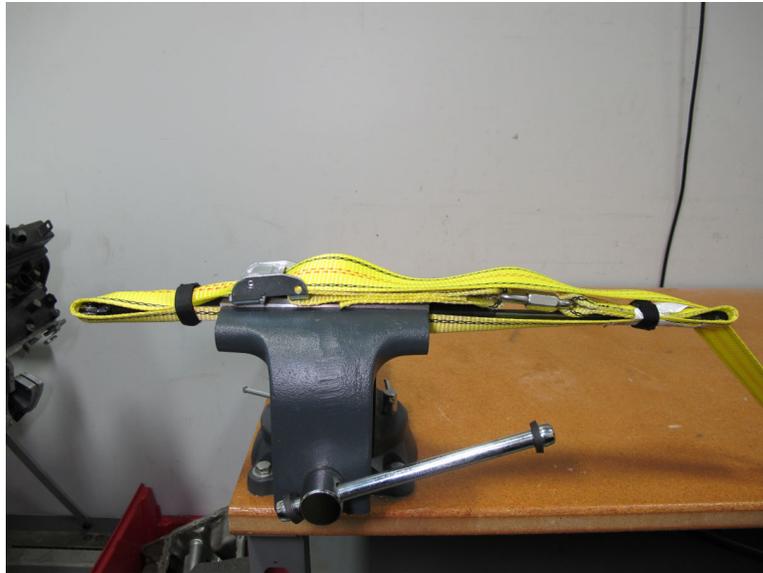
(Figure 3)

3. Secure lift gate stay in vice (Figure 3).

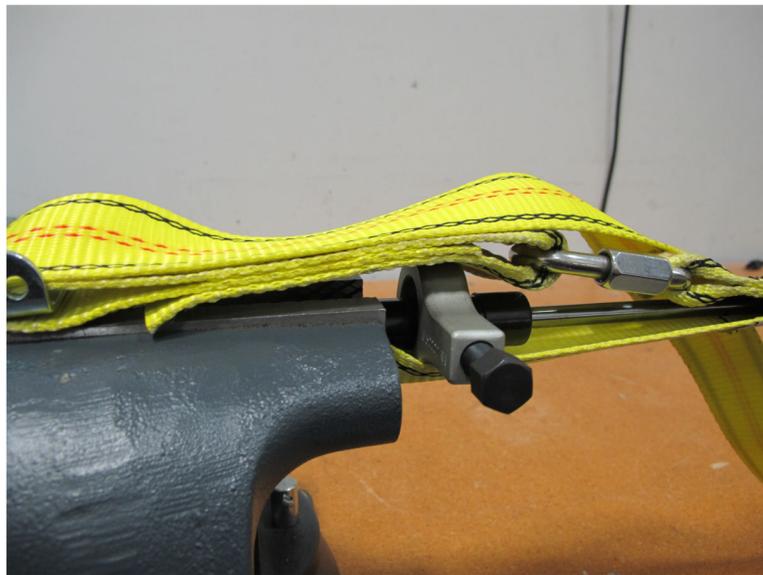
4. Position the gas-venting tool (tool J-52227) just below the top collar of the lift gate stay (Figure 4) and hold in place by finger tightening.

5. Tighten the gas-venting tool (to puncture lift gate stay) until it starts to vent.
  - Allow all gas pressure to completely vent before proceeding.
  - Remove venting tool and remove lift gate stay from vice.
  - Remove safety strap and dispose of lift gate stay through normal parts disposal process.
